21 JANUARY 2022

# **Report of the Inquiry Committee for the accident at Stars Engrg Pte Ltd on 24 February 2021**

**(PART I – MAIN REPORT)**

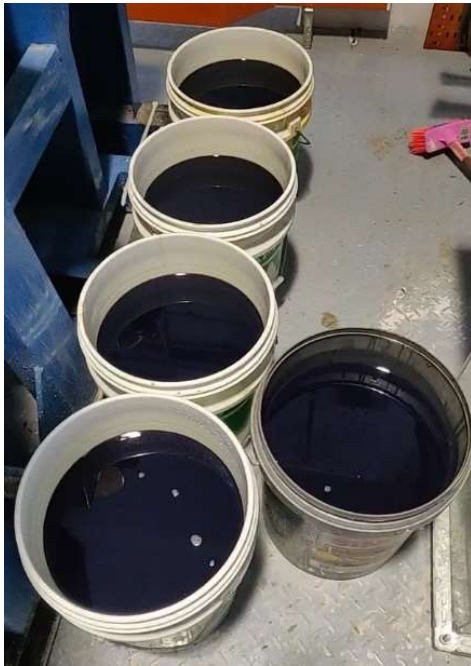
76. Imam and Mehedi observed that the gaskets on the heater openings of the mixer machine's oil jacket were worn out. Imam said that parts of the gasket were stuck to the heater openings and Mehedi said that some parts of the gaskets had broken and fallen off.

Figure 12: Screengrab from video. The 6<sup>th</sup> bucket is not shown here as it was under the drain valve

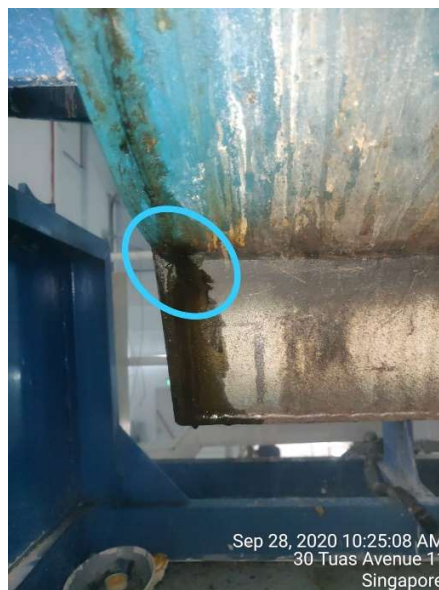
79. Imam sent a photo to Moe at 1025hrs showing oil dripping from a hole on the surface of the oil jacket at the front left bottom corner of the mixer machine with the accompanying messages “hole have small” and “need to welding bro”. Imam heard boiling sounds and saw smoke accompanying the oil leak. It was possibly the first time that an oil leak was noticed since the mixer machine was installed at the worksite. Up to that time, Stars Engrg’s workload in relation to the production of the fire wrap was not high and the mixer machine had, according to Imam, been used only about 2 to 6 times in a month.

Figure 14: First oil leak on jacket, blue circle inherent in Imam’s photograph

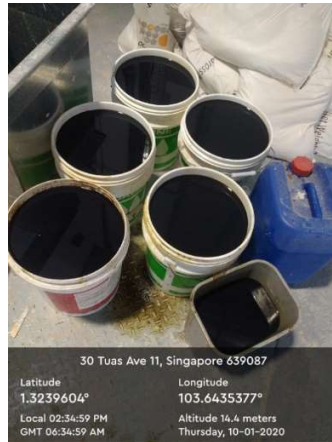
81. Oil was drained for a third time on 1 October 2020. A picture showing five buckets and a smaller container of used oil was taken by Mehedi and sent to Imam. Out of the five buckets, four were the original buckets for the thermic oil. The drained oil once again looked dark in colour.

Figure 15: A total of six containers of darkened used oil were drained from the oil jacket

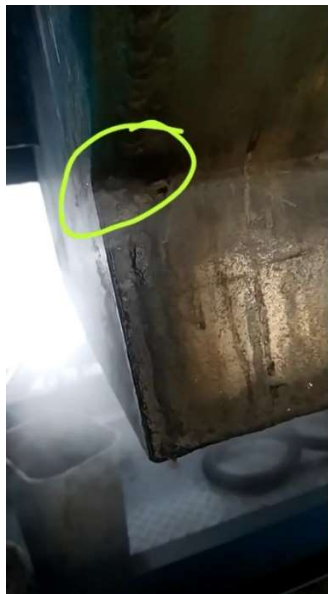
84. On 12 October 2020, Stars Engrg's workers operated the mixer machine although the oil jacket leak of 28 September 2020 had not been repaired. Mehedi sent a video of the leaking oil jacket and smoke around the machine to Moe at 0855hrs. In the video, white smoke could be seen spurting from the leak at the front left bottom corner of the mixer machine, the same location as the first oil leak on 28 September 2020. A hissing and crackling sound could also be heard. Moe thought that the white smoke seen in the video was oil vapour coming out of the crack in the oil jacket. Based on the WhatsApp chat log between Mehedi and Moe, the temperature for the oil jacket was pre-set to 200°C and all the heaters were turned on. However, the RTD with the safety interlock feature that was meant to measure the oil jacket temperature was not affixed and the oil jacket temperature could not be monitored.

Figure 16: Screenshot from video of 12 October 2020 showing oil leak and smoke, green circle inherent in video

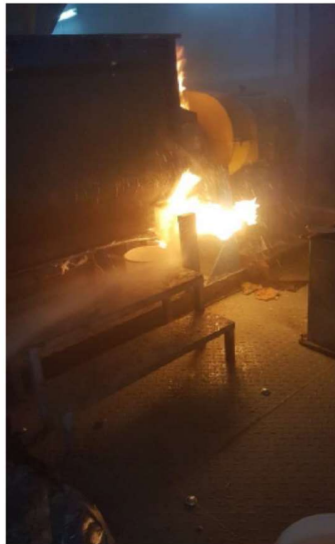
92. On 12 February 2021, which was the first day of Chinese New Year, at about 1650hrs, a fire occurred at the mixer machine near the drain valve at the bottom of the oil jacket. According to Mehedi, Marimuthu, who was operating on the platform, was the first to notice the fire, and said he observed a red-orange flame measuring about 250-300mm high, and 150-250mm wide. Mehedi and Marimuthu then put out the fire with a hose reel, before Marimuthu activated the emergency stop button to turn off the mixer machine. After the fire was extinguished, Mehedi saw beads of black oil leaking from the oil jacket and noticed a lot of smoke from the drain area, where the fire was.

Figure 19: Photograph of the fire taken by Marimuthu on 12 February 2021

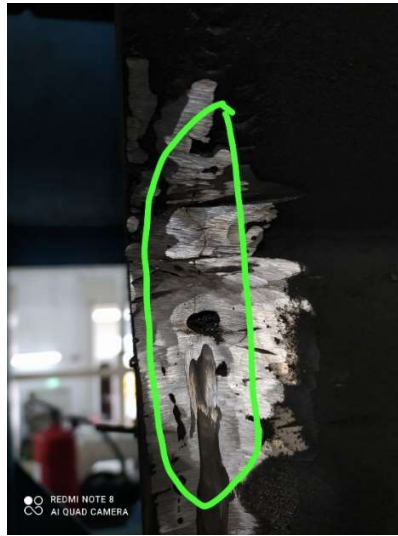
99. On 13 February 2021, Nasim prepared the welding tools and equipment and Marimuthu indicated the welding locations on four corners of the oil jacket with a marker. Oil was drained from the oil jacket before the grinding started. On Nasim’s instructions, Mehedi sent a picture of the old weld to Chua with the message “old welding crack ready”. The grinding revealed two cracks, one on each edge on the front of the mixer machine. To this, Chua replied between 1449hrs-1450hrs, “Ya la” and “Good, we will repair and the machine is good to go again”.

Figure 21: Grinding revealed a hairline crack on front left of machine, green circle inherent in picture

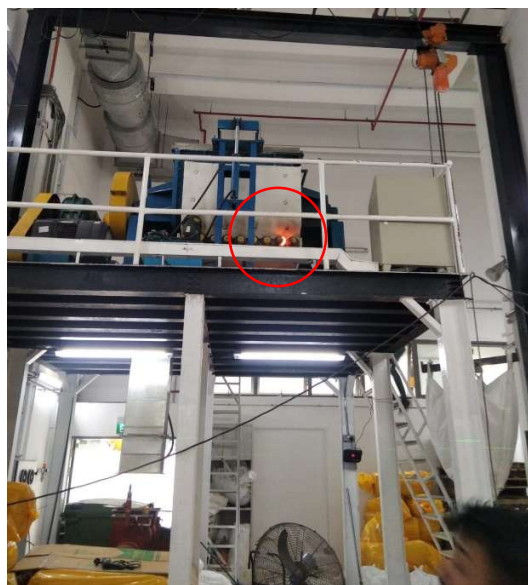
105. On 24 February 2021 at around 0839hrs, a glowing flange and a small flame was observed at heater #2. *Figure 22* below shows a picture of the incident sent by another worker, Anis, to the Shield+Daily WhatsApp chat group at 0839hrs the same day. At about 0921hrs, Moe forwarded to Chua all the photographs that Marimuthu had sent to Moe that morning and Marimuthu's earlier WhatsApp messages. After not receiving any reply from Moe, Marimuthu then forwarded this picture to Chua at 1012hrs on the same day.

Figure 22: Photo of the glowing flange taken by Anis and sent at 0839hrs on 24 February 2021.

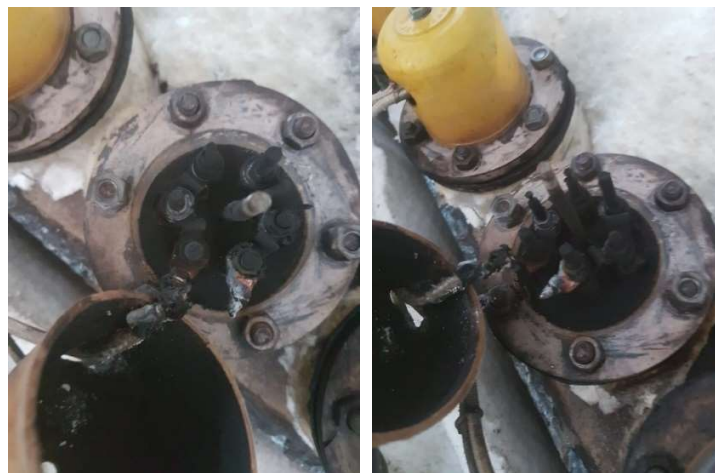
107. At 0840hrs, Marimuthu sent Moe through WhatsApp three close-up photos of the heater, showing that it was damaged. Moe queried if the mixer machine could be turned on, to which Marimuthu replied in the affirmative, but that he would change the heater first. At 0856hrs, Marimuthu told Moe in their WhatsApp chat that he had taken a new heating rod and would change it with Shohel. He went on to tell Moe via WhatsApp chat at 0858hrs that *“now oil heat after 10 o clock can change”*. Marimuthu then messaged Chua at 0909hrs asking whether Chua could speak over the phone. Chua did not respond. A short while later at 0921hrs, Moe forwarded to Chua all the photographs that Marimuthu had sent to Moe that morning. Moe followed up with the following three messages to Chua: *“I thinl we should go tuas”*, *“Heater now muthu changing”*, and *“Wire joint may be fire”*. Chua did not reply to these messages.

Figure 23: One of the cables on heater #2 had snapped, likely due to the earlier fire

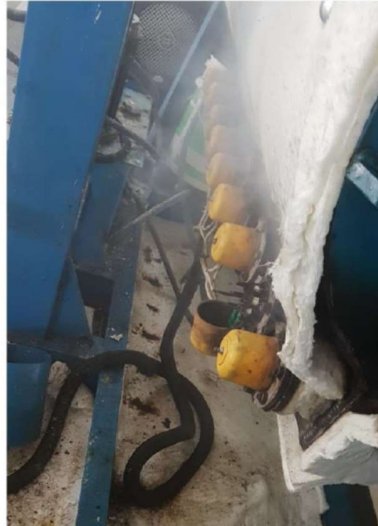
111. At 1110hrs, Moe sent Marimuthu a message asking “How Muthu? Heater ok?”, which Moe admitted meant that he wanted an update from Marimuthu on the status of the damaged heater. In response, Marimuthu sent Moe the following photograph showing the heaters on the mixer machine at 1113hrs. Moe then replied to Marimuthu at 1132hrs saying “Ok let me know ASAP”. Post-accident, Moe deleted, from his and Marimuthu’s mobile phones, the photograph received from Marimuthu at 1113hrs as well as his message to Marimuthu at 1132hrs. The damaged heater #2 with green taped wiring was found still in the oil jacket after the accident.

Figure 25: Photograph taken by Marimuthu on 24 February 2021 at 1113hrs showing that the wiring of the damaged heater #2 had been taped together with green tape

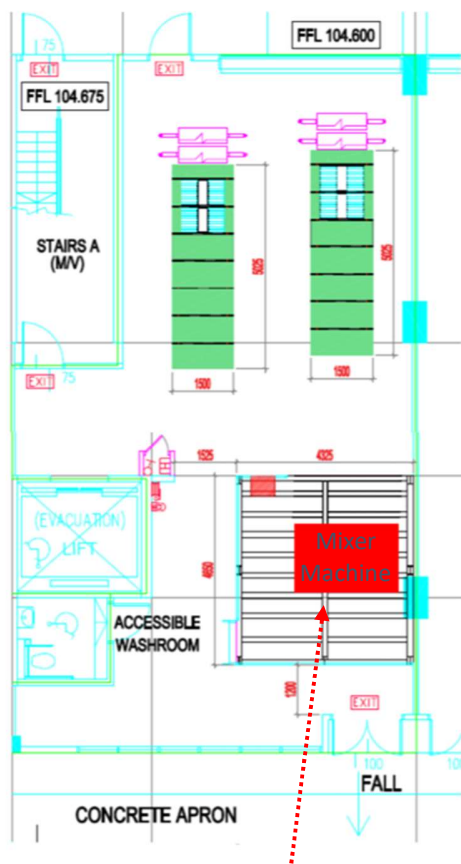
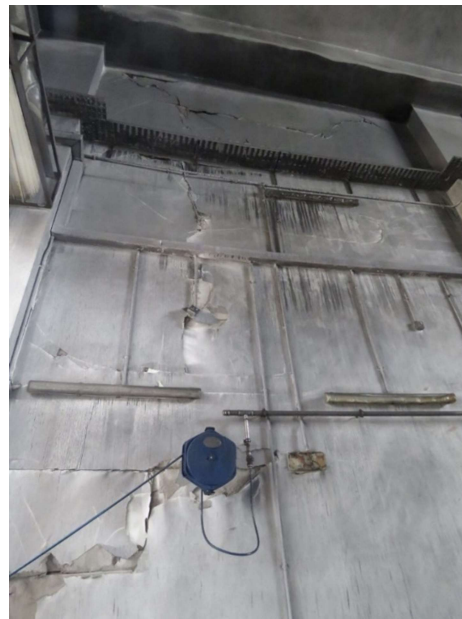
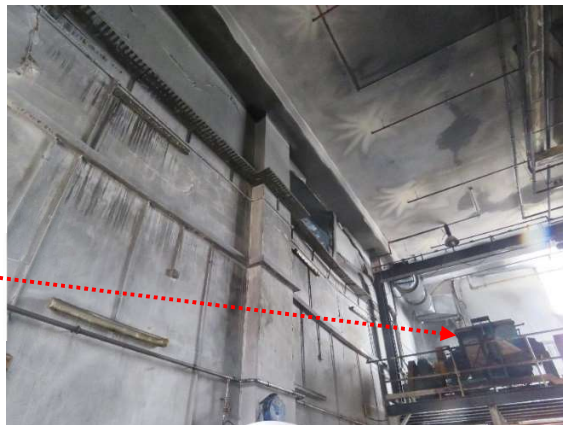
114. The worksite sustained severe damages as shown in *Figures 26 to 28* below.

*Mixer Machine on raised platform*

*Cracks, from the bottom to the top of side wall*

*a gaping hole on the upper part of the side wall*

Figure 26: Side wall damage, at front and rear of the worksite

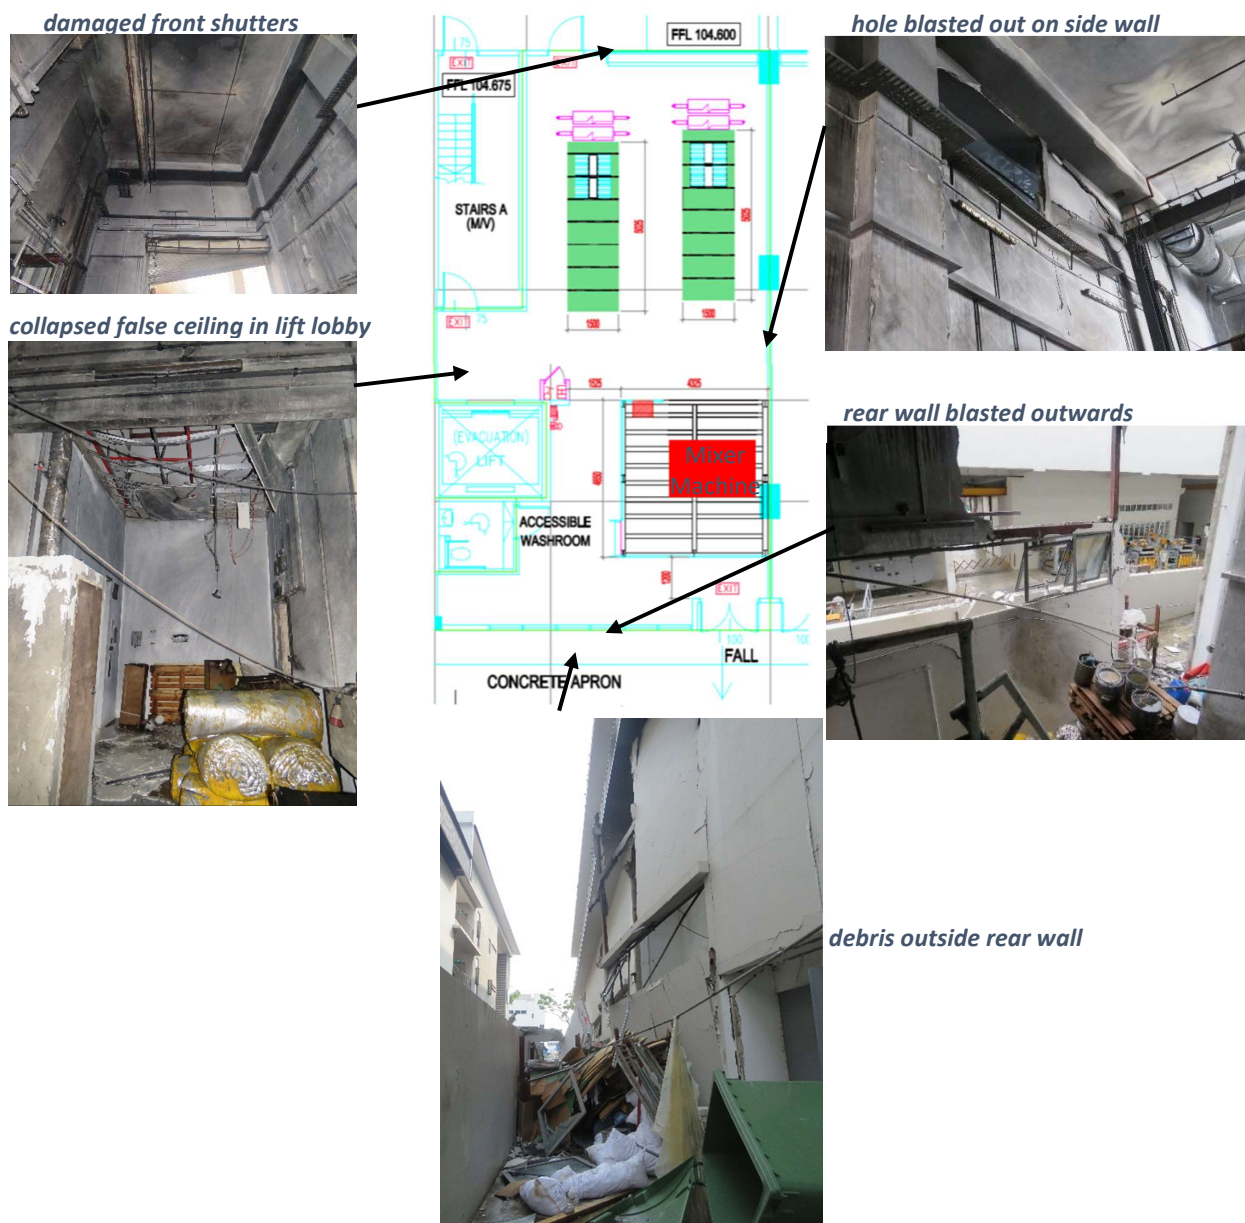
Figure 27: General damage within the worksite

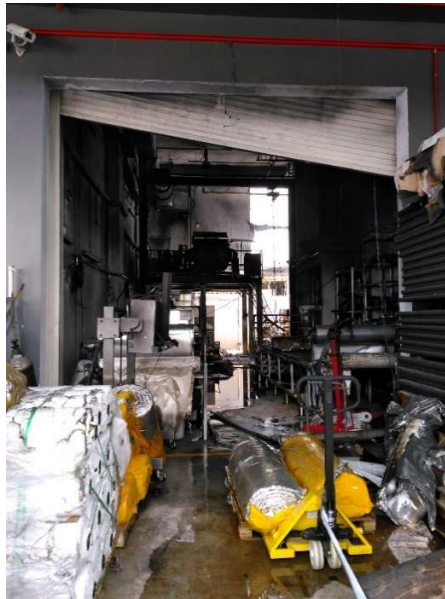
Figure 28: Damaged front shutters of the worksite

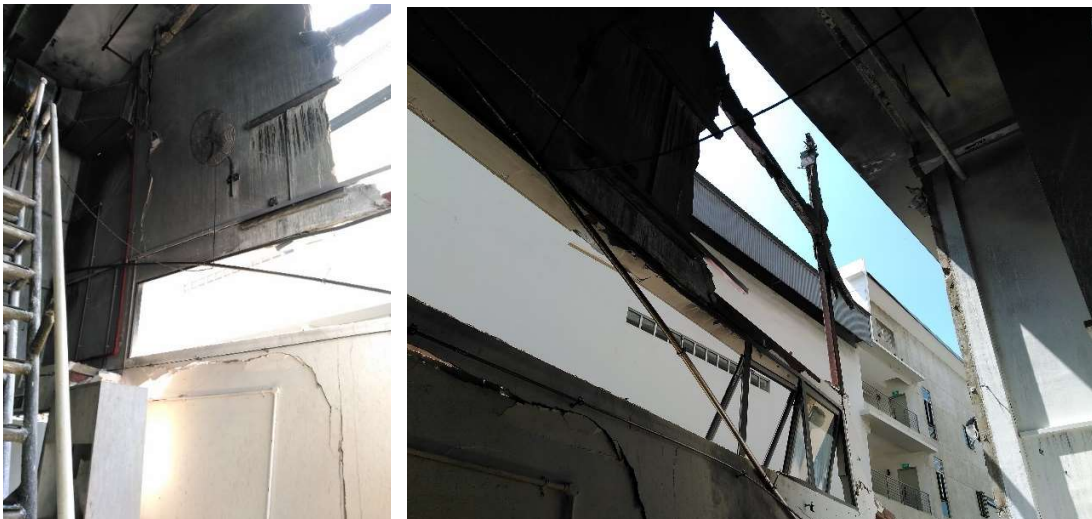
115. The back wall had partially collapsed, and debris was scattered around the back alley of the premises. The back wall also showed two different shades – the upper part had a blackish hue while the lower part largely retained its original colour.

Figure 29: Photos showing dual tones on the rear back wall of the worksite

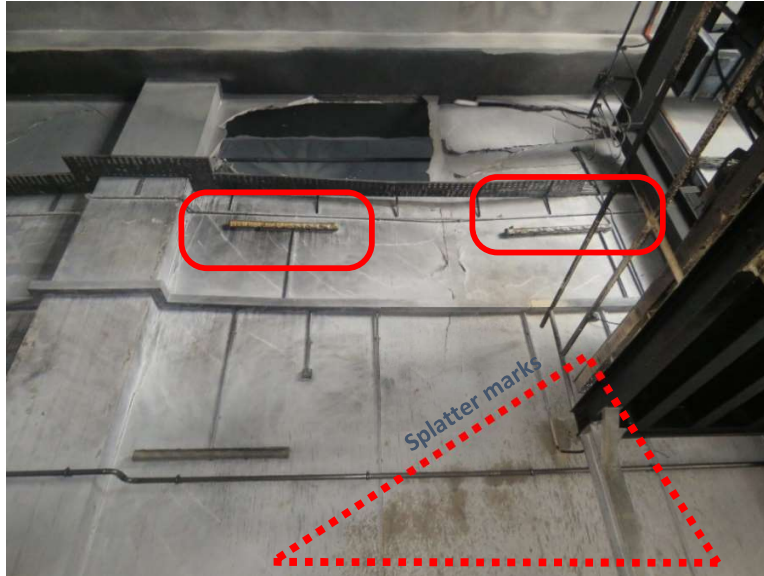
117. Splatter marks were observed on the side wall in the vicinity of the platform (*Figure 30*, dotted triangle in red). Based on the pattern of the splatter marks, the source appeared to be from the platform.

Figure 30: Photo showing the damaged light fixtures and splatter marks from platform

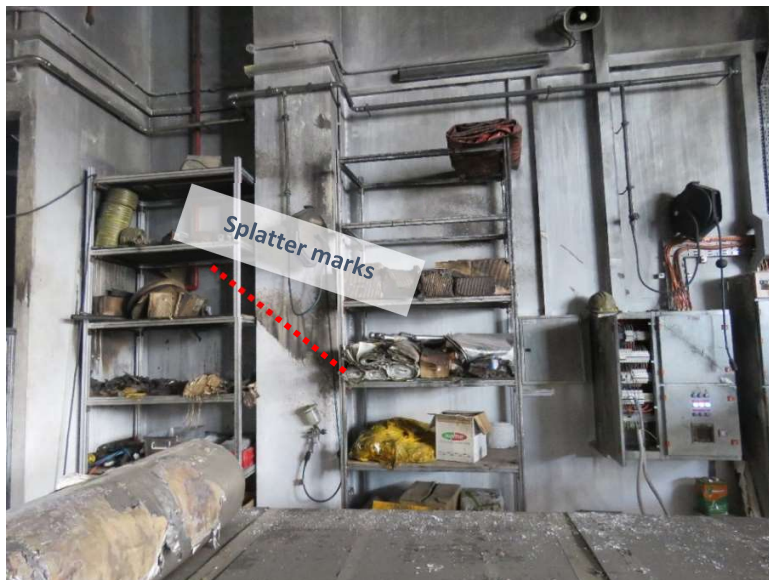
118. Splatter marks, as dotted in red in *Figure 31*, were also observed on the opposite side wall.

Figure 31: Photo showing splatter marks on the opposite side wall from platform

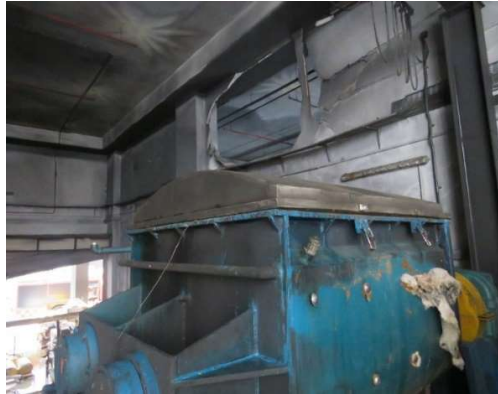
Figure 32: Hole at the top of side wall

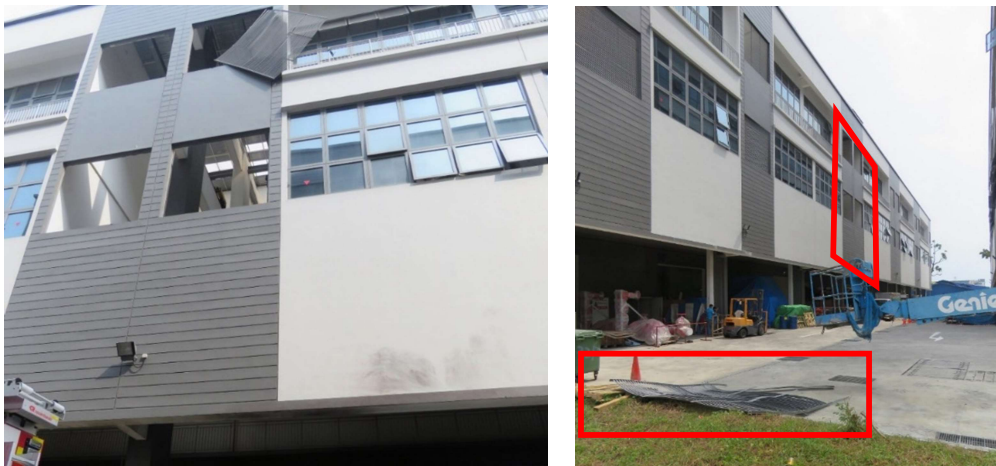
121. Four louvre panels were dislodged from the exterior façade of the building directly above the worksite. One of the dislodged panels was found dangling from its frame, and one of the panels was found some distance away close to the grass patch.

Figure 33: Photos showing the dislodged louvre panels

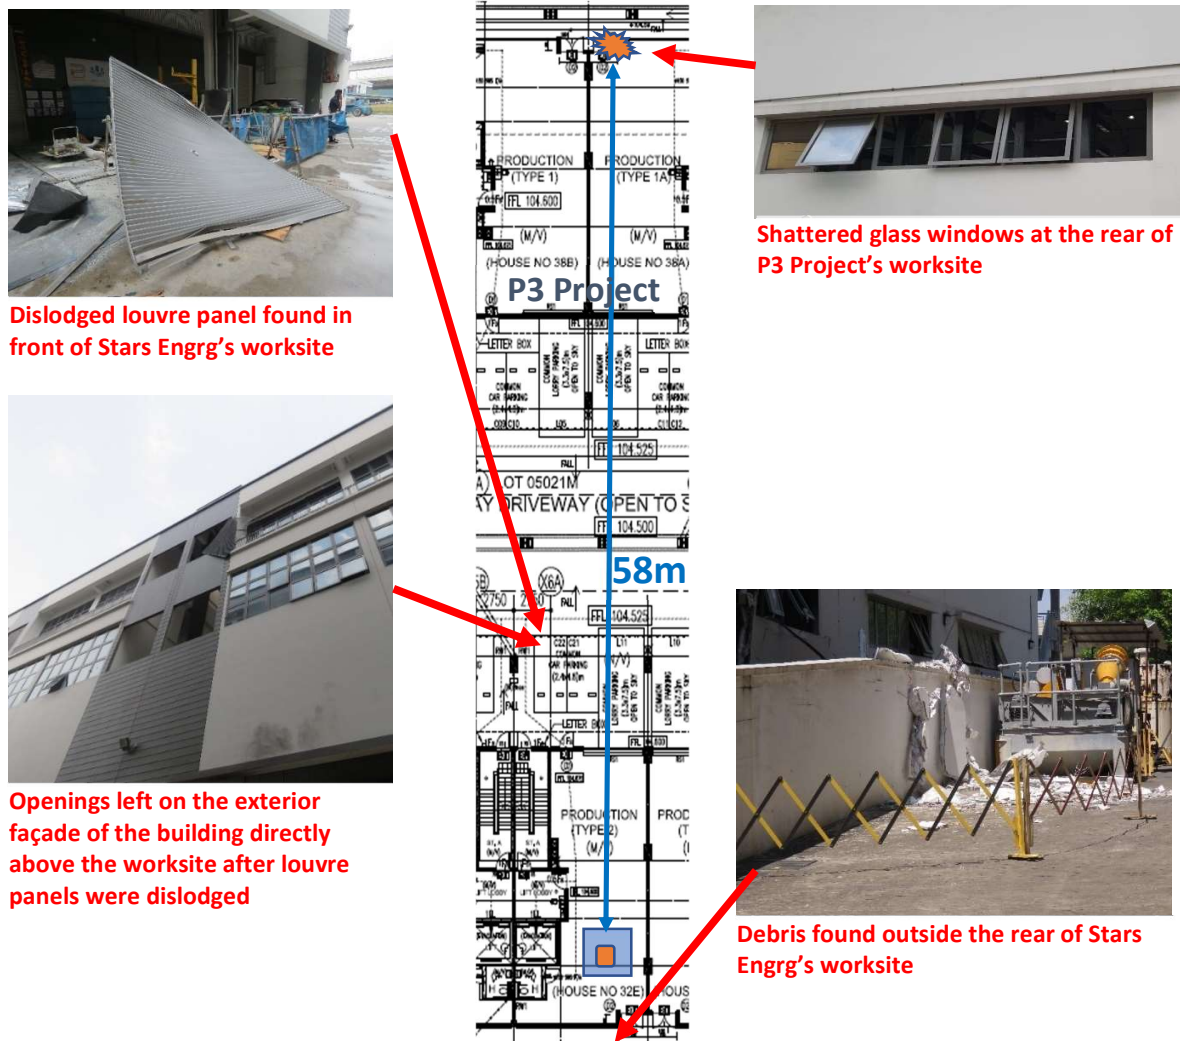
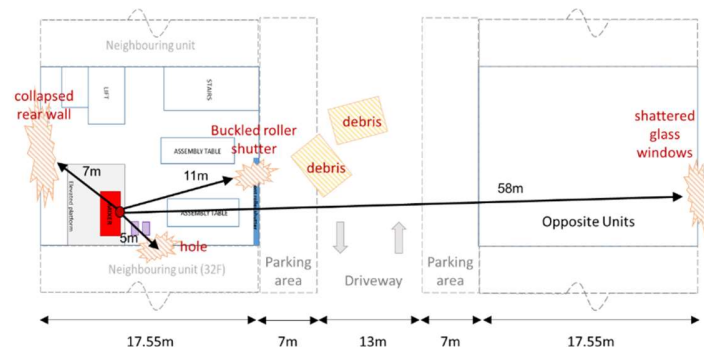
123. From the damages pieced together on the layout diagrams in *Figures 34 and 35* below, the accident was likely an explosion from the mixer machine that generated blast overpressures sufficient to shatter glass at 58m away, dislodged panels, and destroyed walls.

Figure 34: Damage overlaid on layout plan, from the Tuas Site to P3 Project's rear windows

Figure 35: Schematic diagram with measured distances from the mixer machine

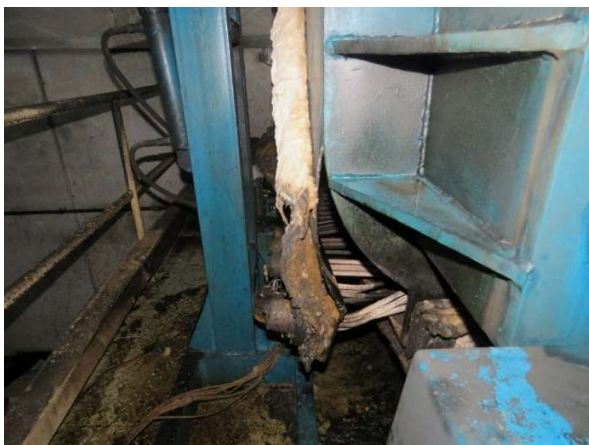
125. The oil jacket ruptured widest at the seam closest to where the replacement heater was placed. From the rupture's opening, the heating elements inside the jacket were observed to be bent and deformed as shown in *Figure 37*. The other end of the oil jacket had a darkened stain around the seam as shown in *Figure 38*. The stain was likely caused by leaked oil, so the seam at this end likely fractured as well, albeit to a smaller extent.

Figure 37: Deformed heating elements seen through the rupture on the oil jacket, rear of machine

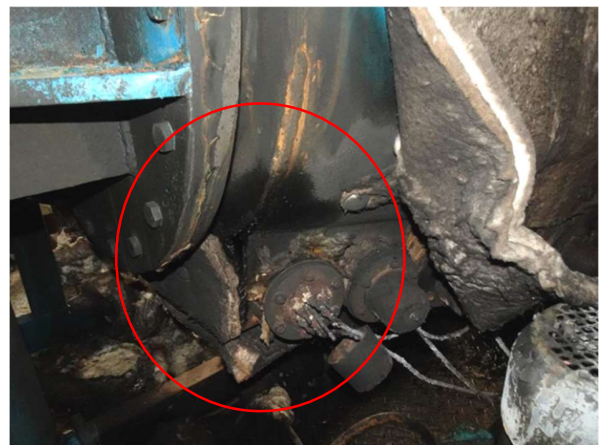
Figure 38: Dark stain on oil jacket, circled in red

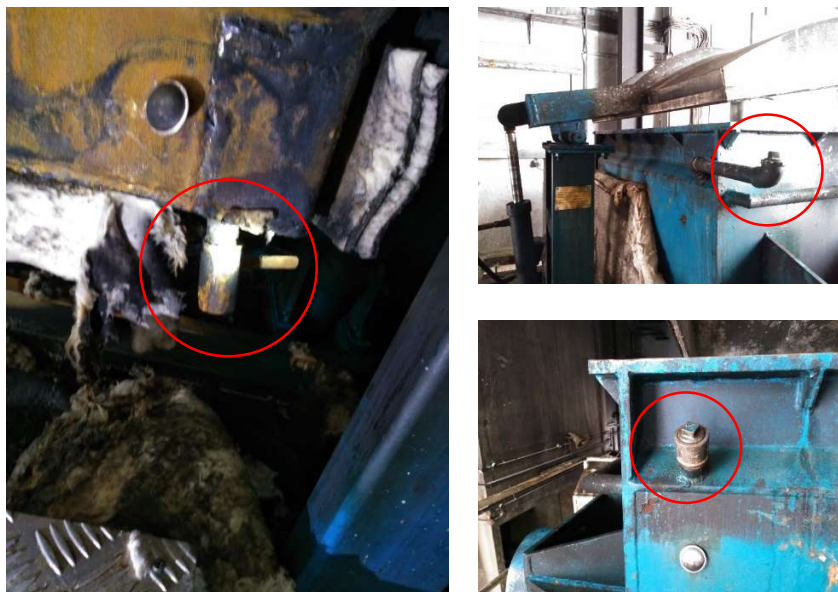
126.A cable from the control panel was found connected to a RTD which was placed inside the mixing chamber of the mixer machine (*Figure 39*). Remnants of the insulation on the mixer machine were found with some soot on the exterior. All three openings on the oil jacket were found closed post-accident. Both openings at the top of the jacket had end caps that rendered them sealed, while the drain valve was found in a closed position (*Figure 40*).

Figure 40: All three openings on the oil jacket circled in red were found closed

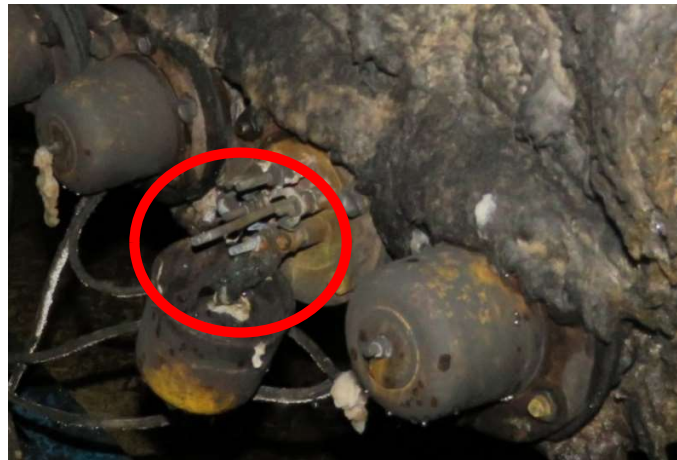
131. Upon closer inspection, some green tape was found on the wires connected to the terminals of heater #2, as shown in *Figure 46*.

Figure 46: Green tape found on wires connected to two terminal connections of heater #2

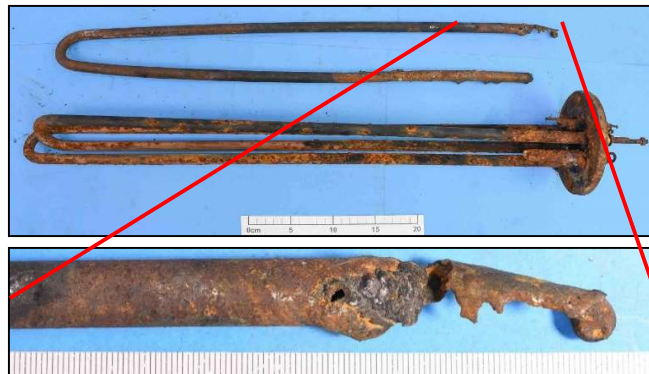
of around 1400°C, indicating that excessive heating had already occurred by 8 August 2020.

Figure 51: Post-explosion view of spoilt heater, likely to be heater #1, that was replaced on 8 August 2020

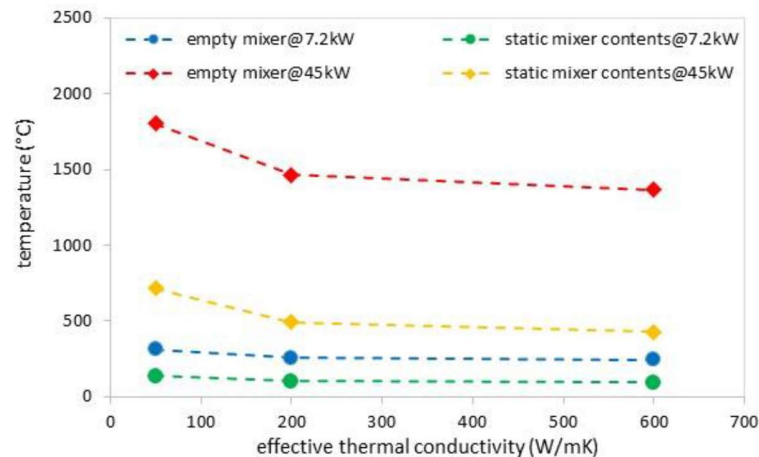
150. FEA modelling with a 45kW heat source (*Figure 52*, extracted from A\*STAR's report) showed that the temperature of the oil jacket reached around 700°C to 1800°C when the effective thermal conductivity between the heat transfer fluid and the mixer contents was low. This was the operating condition of the mixer machine due to the large air insulation layer that existed within the jacket based on the low amounts of thermic oil used by Stars Engrg.

Figure 52: FEA modelling showing how low thermal conductivity of the heat transfer fluid affected jacket temperatures

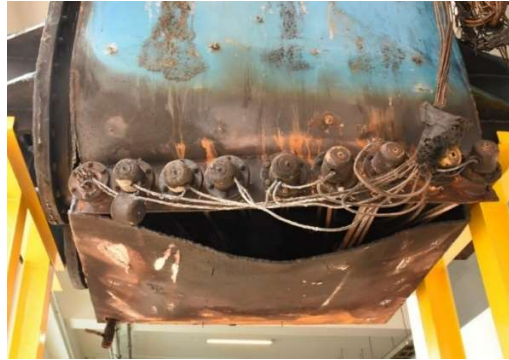
Figure 53: Bulging deformation, indicative of overpressure release from inside out
