# **Report of the Inquiry Committee for the accident at Stars Engrg Pte Ltd on 24 February 2021**

**(PART II – ANNEXES)**

| Report No:<br><b>M21091</b> | Subject Group:<br><b>11219</b> | Date:<br><b>10<sup>th</sup> September 2021</b> |
| Title of Report:<br><b>Failure Analysis of a Failed Mixer Machine Retrieved from Unit 32E of Platinum @ Pioneer Building involved in a Fire Explosion Incident</b> | | Date of Last Revision/Revision No: |

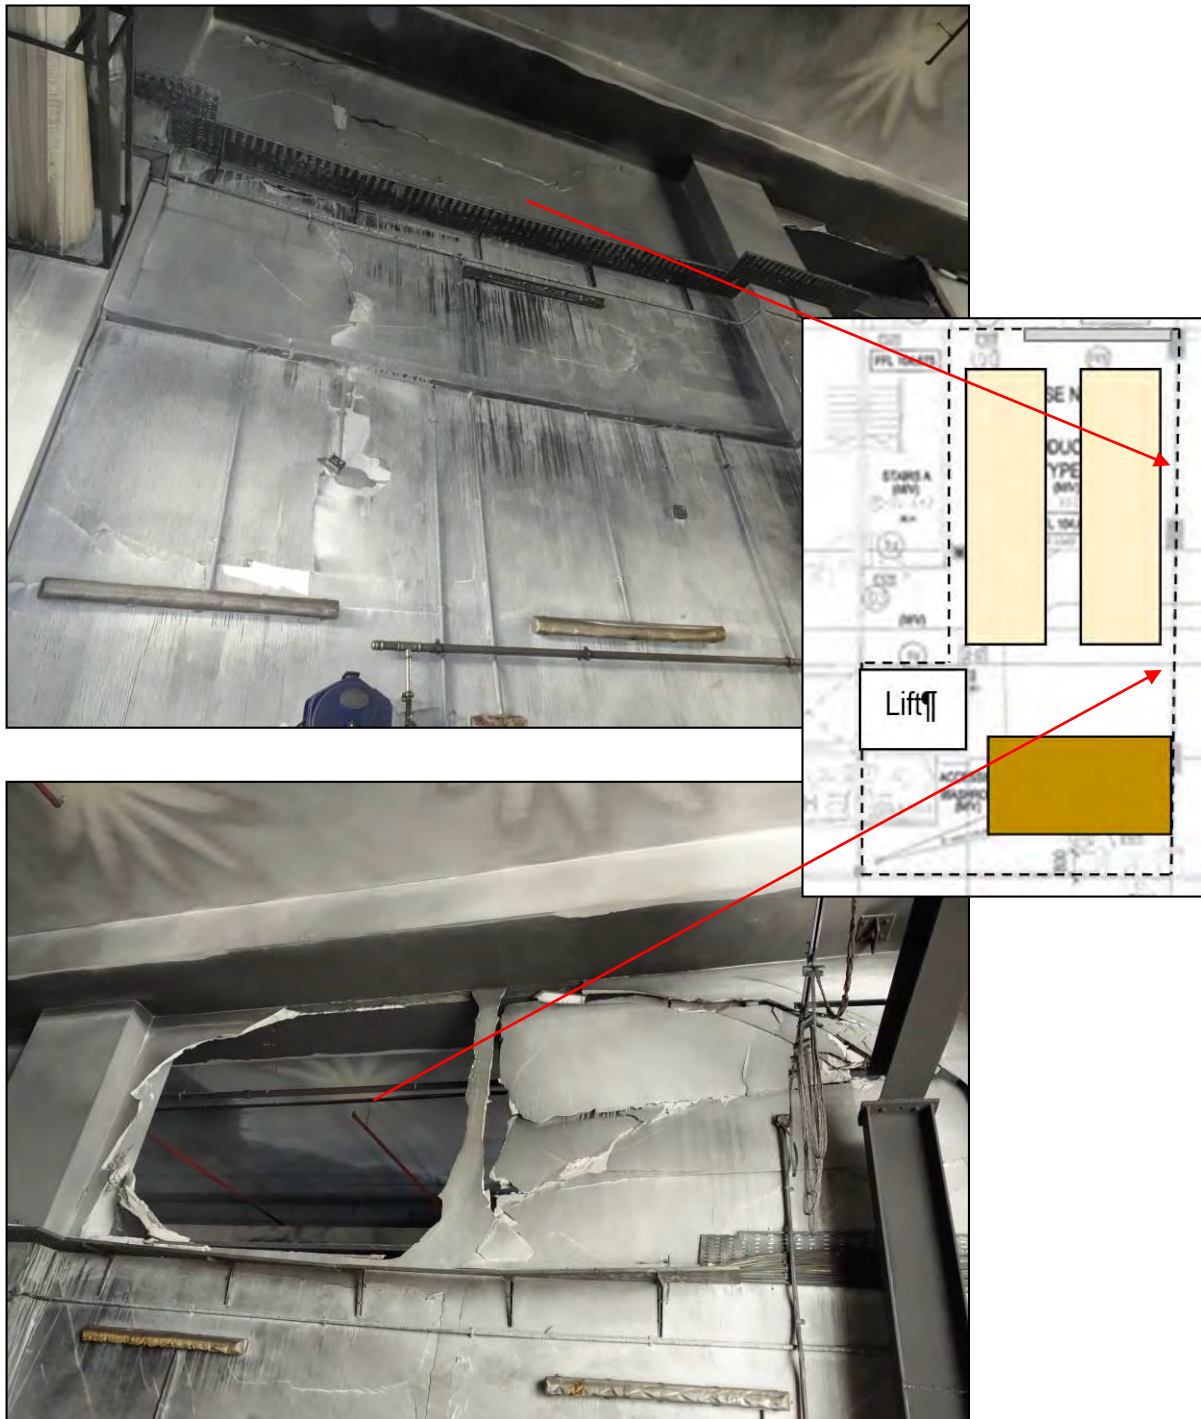
- 12 ➤ The explosion at the time of incident had cracked and punctured through the  
14 side wall in the vicinity of the Platform floor as well as top half of the rear walls  
(Figure 3 to Figure 7).

Punctured and cracked wall at localized areas on the top of the unit

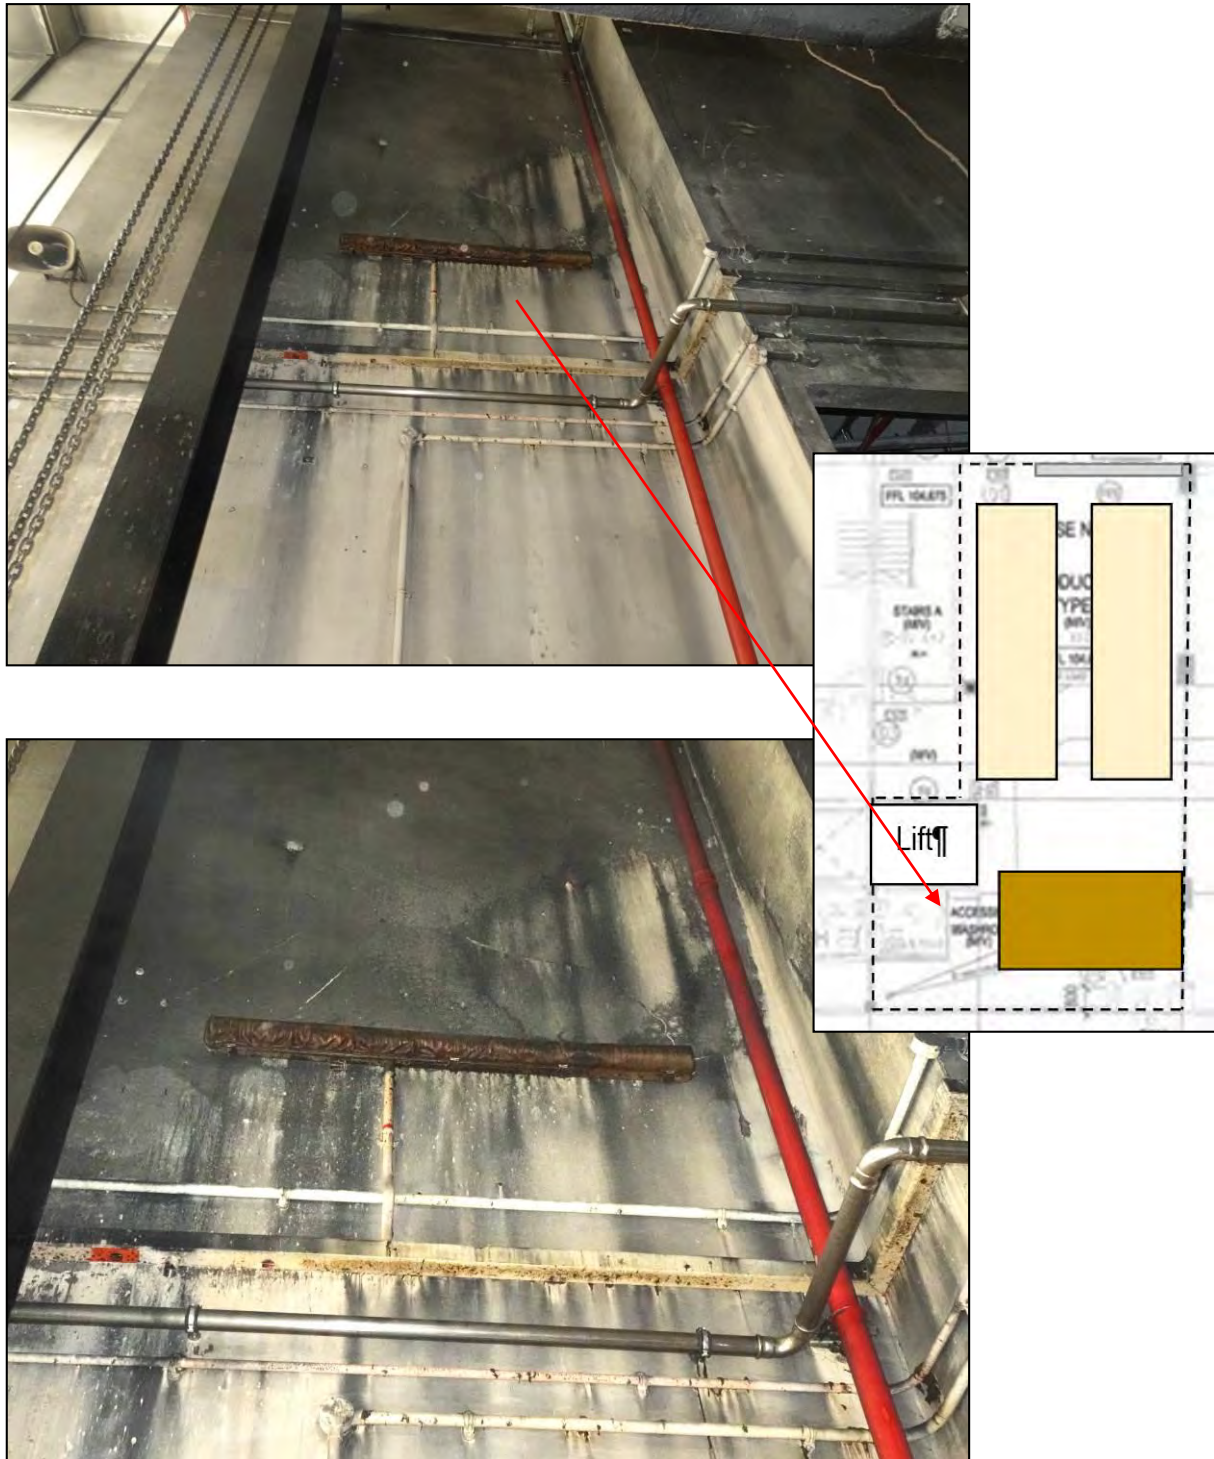
Cracked wall at localized area in the vicinity of the Platform floor

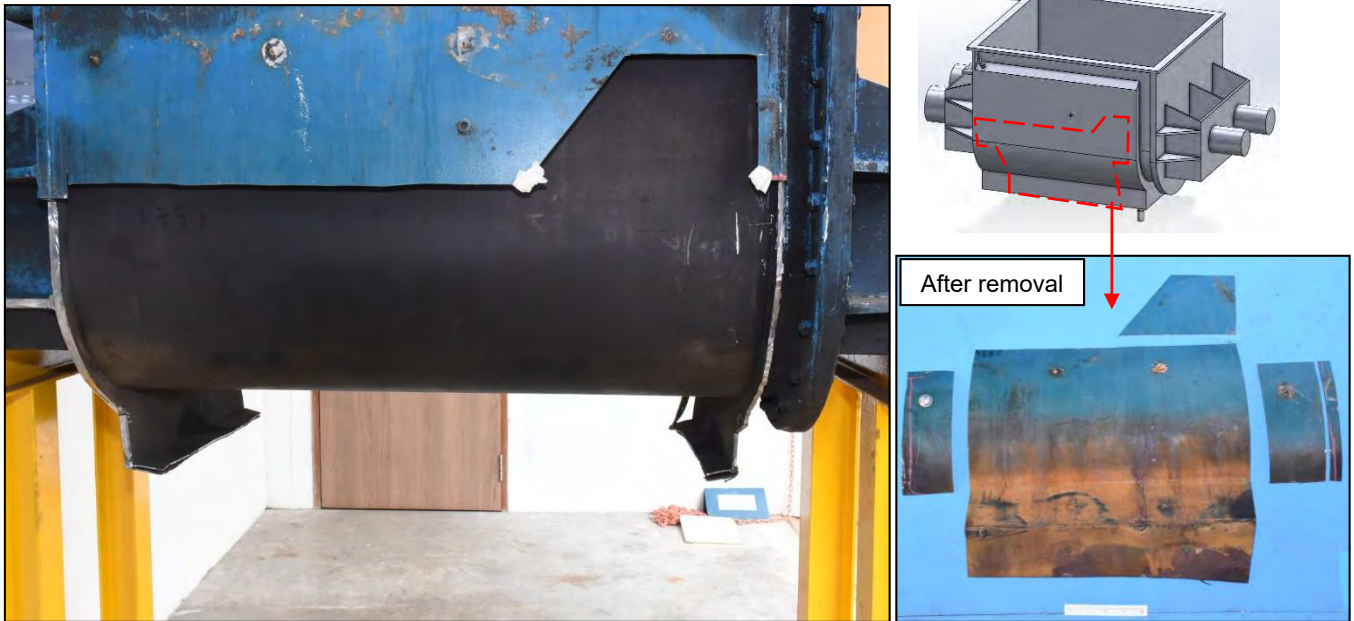
**Figure 39:** Internal condition of the oil jacket from the front side. The internal surface was generally covered by black soot.

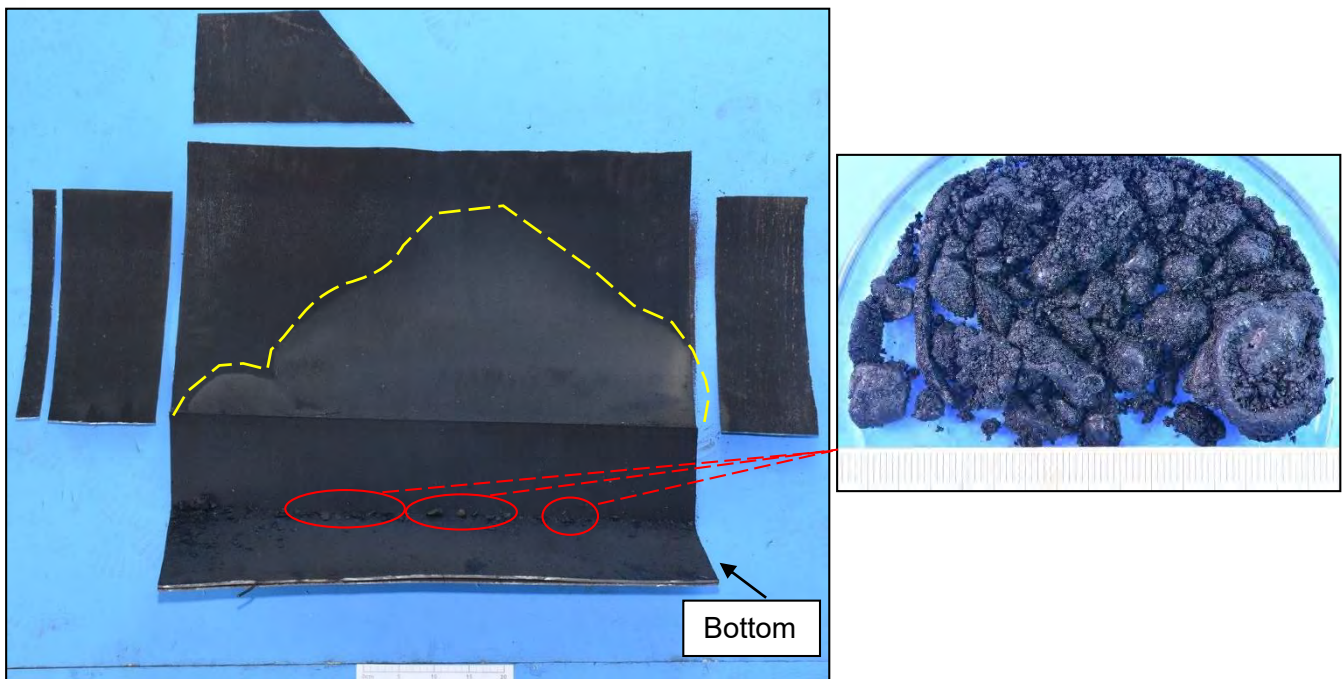
**Figure 40:** Cut out sections of oil jacket wall and bottom. Hard debris of various sizes (up to about 20 mm) were found at the bottom face (see red). There was also a layer of black soot/deposits masking the internal surface and the bottom face of the oil jacket (see also Figure 143). Oil stains and drips pattern were visible (see yellow line).

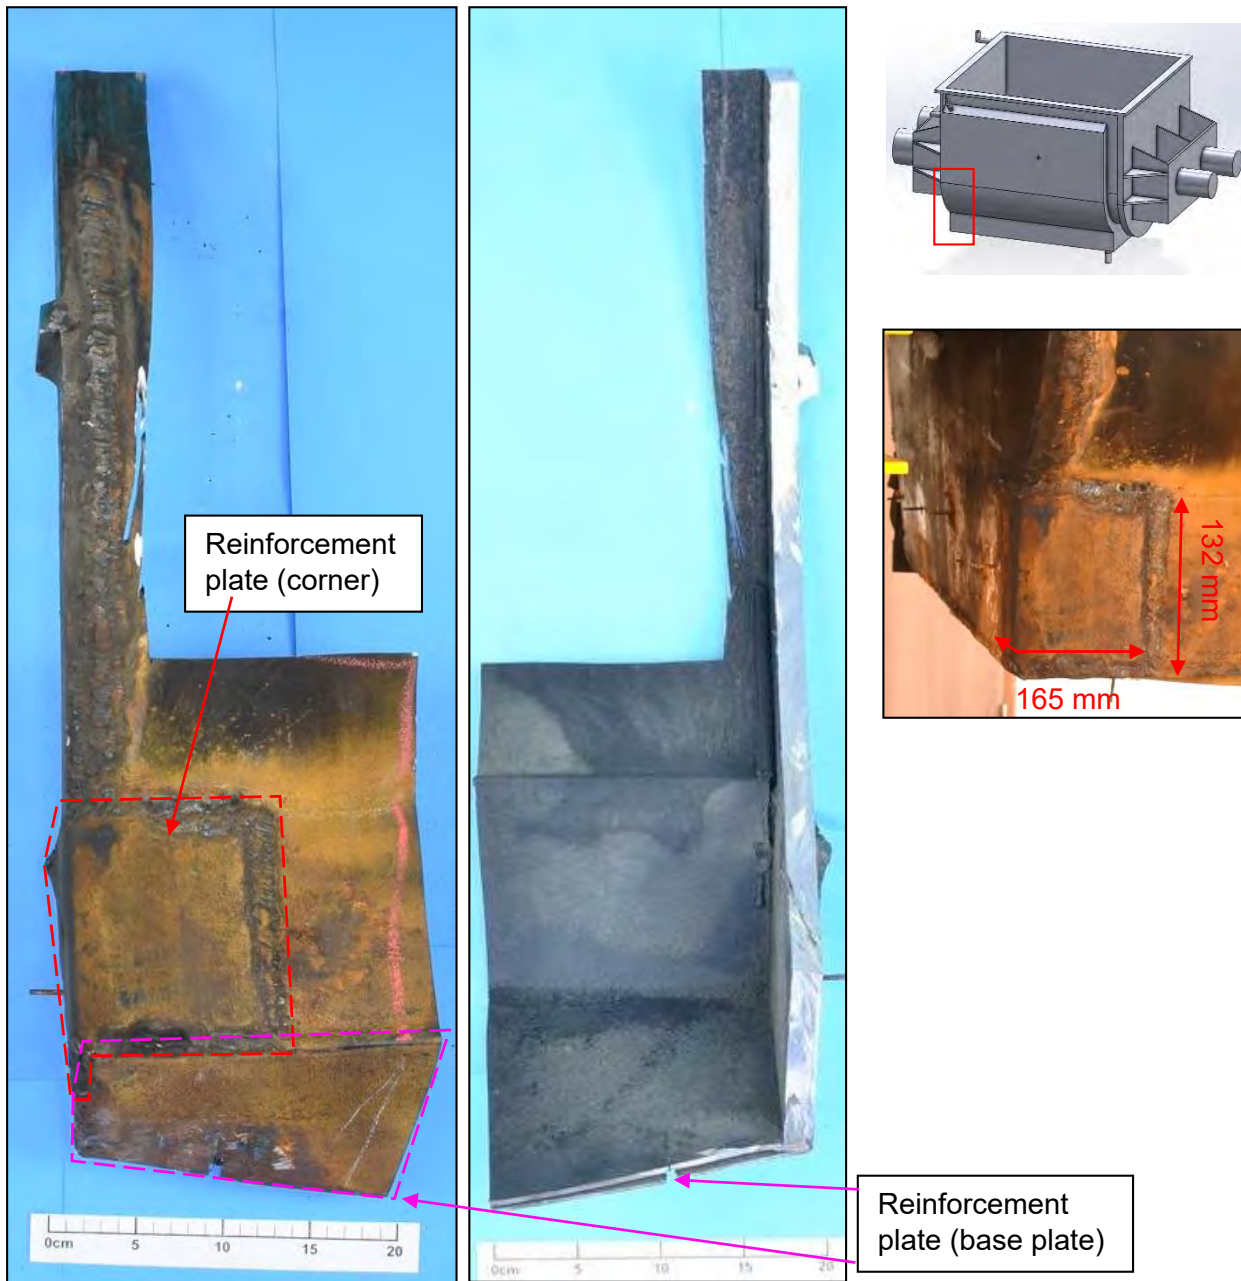
**Figure 41:** Cut out section of the front side, left edge weld. The left figure shows the external condition and the right figure shows the internal condition of this section. This cut out section included the original and repair welds. Parts of the reinforcement plates (corner and base plate identified with red and pink dotted lines) were visible here. The corner reinforcement plate had dimension of about 165 mm by 132 mm.

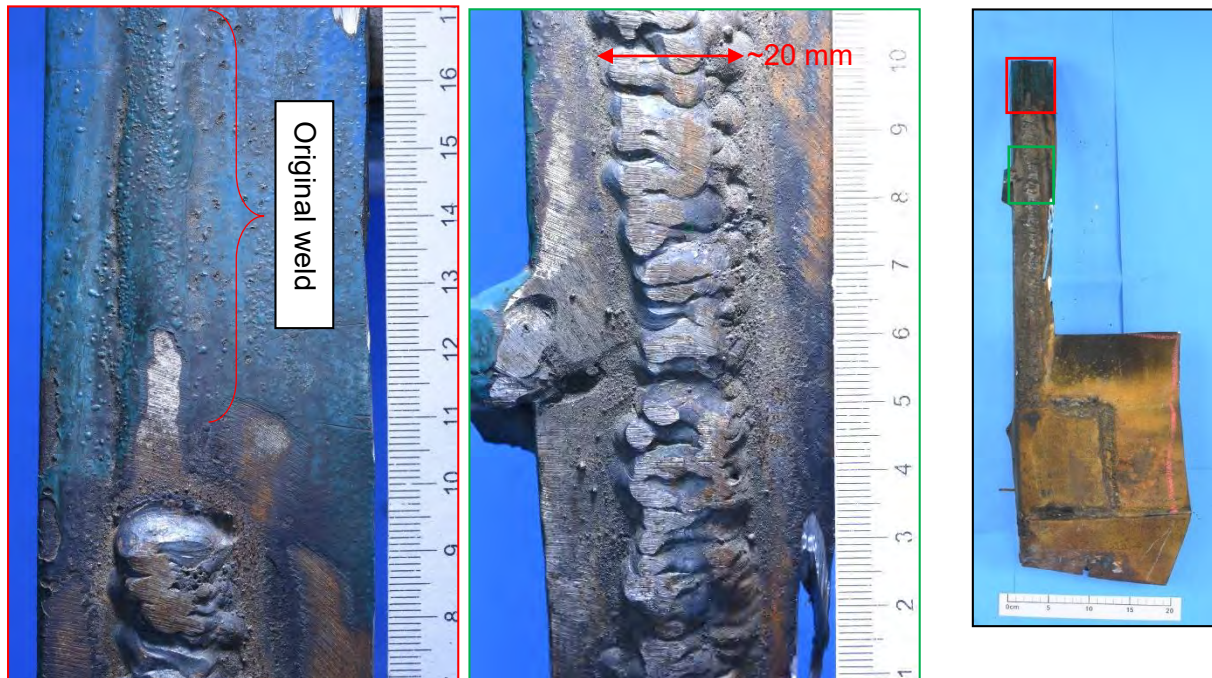
- At the front side, left edge weld, the face width<sup>3</sup> of the repair weld increased towards the bottom, measuring up to about 30 mm (Figure 42 and Figure 43).
- The weld root of the original weld had an irregular shape (Figure 46).
- The root of the repair weld had a root surface width of about 4 mm and increased up to 9 mm towards the bottom. Some areas of the weld root had gaps and lack of penetration<sup>4</sup> (Figure 46 and Figure 47).
- A sector near the bottom end of the curved part (just above the vertical plane) an insert plate with length of 120 mm was observed at the weld root (Figure 47). See also Section 3.4 for chemical analysis and Figure 153 for cross sectional examination.

**Figure 42:** Close up view of side weld. Part of the original weld is indicated (in red) in the left figure. The rest of the weld towards the bottom was repaired and had a face width of about 20 mm.

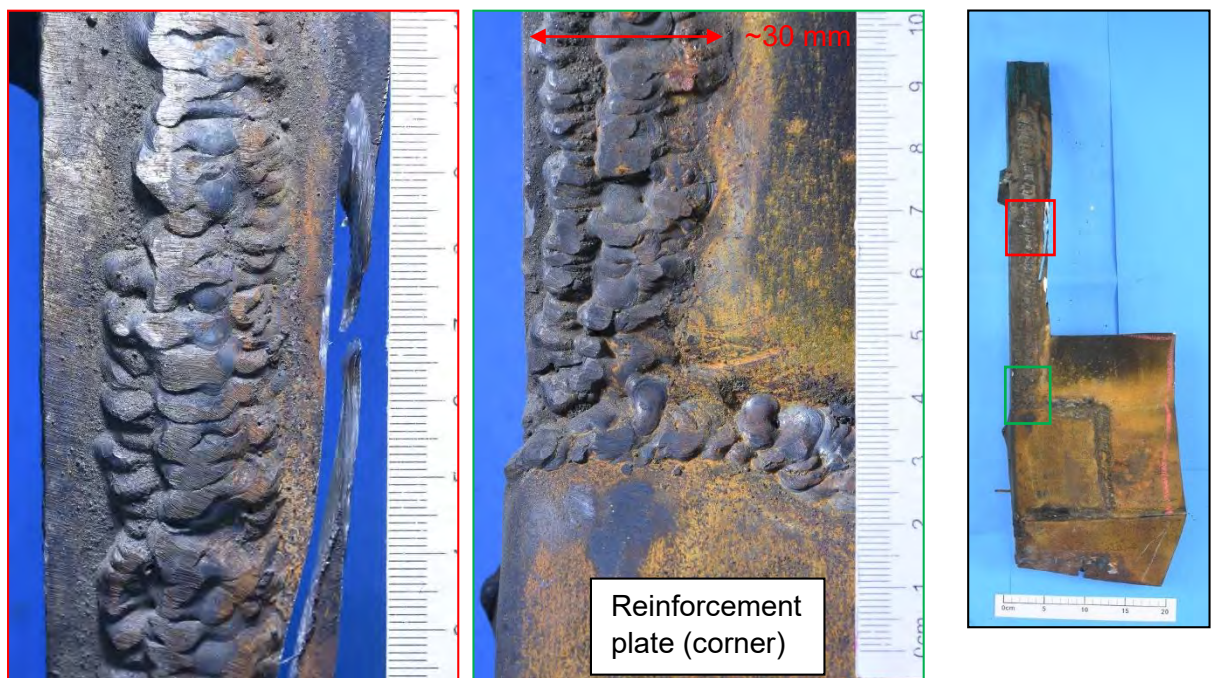
**Figure 43:** Close up view of side weld. The face width of the weld increases towards the bottom and reinforcement corner plate. The face width was up to about 30 mm.

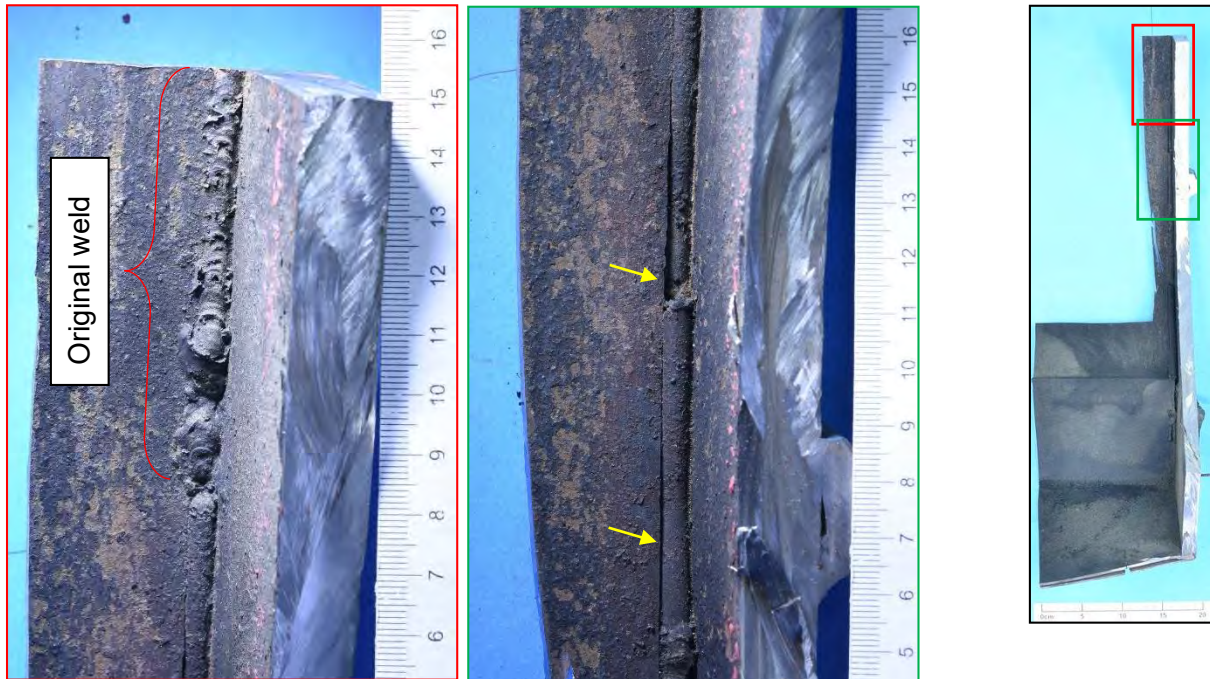
**Figure 46:** Condition of weld from inside the oil jacket. Part of the original weld is indicated (in red) in the left figure. The original weld root had an irregular shape. The rest of the weld was repaired, had a root surface width of about 4 mm and lack of penetration at some areas (indicated with yellow arrows).

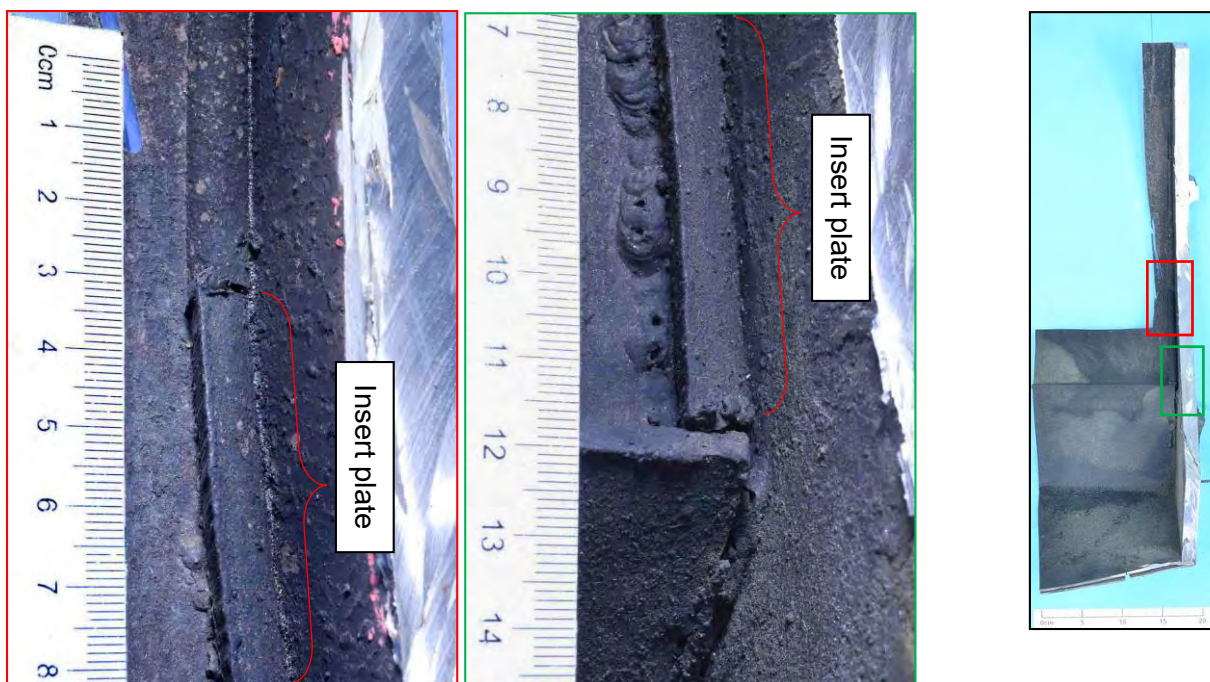
**Figure 47:** Condition of weld from inside the oil jacket. The width of the root surface increases towards the bottom (up to 9 mm). An insert plate with length of 120 mm was observed at a sector of the bottom end of the curved edge. (see also Section 3.4 and Figure 151)

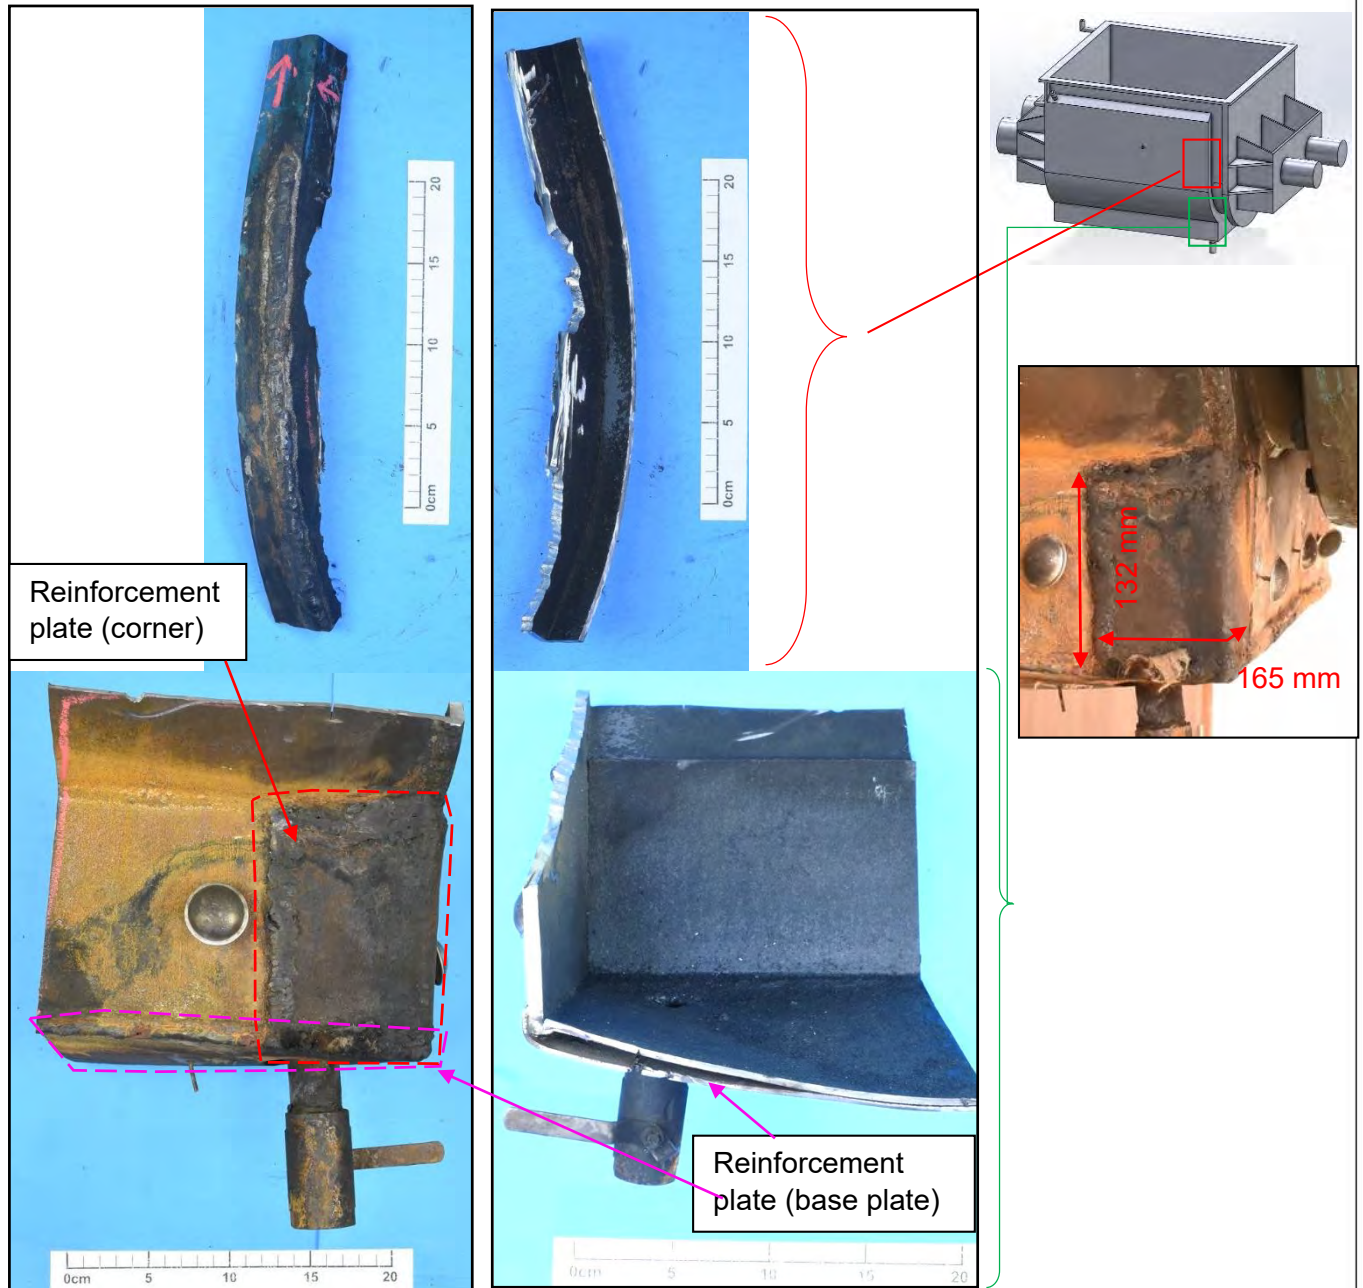
**Figure 50:** Cut out section of the front side, right edge weld. The left figure shows the external condition and the right figure shows the internal condition of this section. This cut out section included the original and repair welds. Parts of the reinforcement plates (corner and base plate identified with red and pink dotted lines) were visible here. The corner reinforcement plate had dimension of about 165 mm by 132 mm.

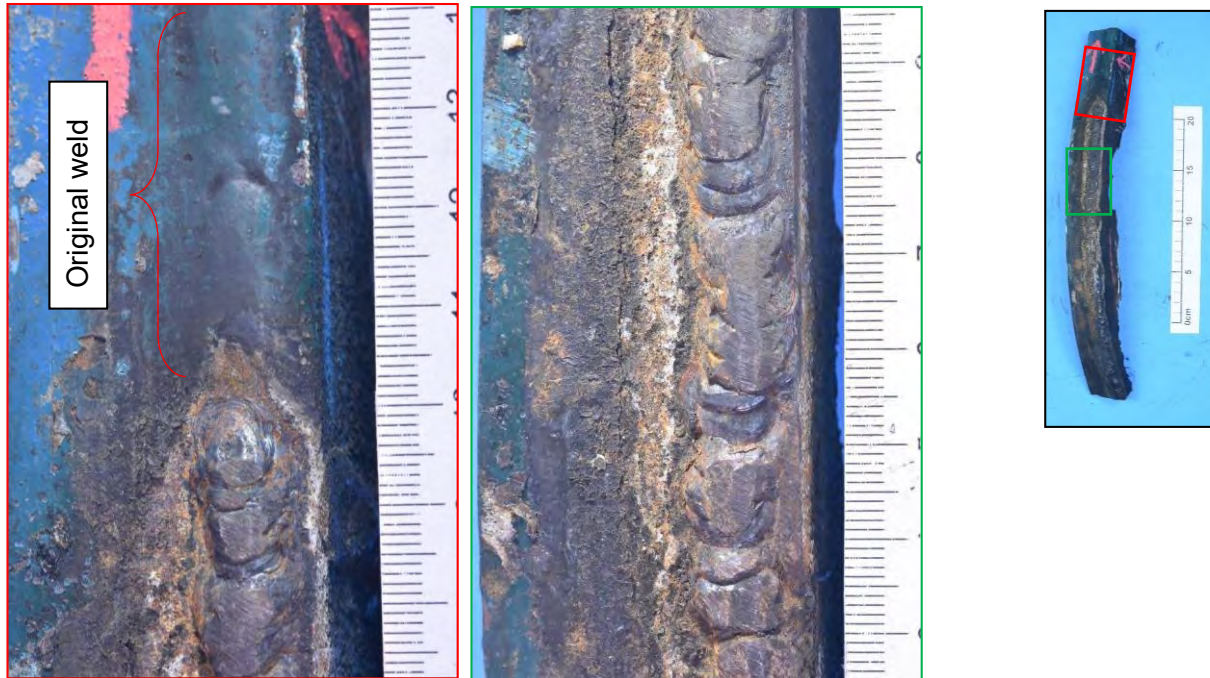
- At the front side, right edge weld, the face width of the repair weld face was up to about 20 mm. The weld root was smaller and had signs of lack of root penetration at some areas (Figure 51 and Figure 52).
- The bottom reinforcement plate was found to be folded over the original weld and welded to the side wall (side away from Platform stairs) (Figure 54).
- Cross sections made across the corner reinforcement plate revealed voids in the weld metal of reinforcement plate (Figure 56).

**Figure 51:** Close up view of side weld. Part of the original weld is indicated (in red) in the left figure. The rest of the weld was repaired and had a face width of about 20 mm.

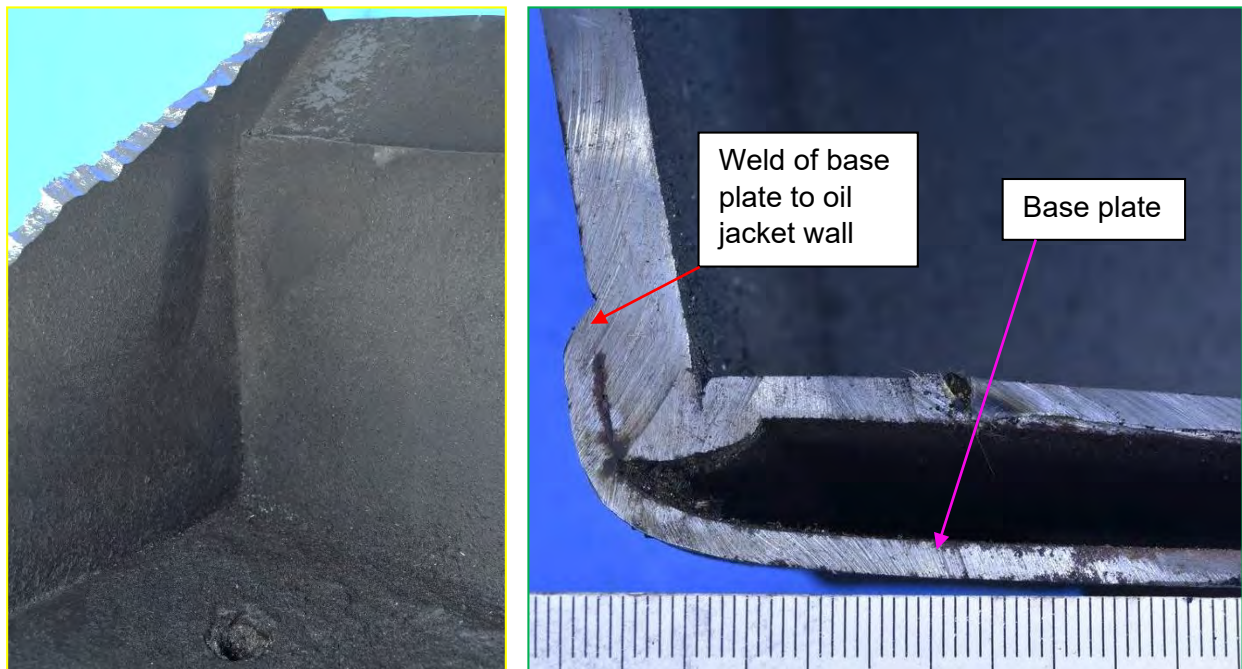
**Figure 54:** Close up view of the corner from inside the oil jacket (left figure). No gaps were visible at the corner joint. The base plate was folded over the original weld and welded onto the oil jacket wall (right figure).

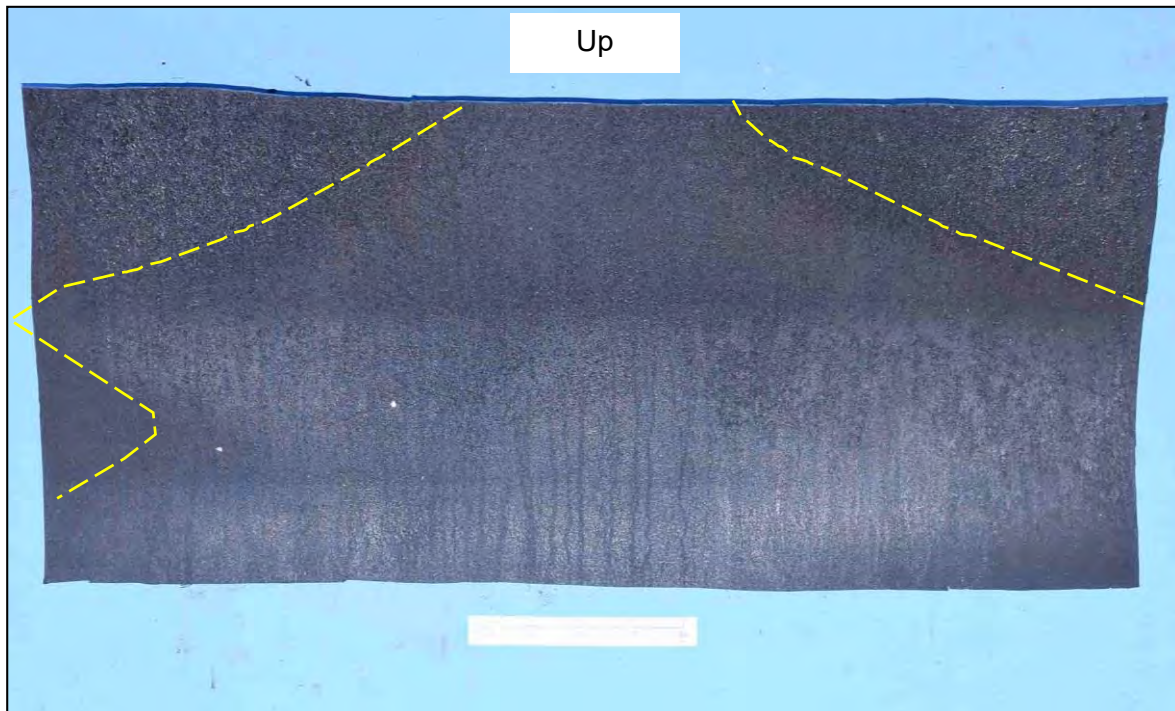
- The internal surface of the oil jacket wall at the rear side was generally covered by black soot (Figure 59).
- Oil stains and drip marks were visible on the internal surface of the oil jacket (Figure 60).

**Figure 60:** Cut out section of oil jacket wall, internal condition. The surface was generally covered with black soot. Oil stains and drip pattern were visible (see yellow line).

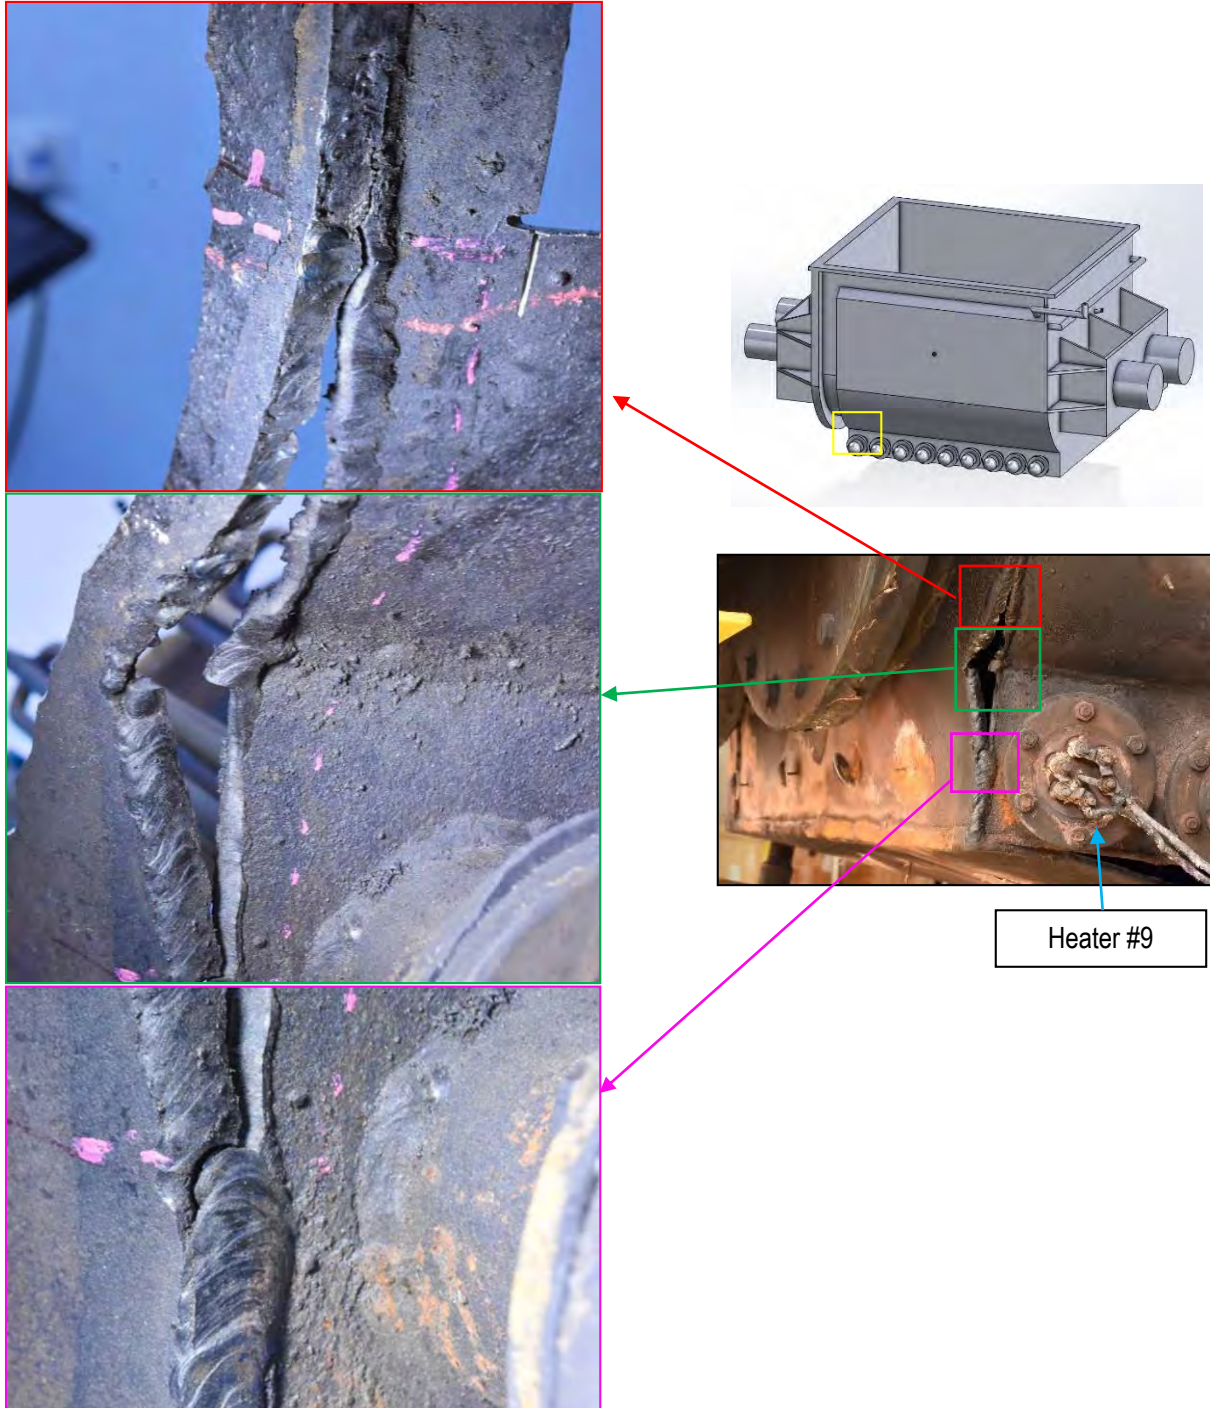
- A fracture opening was observed at the rear side, left edge weld (repair weld). The fracture path was predominantly centred along the weld face at the curved part of the oil jacket. The path changed and propagated along the weld toe at the vertical plane of the oil jacket (Figure 62).
- On the fracture surface of the rear side, left edge weld, voids were visible especially along the curved part (Figure 63). At the vertical plane, the fracture surface was flatter (Figure 64).

**Figure 62:** Close up view of rear-left side weld. The fracture path was predominantly centred along the weld face at the curved part of the oil jacket (see red and green bordered figures). The fracture path changes and propagated along the weld toe at the vertical plane of the oil jacket (see green and pink bordered figures).

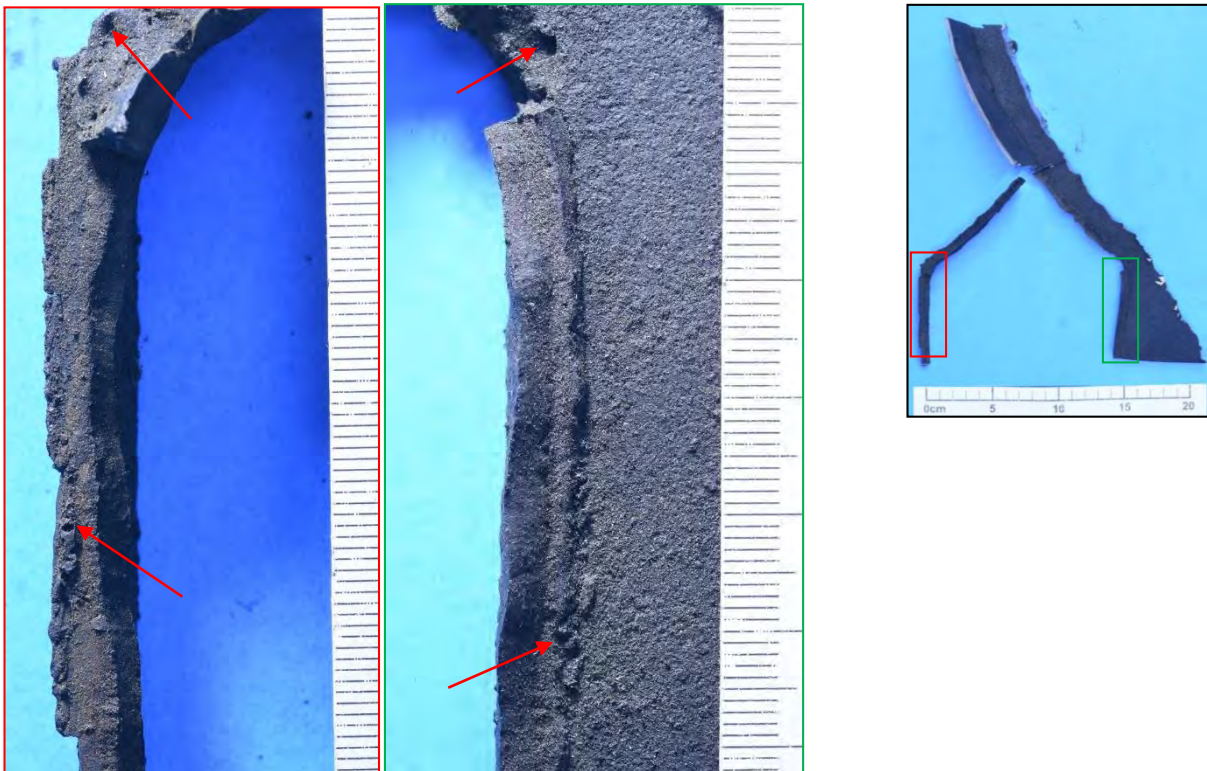
**Figure 64:** Close up view of side weld fracture surface at the straight and vertical plane. Some voids were observed.

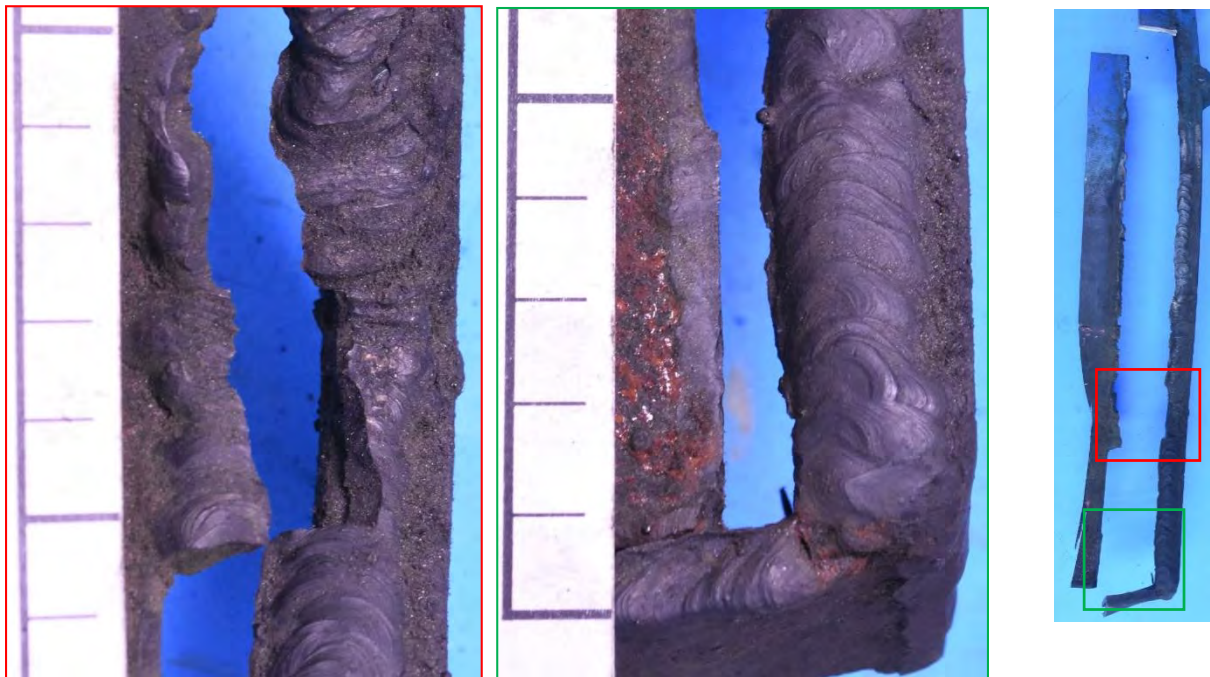
- The fracture at the rear side, right edge weld had a similar fracture path at the repair weld. The fracture path was slightly off-centred along the weld face at the curved part of the oil jacket and along the weld toe at the vertical plane of the oil jacket (Figure 66 and Figure 67).

**Figure 67:** Close up view of side weld fracture surface at the straight and vertical part. The fracture path changes and propagated along the weld toe at the vertical plane of the oil jacket.

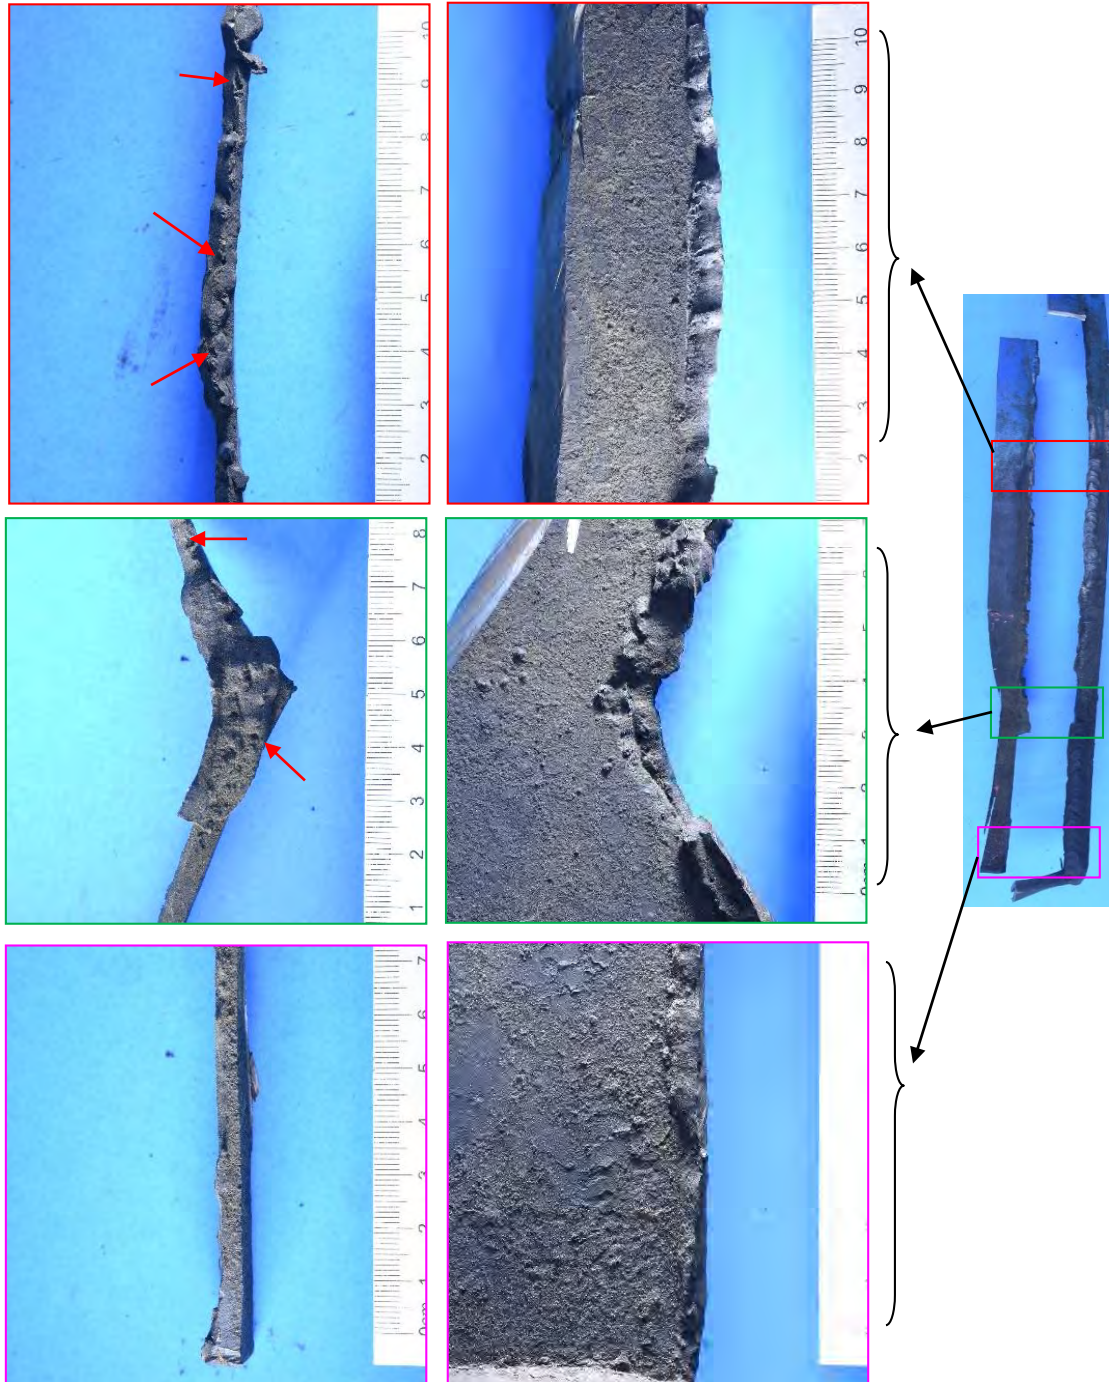
- 4 ➤ Similarly, on the fracture surface of the rear, right edge weld, voids were visible  
6 along the curved part while at the vertical plane the fracture surface was flatter (Figure 68).

**Figure 68:** Close up view of the side weld fracture surface. Voids were observed along the fracture surface of the curved part where the fracture was slightly off-centred on the weld face (see red and green bordered figures). At the vertical plane of the wall, the fracture surface was relatively flat (see pink bordered figures).

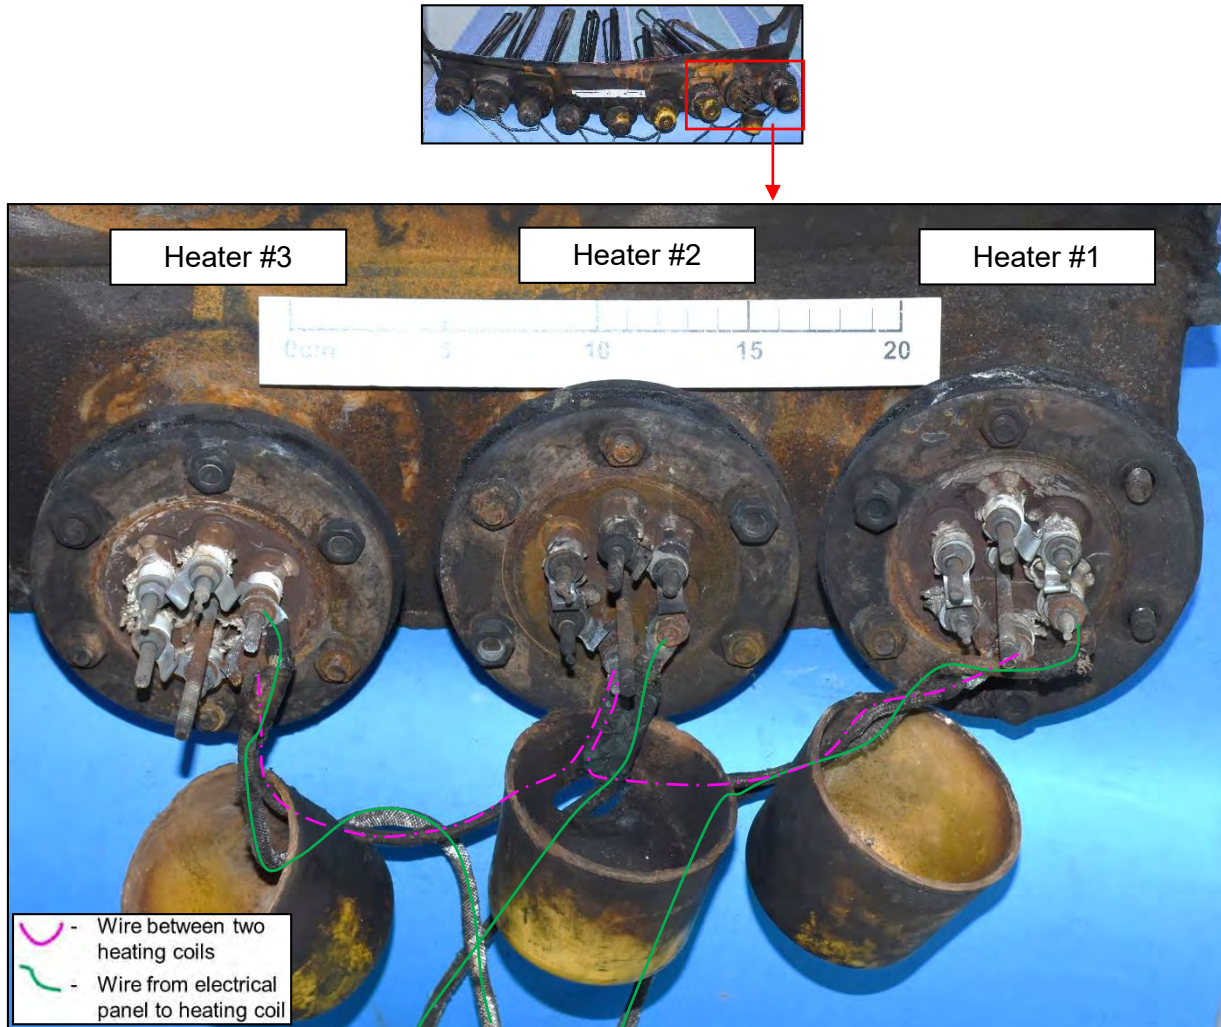
- 8 ➤ The terminals of heater #2 also had a blacker appearance compared to the terminals of the rest of the heaters (Figure 77).
- 10 ➤ Green tapes were observed wrapped around the wires of both terminal #3 and terminal #4 of heater #2. The tapes on each of the aforementioned wire, had likely melted and adhered together. The position of both wire lugs were close together. Beneath the green tape wrapped around the wires at terminal #4 was a yellow clip tab that bound the end of the wire from heater #1 to the wire to heater #3 (Figure 79 and Figure 80).

**Figure 77:** The as-received condition of the heaters (from right, heaters #1, #2 and #3). The flanges generally had blackish appearance. Some of the terminal covers (rounded yellow caps) were blackish on the internal surface as well. The terminals of heater #2 also had a blacker appearance compared to the terminals of the rest of the heaters
