# **Report of the Inquiry Committee for the accident at Stars Engrg Pte Ltd on 24 February 2021**

**(PART II – ANNEXES)**

| Report No:<br><b>M21091</b> | Subject Group:<br><b>11219</b> | Date:<br><b>10<sup>th</sup> September 2021</b> |
| Title of Report:<br><b>Failure Analysis of a Failed Mixer Machine Retrieved from Unit 32E of Platinum @ Pioneer Building involved in a Fire Explosion Incident</b> | | Date of Last Revision/Revision No: |

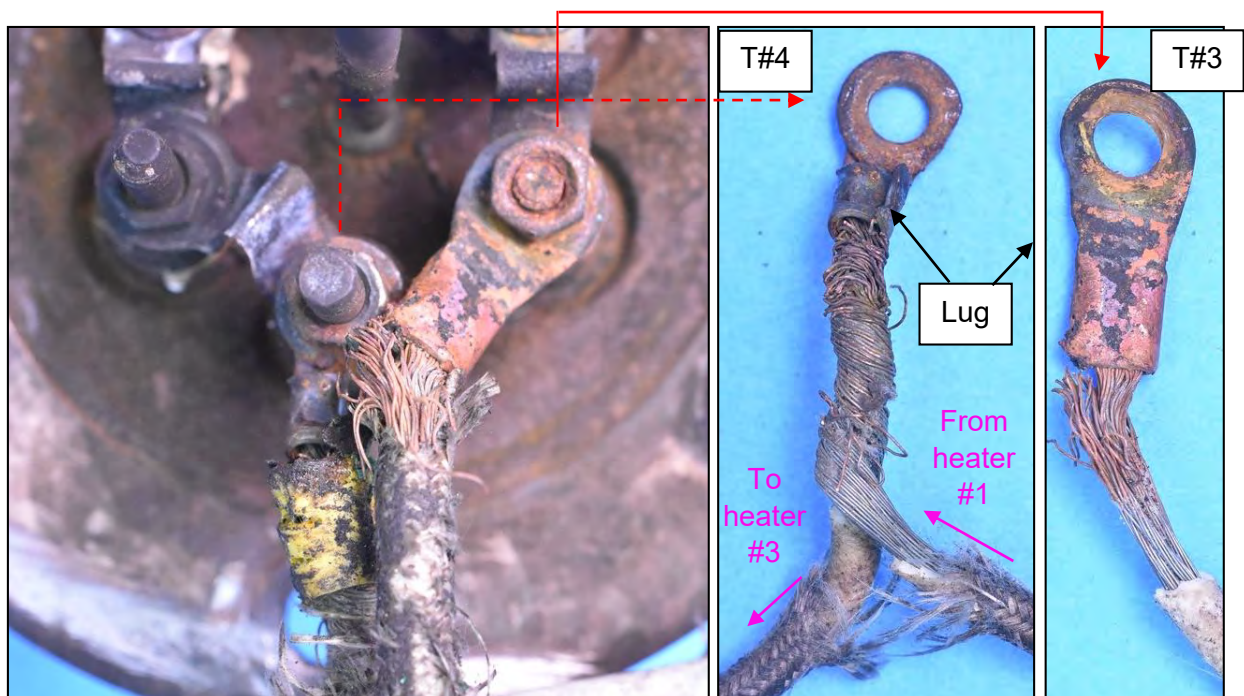
- 8 ➤ The terminals of heater #2 also had a blacker appearance compared to the terminals of the rest of the heaters (Figure 77).
- 10 ➤ Green tapes were observed wrapped around the wires of both terminal #3 and terminal #4 of heater #2. The tapes on each of the aforementioned wire, had likely melted and adhered together. The position of both wire lugs were close together. Beneath the green tape wrapped around the wires at terminal #4 was a yellow clip tab that bound the end of the wire from heater #1 to the wire to heater #3 (Figure 79 and Figure 80).

**Figure 80:** Beneath the green tape wrapped around the wires at terminal #4 was a yellow clip tab (left figure). The yellow clip tab and wire insulations were removed, revealing the wires shown in figures on the right. The wire from heater #1 were wound around the wire to heater #3 (see also Figure 82 to compare). Microscopic examination was conducted and presented in Figure 131.

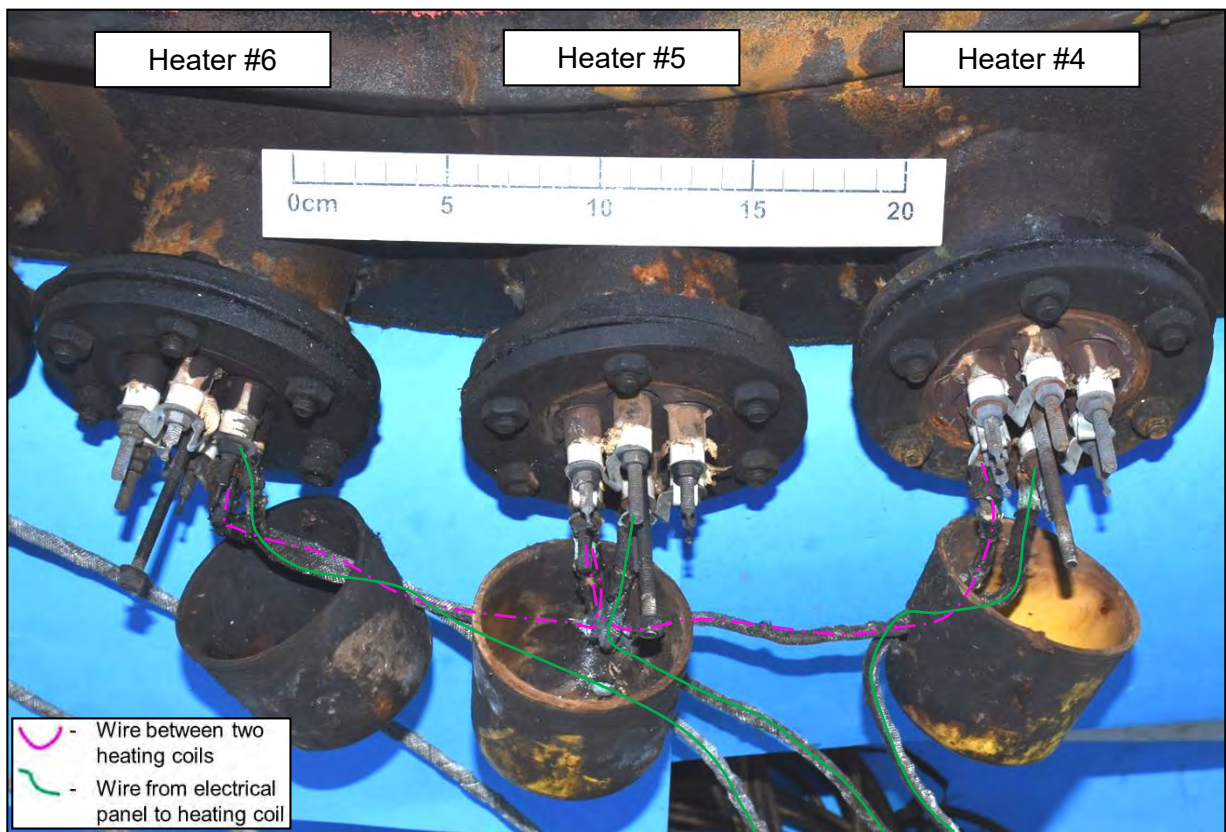
**Figure 81:** The as-received condition of the heaters (from right, heaters #4, #5 and #6). The flanges generally had blackish appearance. Some of the terminal covers (rounded yellow caps) were blackish on the internal surface as well.

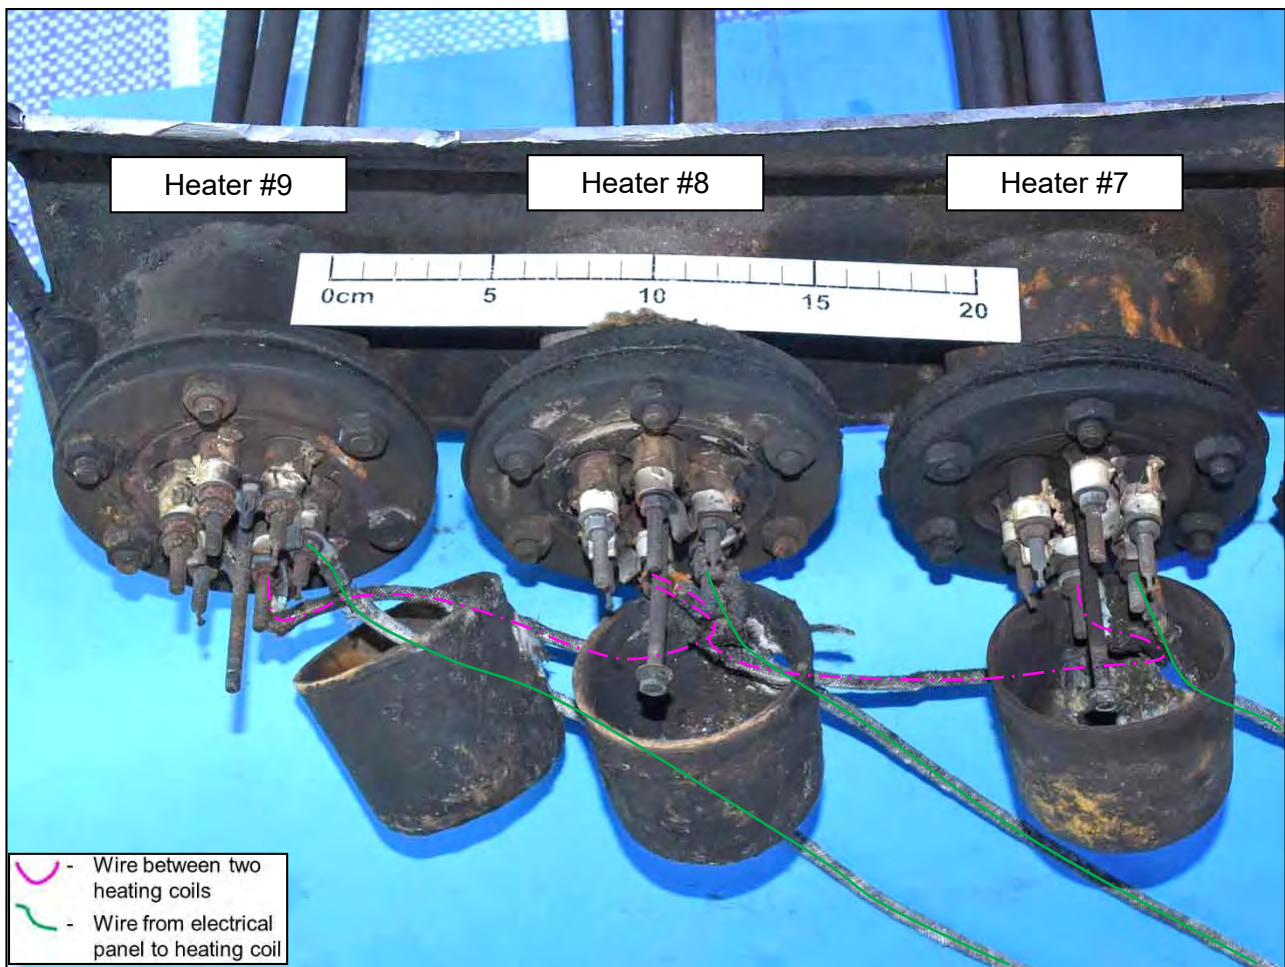
**Figure 83:** The as-received condition of the heaters (from right, heaters #7, #8 and #9). The flanges generally had blackish appearance. Some of the terminal covers (rounded yellow caps) were blackish on the internal surface as well.

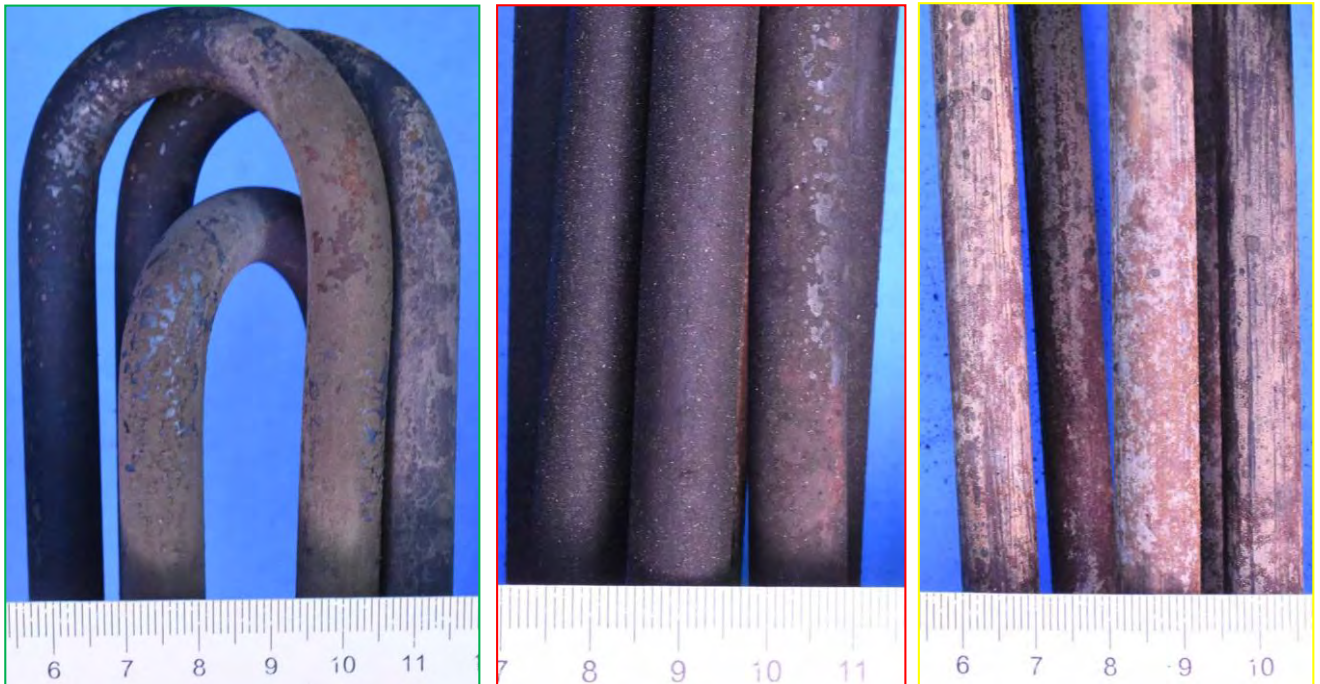
- 14 ➤ Signs of corrosion and peeling of coating were observed at various parts of the metal tubes (Figure 86).
- 16 ➤ All the gaskets had degraded and were generally brittle to the point where they broke with slight pressure (Figure 87 and Figure 90).

**Figure 86:** Signs of corrosion and peeling of coating were observed at various parts of the metal tubes.

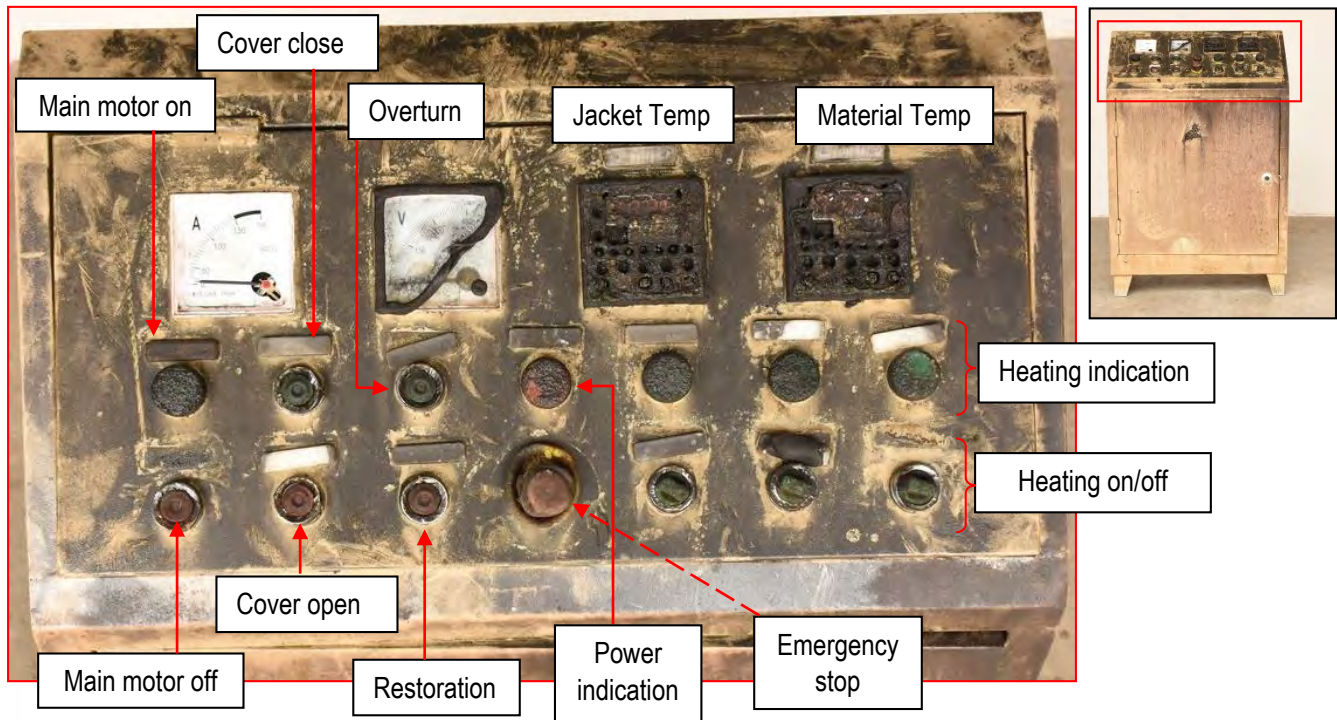
**Figure 107:** Electric panel – top area. The labels were made based on the reference photograph provided in *Annex 4*. The thermostats labelled “Jacket Temp” and “Material Temp” were used to indicate the temperature measured by RTDs A and B respectively. The thermostats and buttons sustained fire damages during the incident.

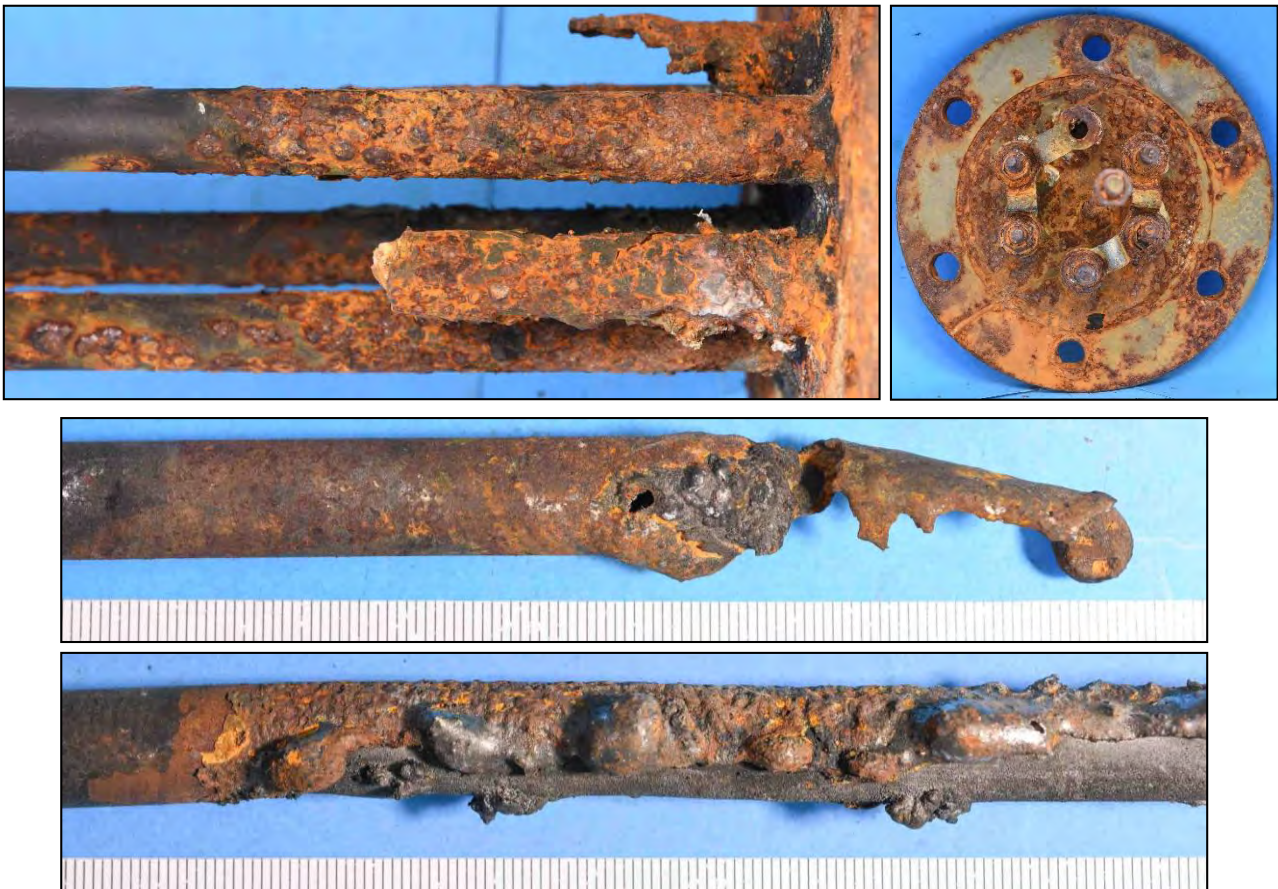
**Figure 114:** One of the coil had broken off from the heater. The metal tube had deformed and melted off around the breakage location as evidenced by the bulbous and droplet-like shape of the metal.

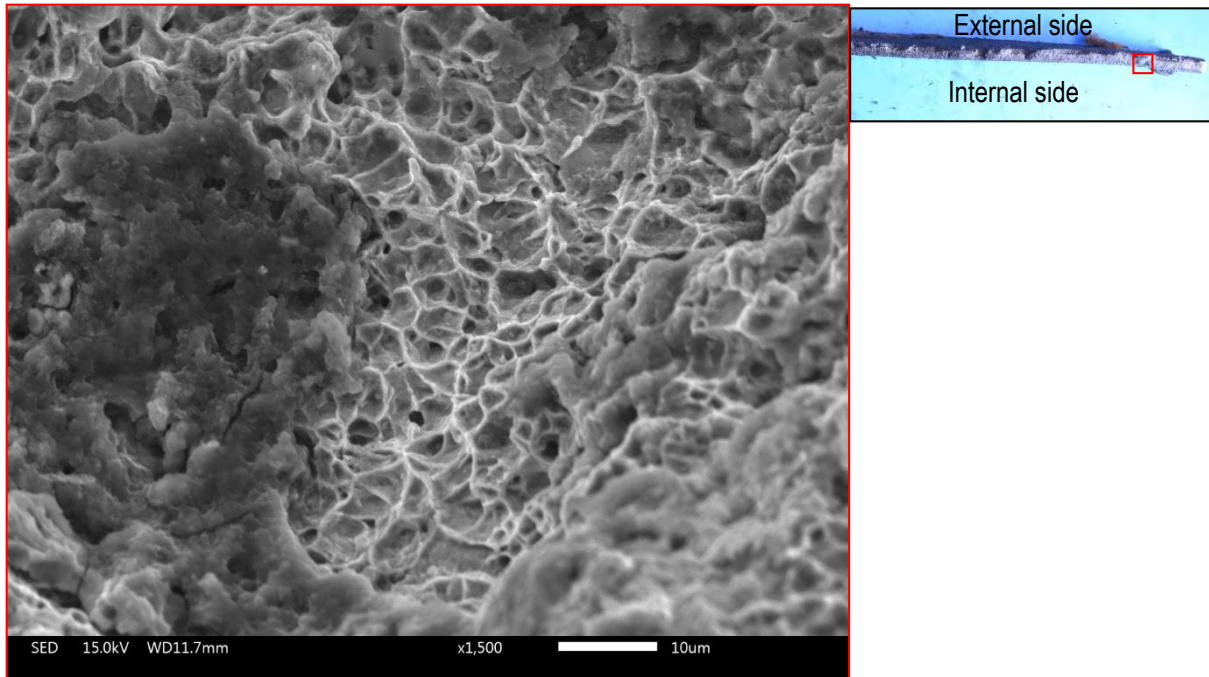
**Figure 129:** Equiaxed dimples were generally observed throughout the fracture surface at regions adjacent to the internal side.

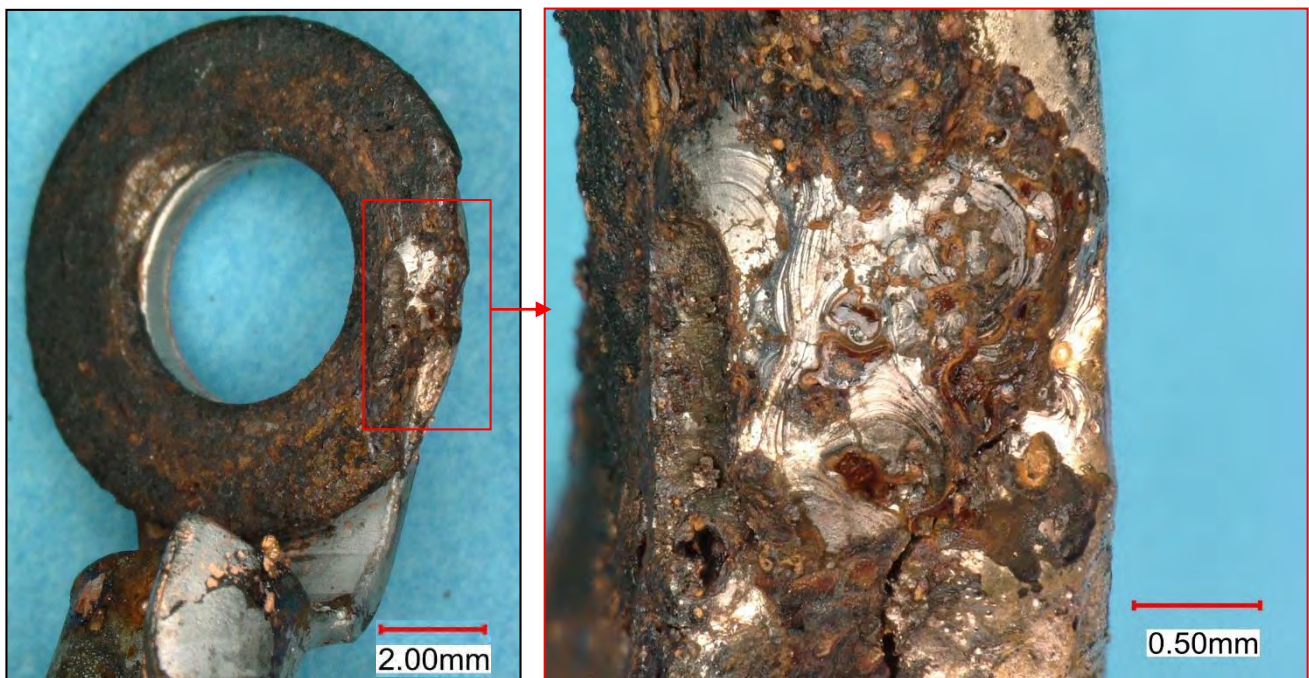
**Figure 138:** Condition of lug after cleaning in an ultrasonic bath of Alconox solution. Resolidification waves, a characteristic trait of arcing, observed at the lug and washer.

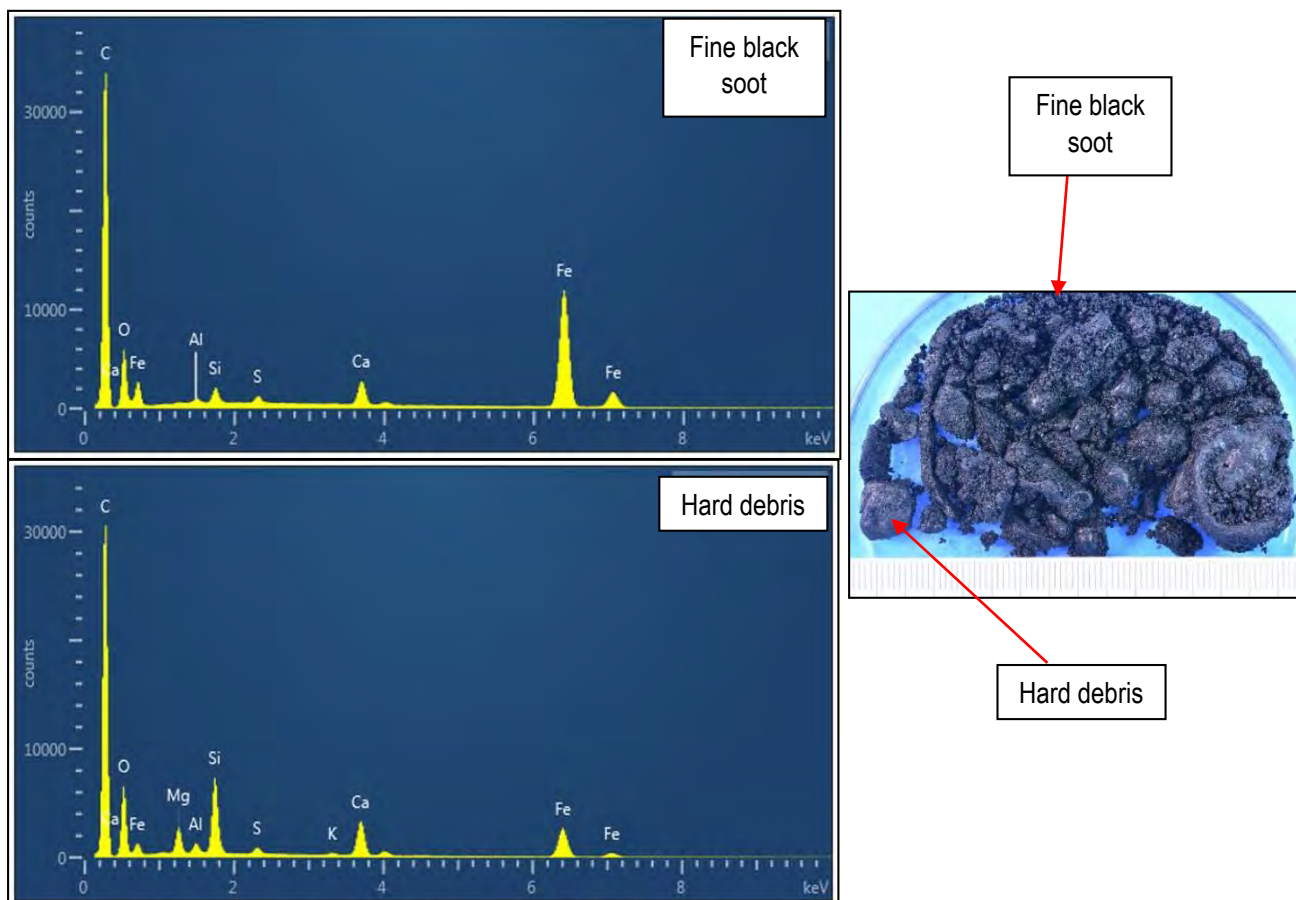
**Figure 143:** The major elements detected on the fine black soot were mainly associated with the thermic oil. The hard debris had high peaks of silicon and magnesium apart from elements associated with the service medium.

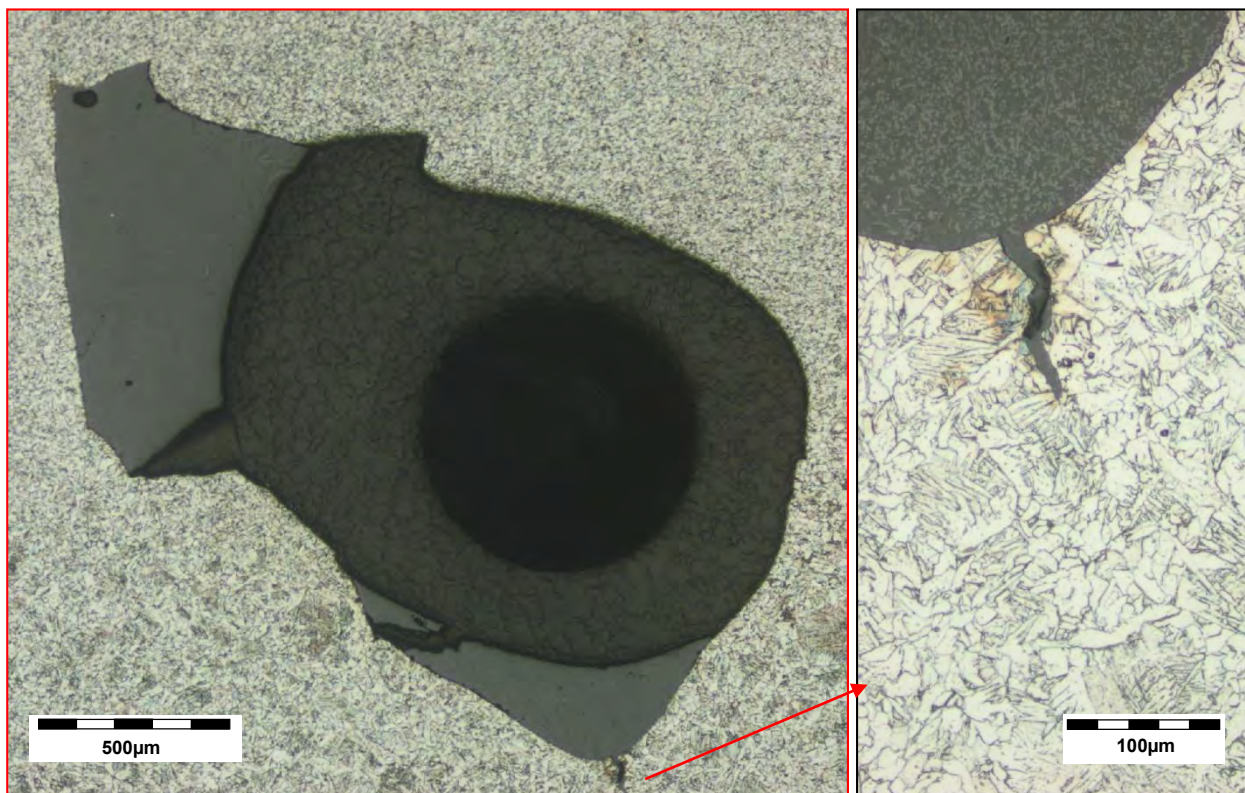
**Figure 148:** Micrograph of at 50x (left) and 200x (right) magnifications. A 115 µm incipient crack was at the edge of the void, propagating towards the weld face.

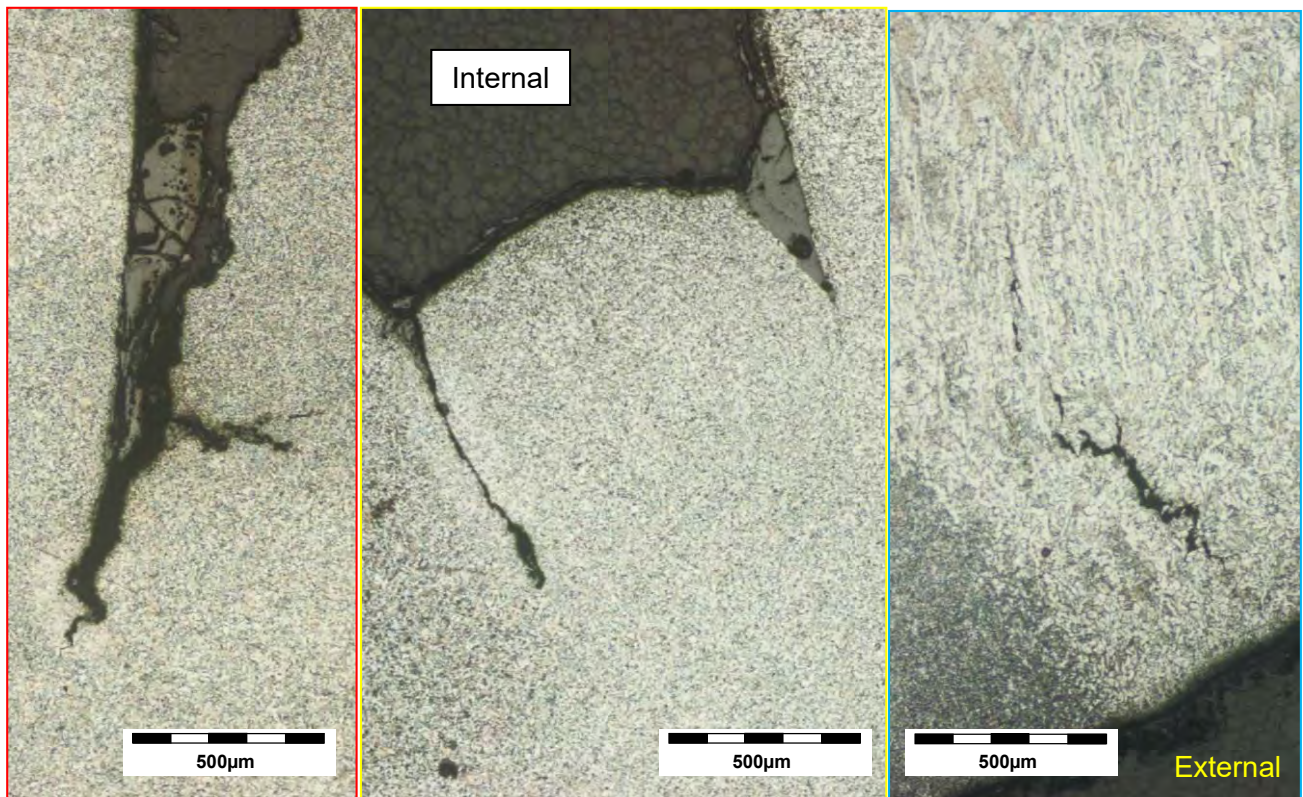
**Figure 150:** Micrographs at 50x magnification. Incipient cracks and discontinuities were observed at the weld root and near the weld face. The cracks were filled with oxide scales.

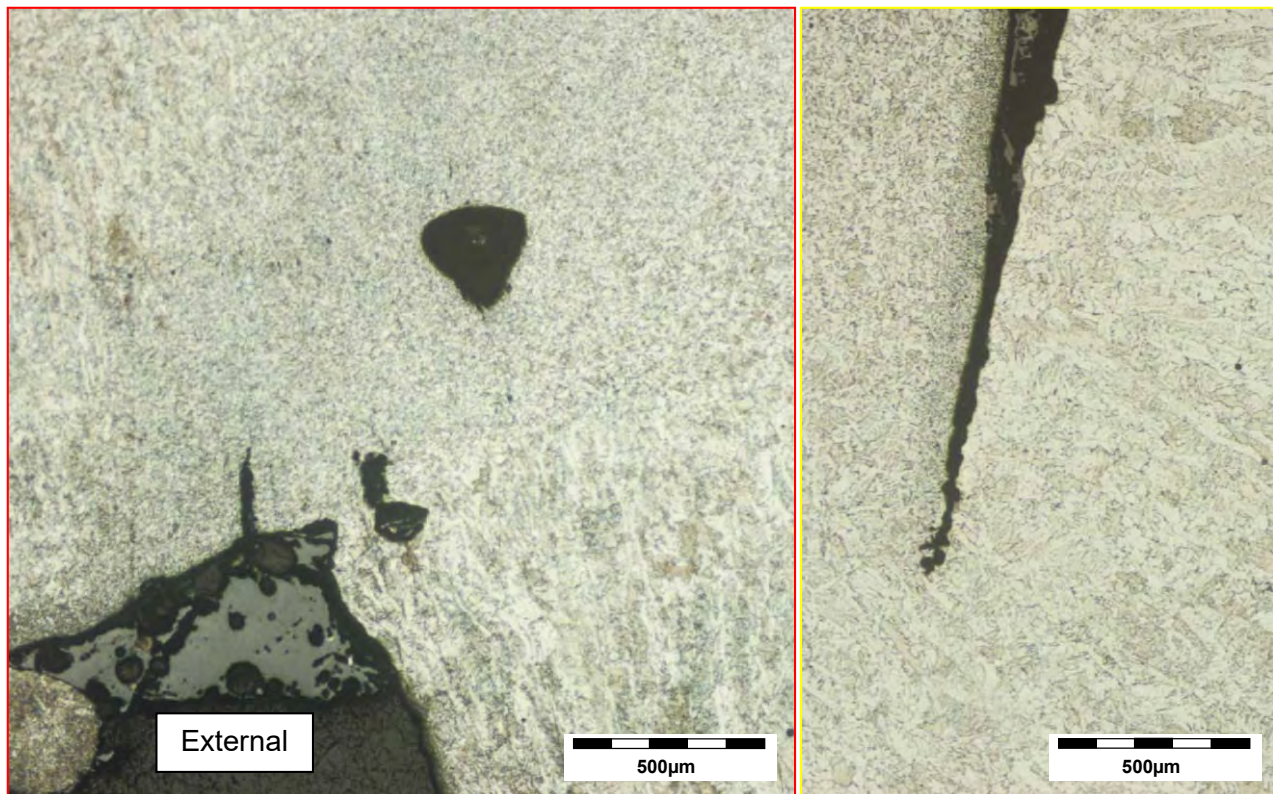
**Figure 152:** Micrographs at 50x magnification. Voids were observed within the weld metal (left). Oxide filled incipient crack was observed at the weld root (right).

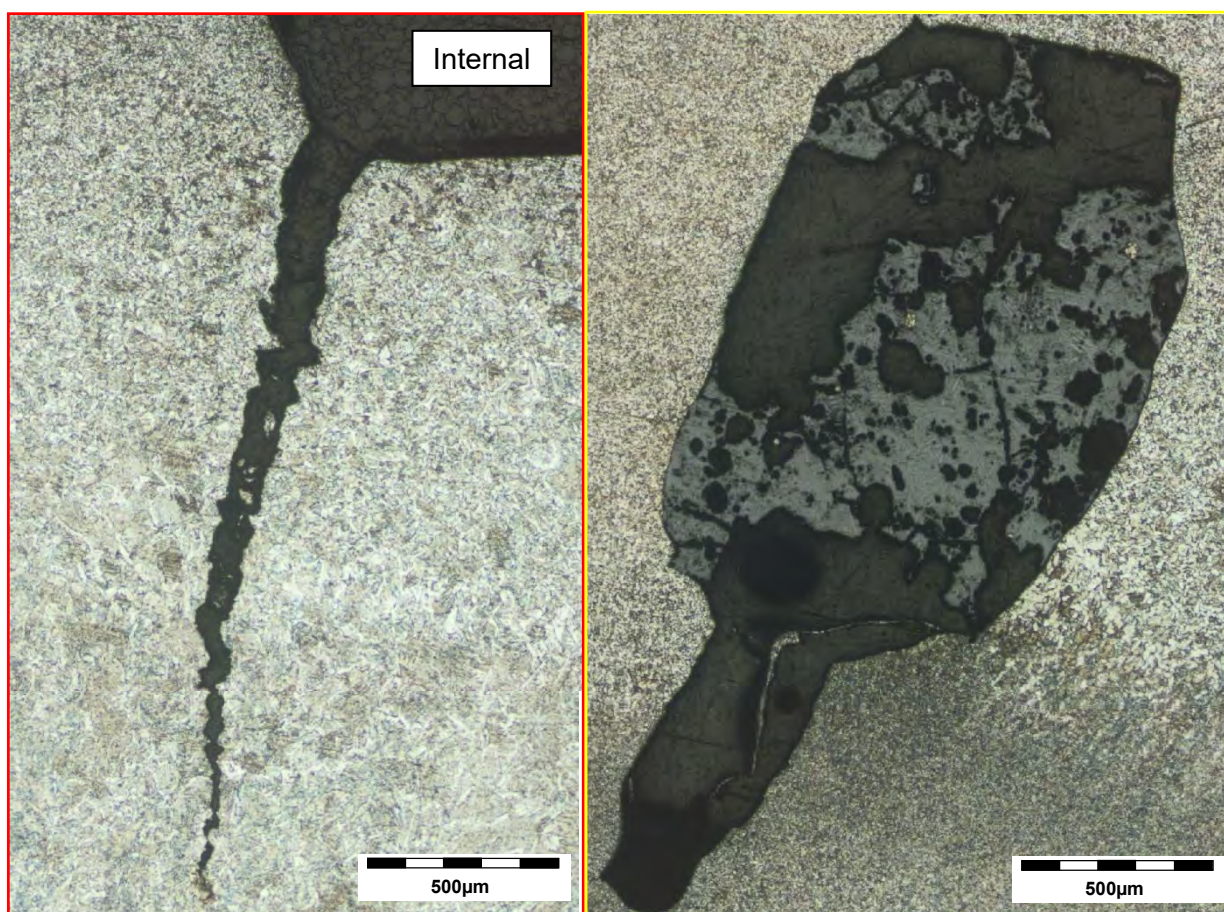
**Figure 156:** Micrographs at 50x magnification. Crack with a length of about 2.0 mm was observed to have initiated at the weld root and propagated towards the weld face.

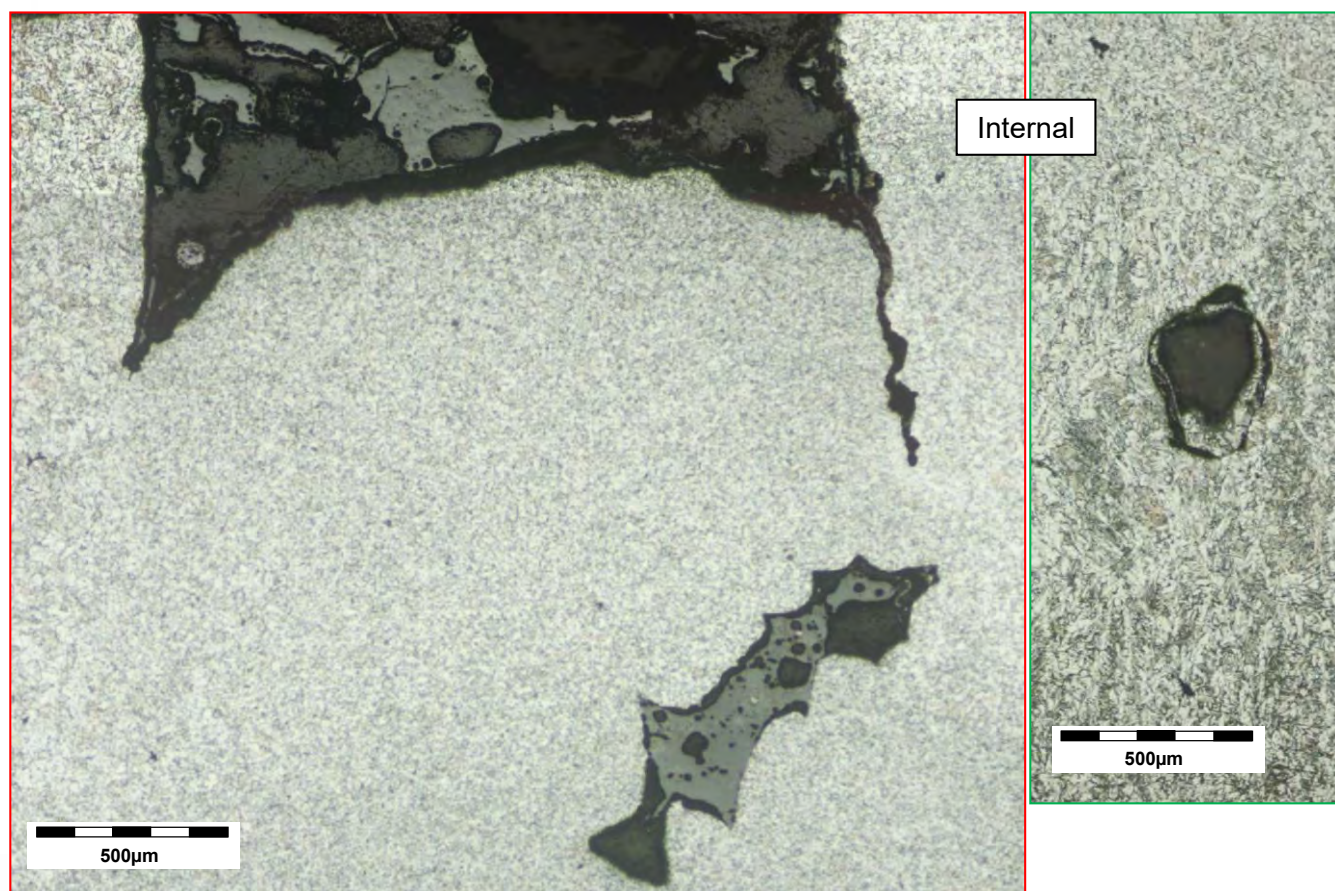
**Figure 160:** Micrographs at 50x magnification. Oxide filled incipient crack was observed at the weld root (left). Voids were scattered in the weld metal (right).

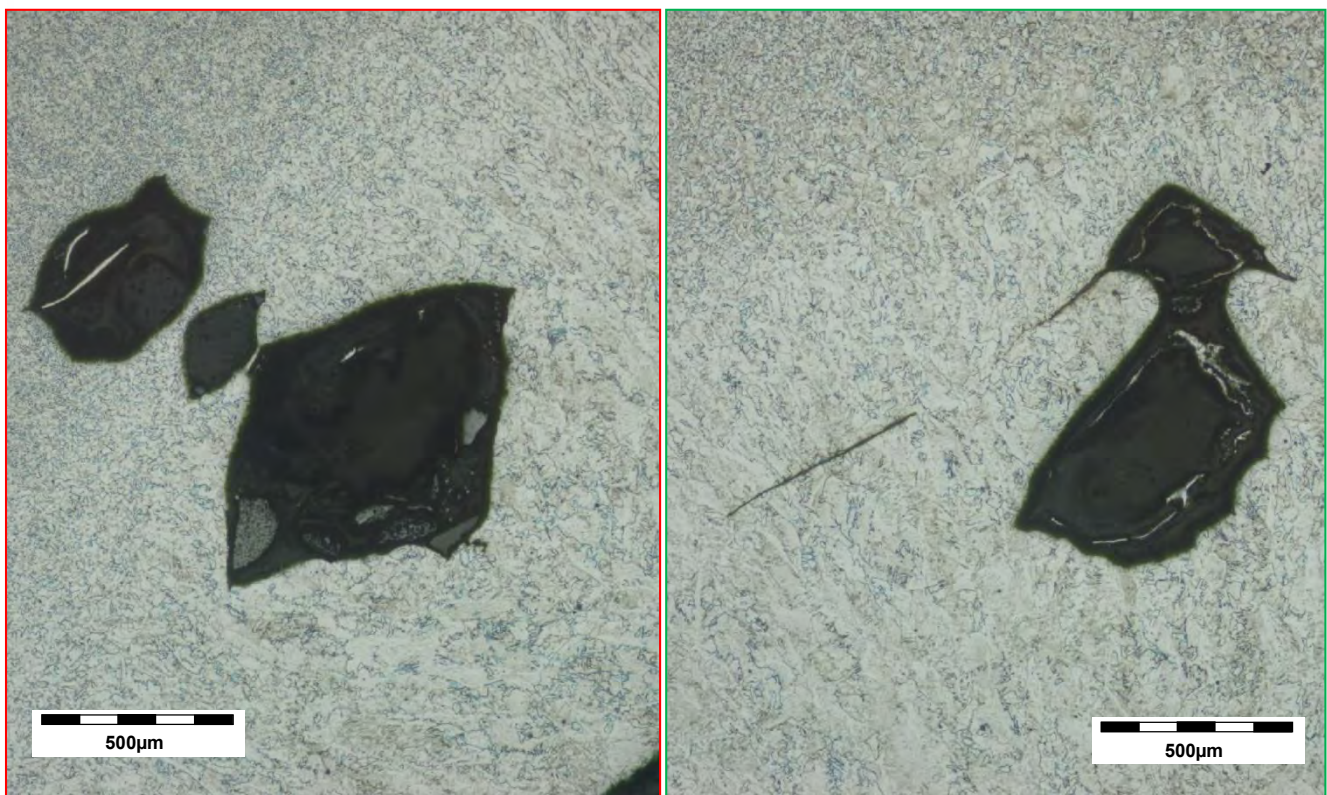
**Figure 162:** Micrographs at 50x magnification. Voids were scattered in the weld metal.

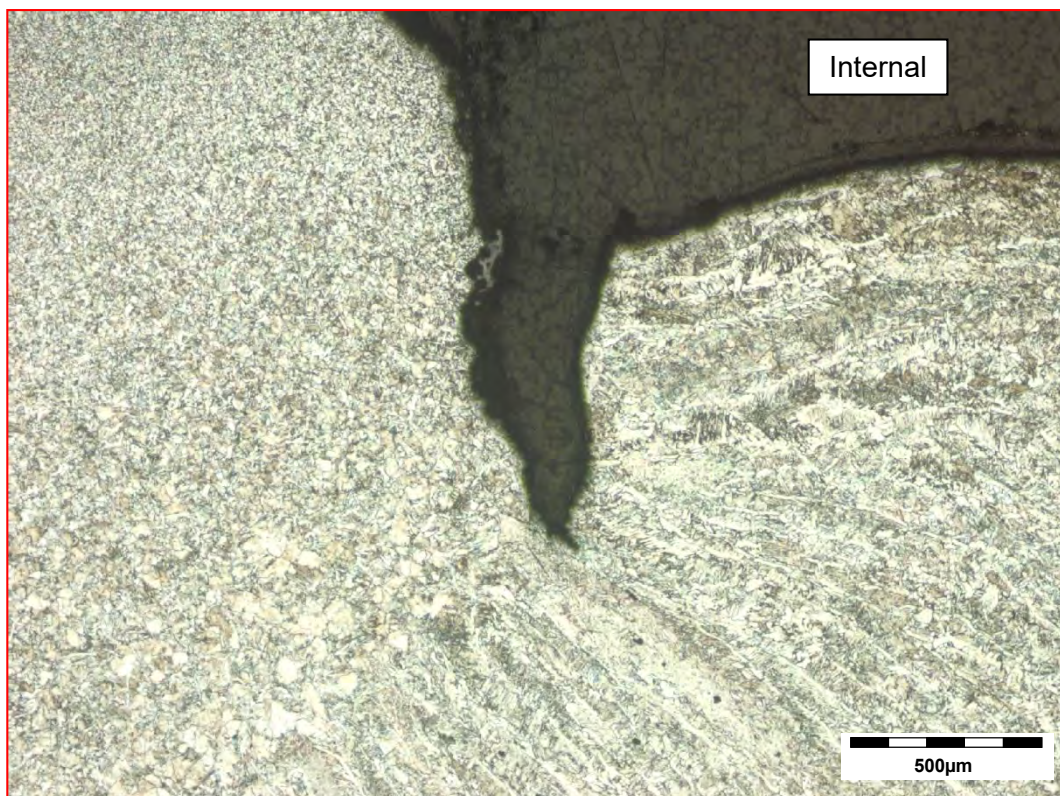
**Figure 164:** Micrographs at 50x magnification. Incipient crack (with some oxide scale) was observed at the weld root.

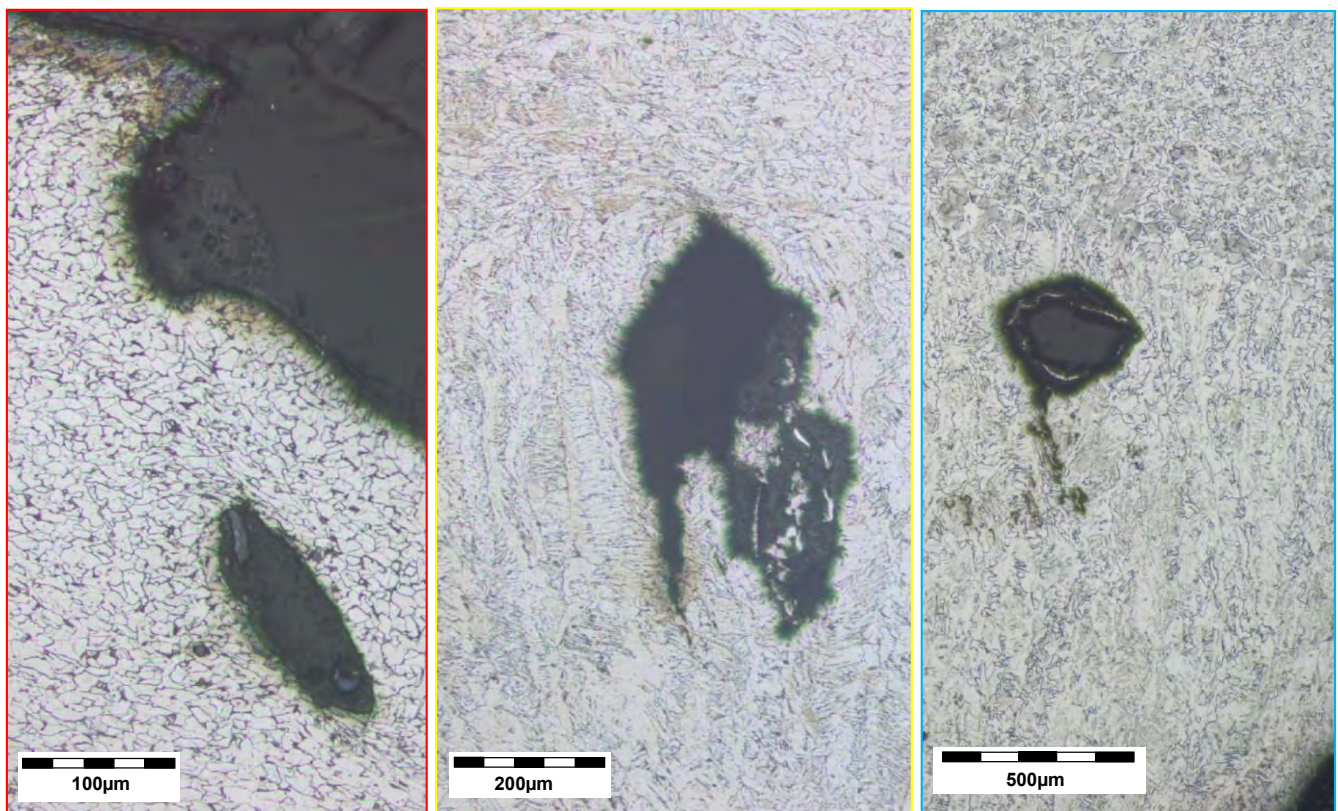
**Figure 166:** Micrographs at 200X (left), 100X (middle) and 50X (right) magnifications. Voids were scattered in the weld metal and along/across the crack path (left figure).

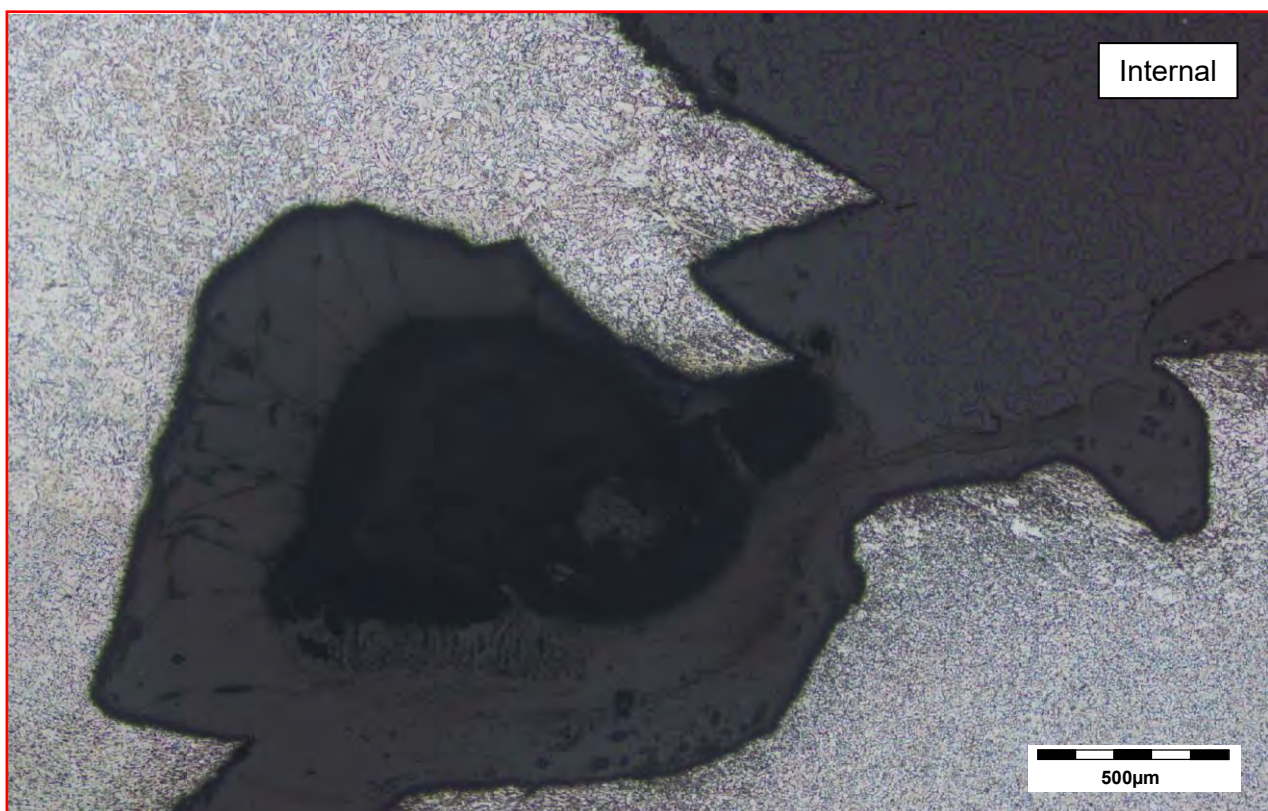
**Figure 170:** Micrographs at 50x magnification. The crack had propagated through the voids.

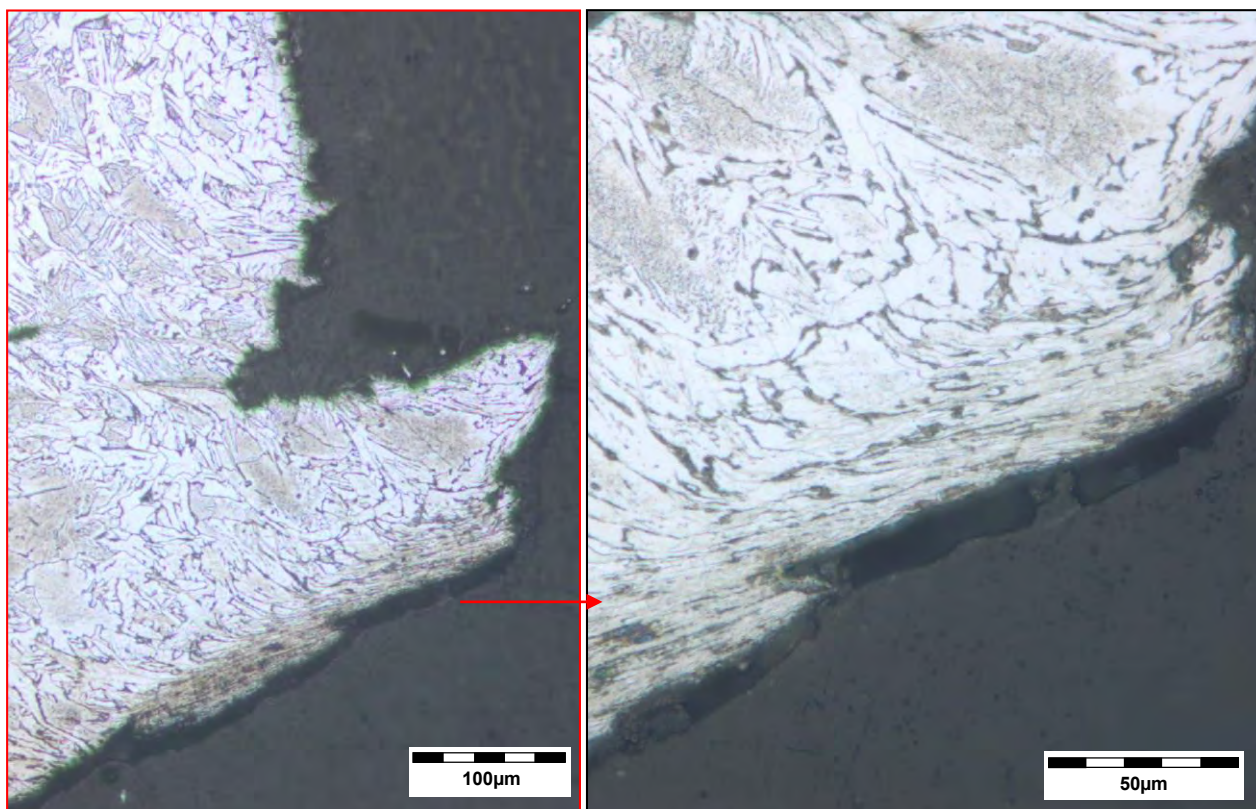
**Figure 172:** Micrographs at 200x (left) and 500X (right) magnifications. The structure along the crack edge had elongated grains, consistent with overload fracture.

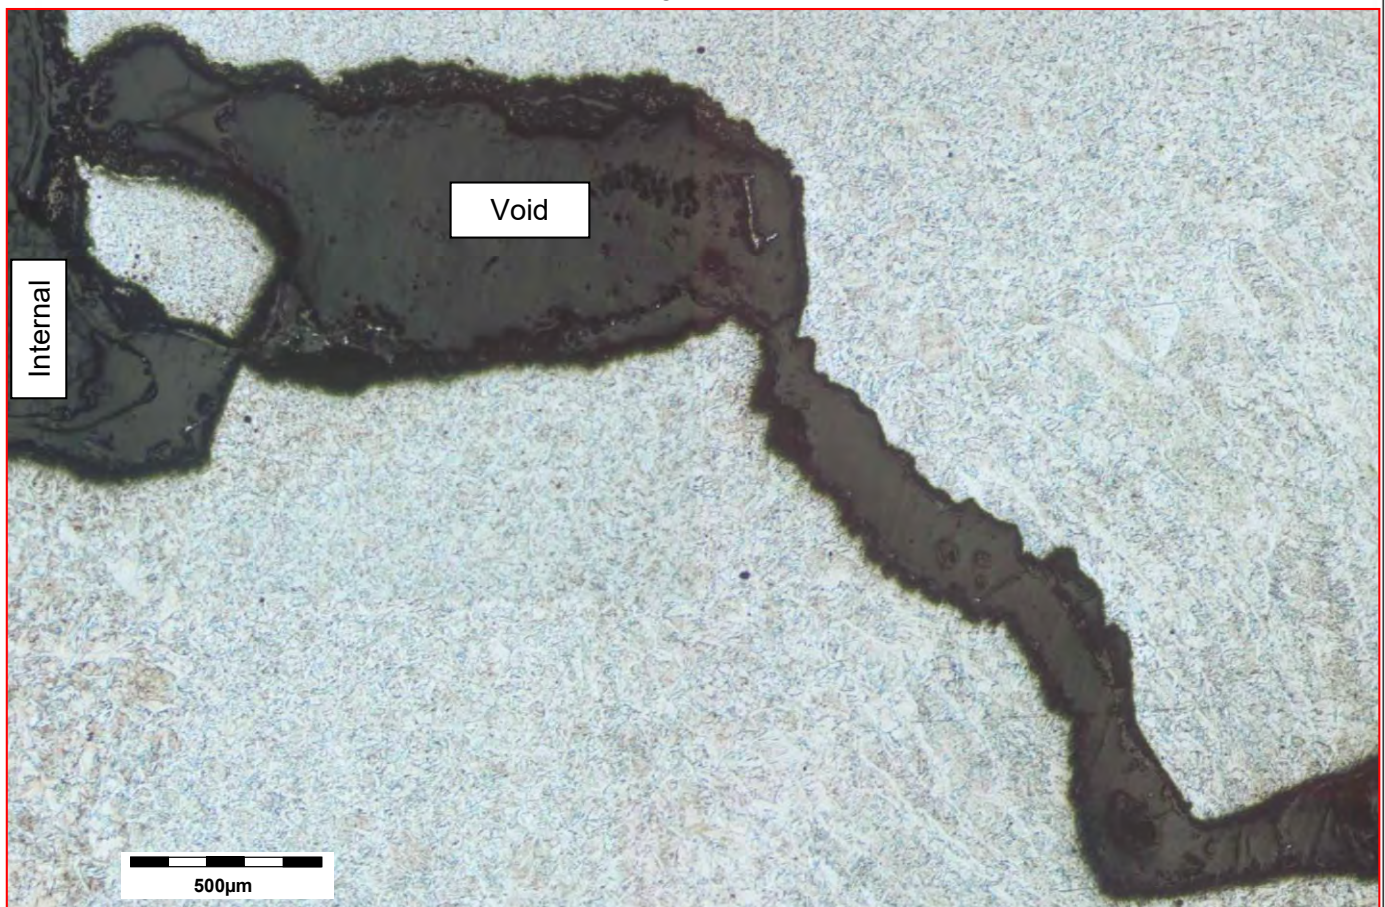
**Figure 174:** Micrographs at 50x magnification. The crack had propagated through a void before reaching the external side at the weld face.

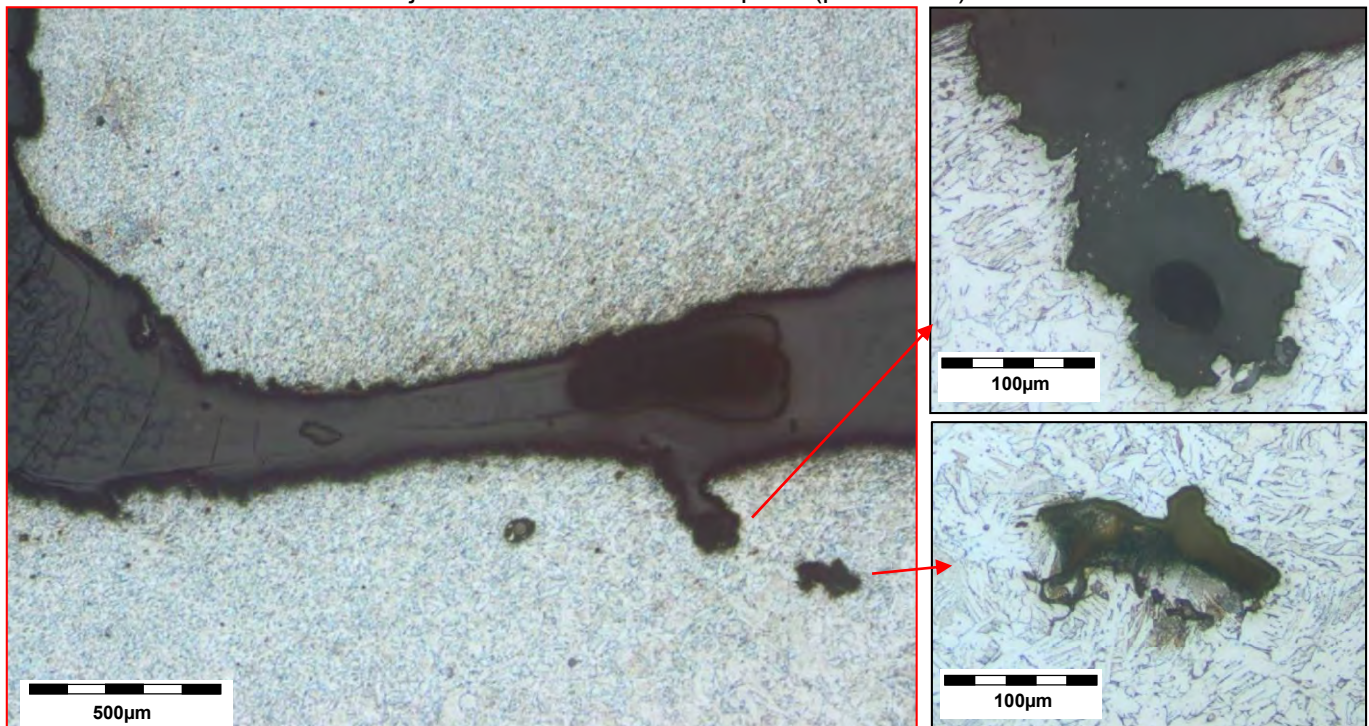
**Figure 176:** Micrographs at 50x (left) and 200X (right) magnifications. Closer examination along crack path at the weld joint between the oil jacket bottom plate and wall revealed voids of up to about 160 µm within the weld metal.
