# **Report of the Inquiry Committee for the accident at Stars Engrg Pte Ltd on 24 February 2021**

**(PART II – ANNEXES)**

| Report No:<br><b>M21091</b> | Subject Group:<br><b>11219</b> | Date:<br><b>10<sup>th</sup> September 2021</b> |
| Title of Report:<br><b>Failure Analysis of a Failed Mixer Machine Retrieved from Unit 32E of Platinum @ Pioneer Building involved in a Fire Explosion Incident</b> | | Date of Last Revision/Revision No: |

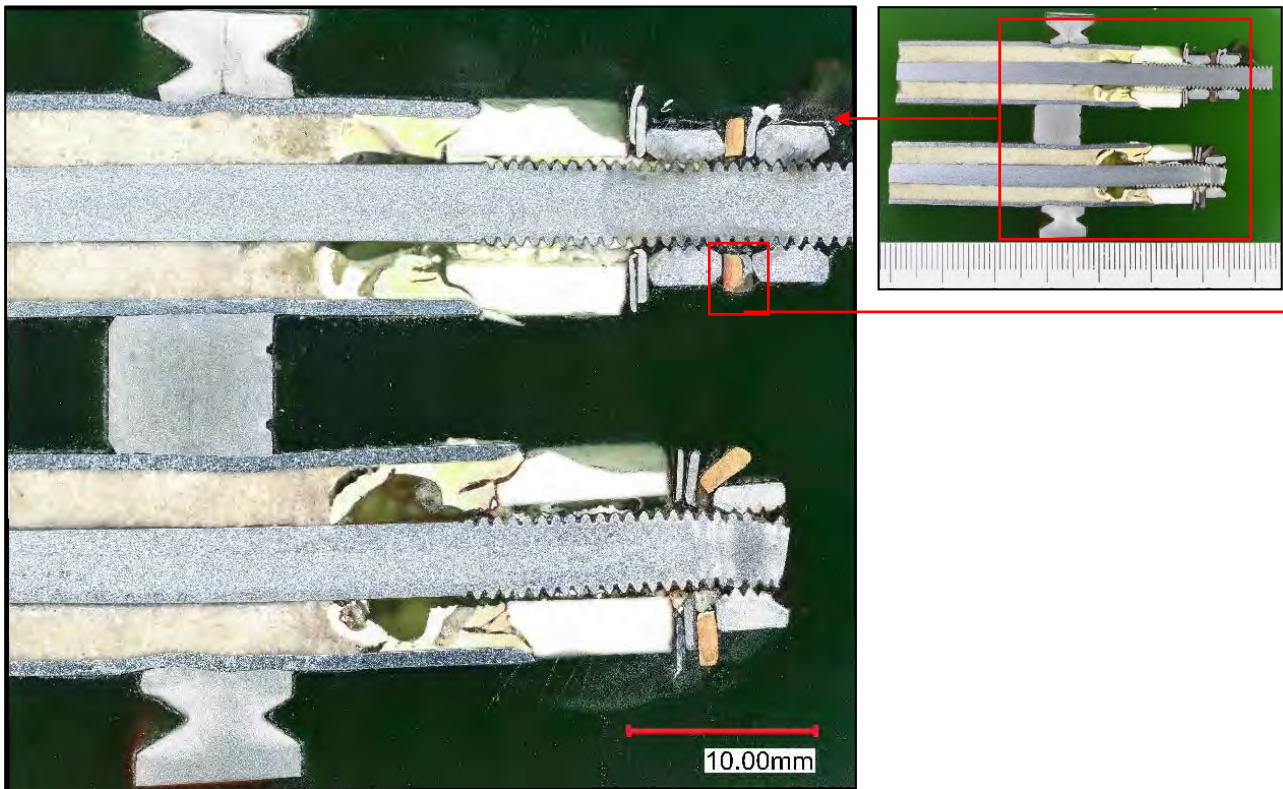
**Figure 179:** Sectional metallographic examination was conducted across the wired terminals (terminals #3 and #4). The arc damage is visible at the lug.

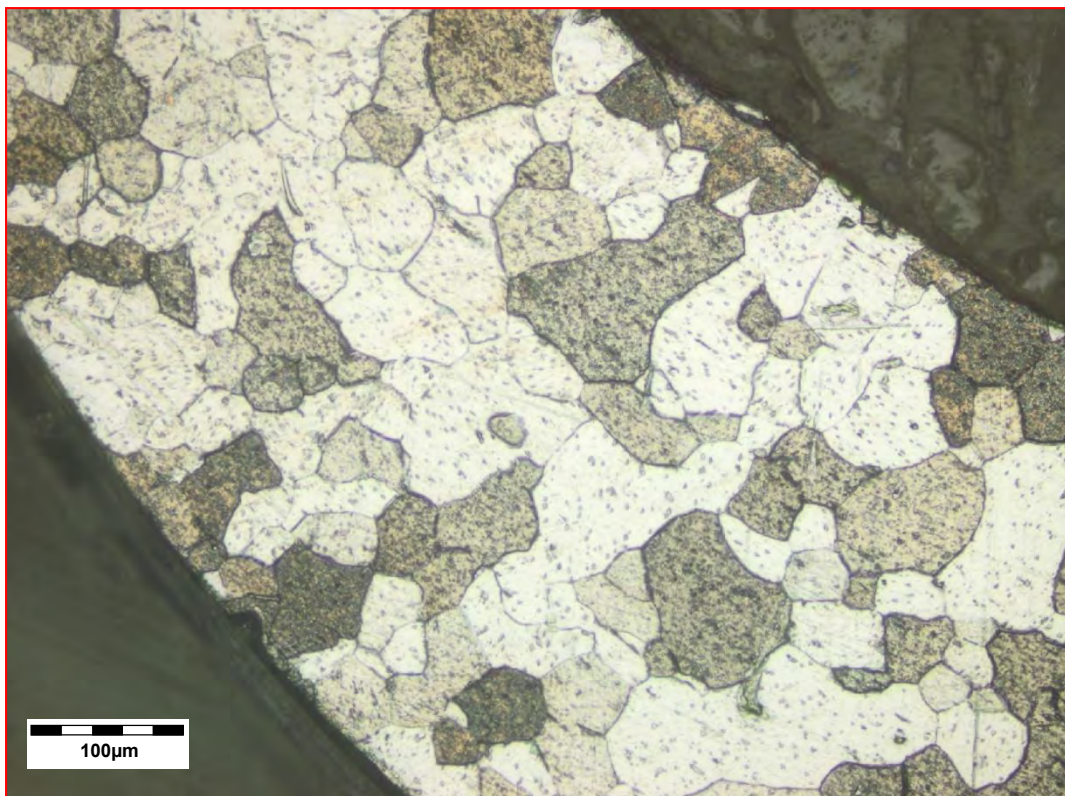
**Figure 184:** Micrograph of the resistance wire at 200X magnification. All the resistance wires within metal tubes were generally similar in microstructure had experienced grain growth (compared with H New, Figure 202).

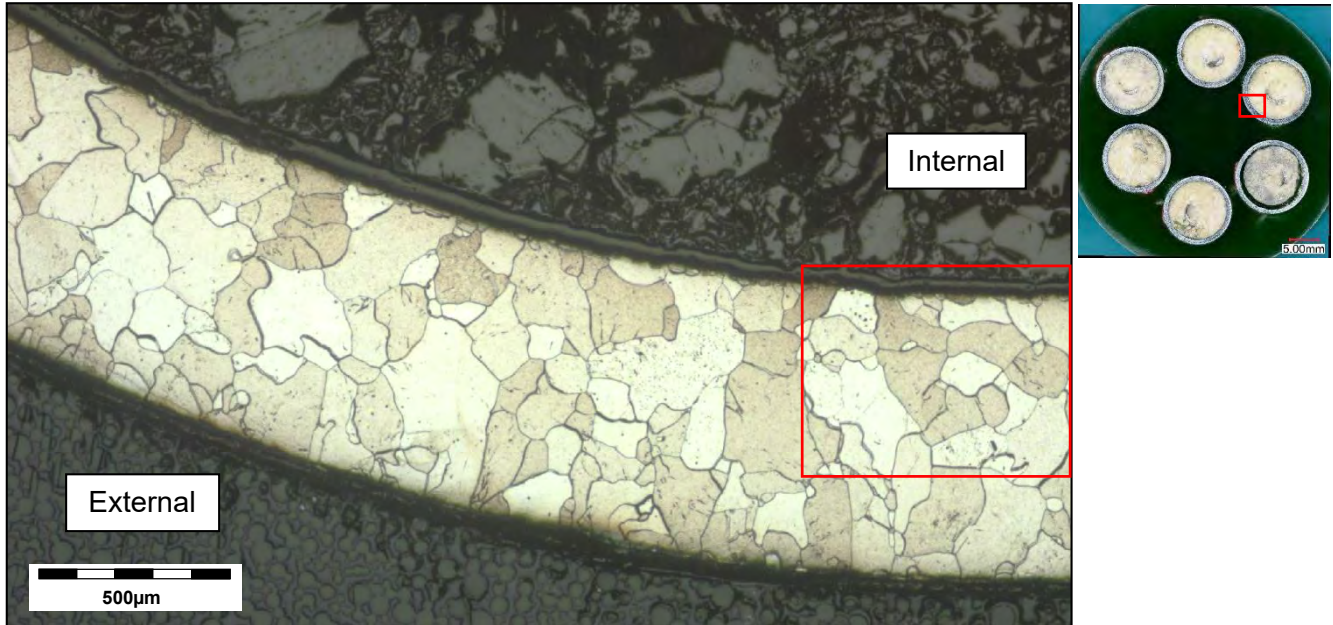
**Figure 185:** Micrograph of the metal tube at 50X magnification. All the metal tubes were generally similar in microstructure and had experienced grain growth (compared with H New, Figure 203).

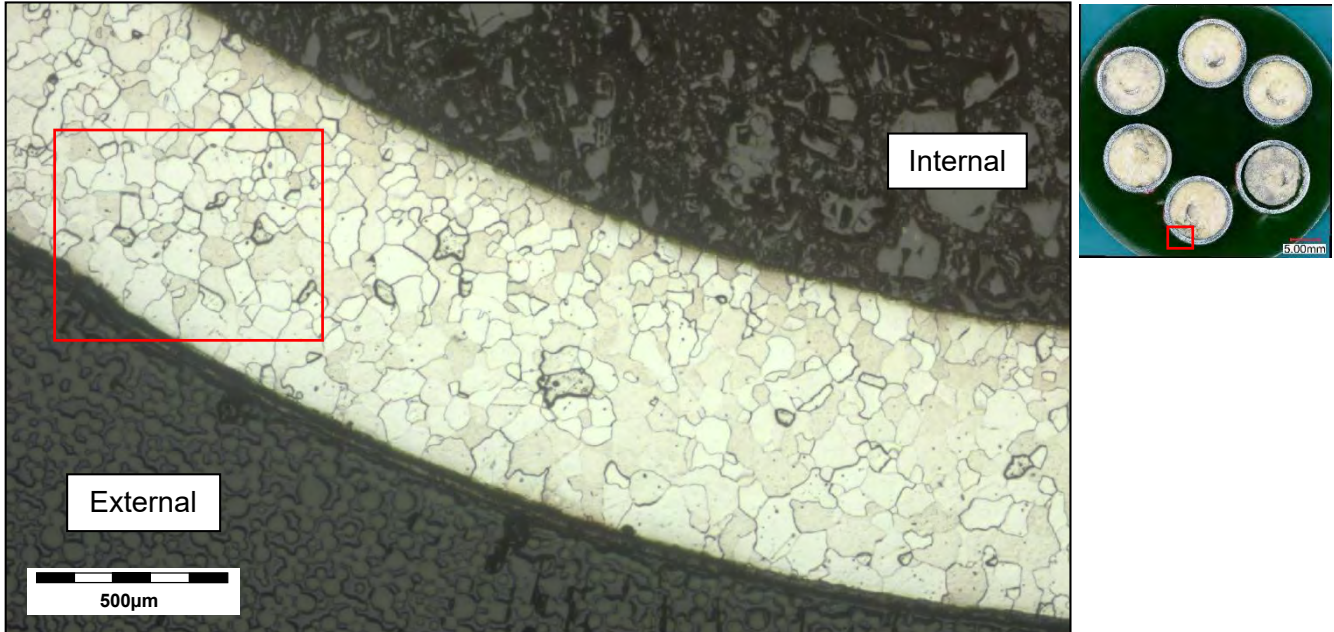
**Figure 187:** Micrograph of the metal tube at 50X magnification. All the metal tubes were generally similar in microstructure and had experienced grain growth (compared with H New, Figure 203).

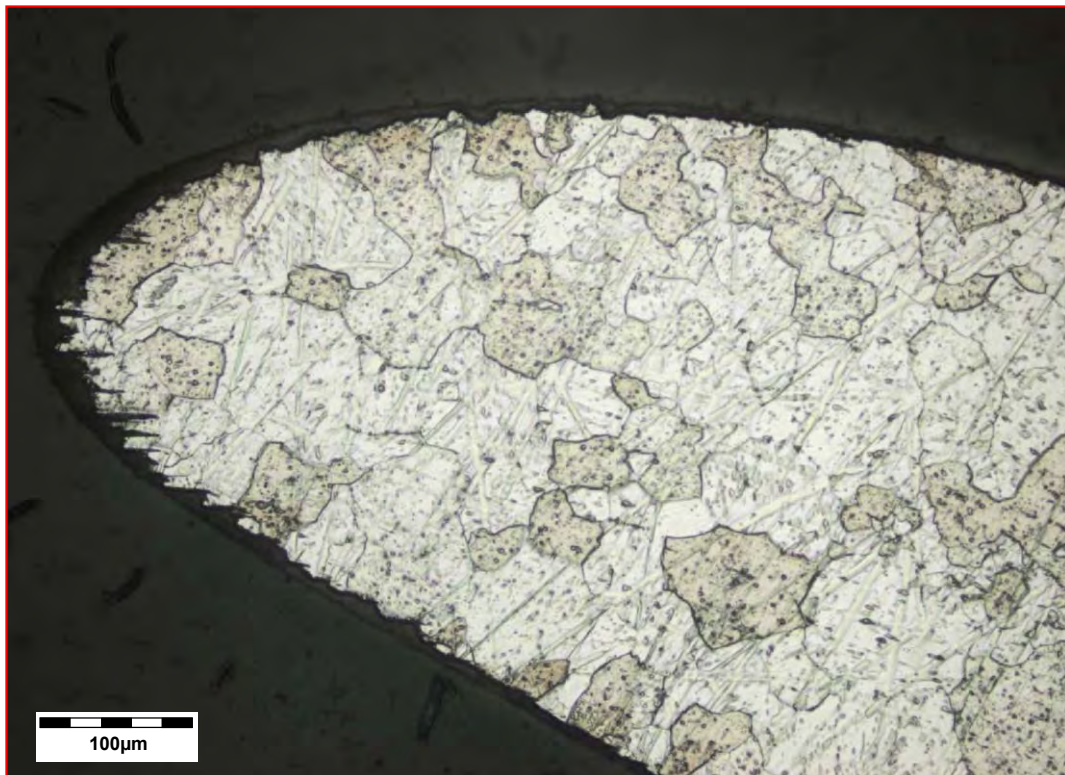
**Figure 190:** Micrograph of the resistance wire at 200X magnification. All the resistance wires within metal tubes were generally similar in microstructure had experienced grain growth (compared with H New, Figure 202).

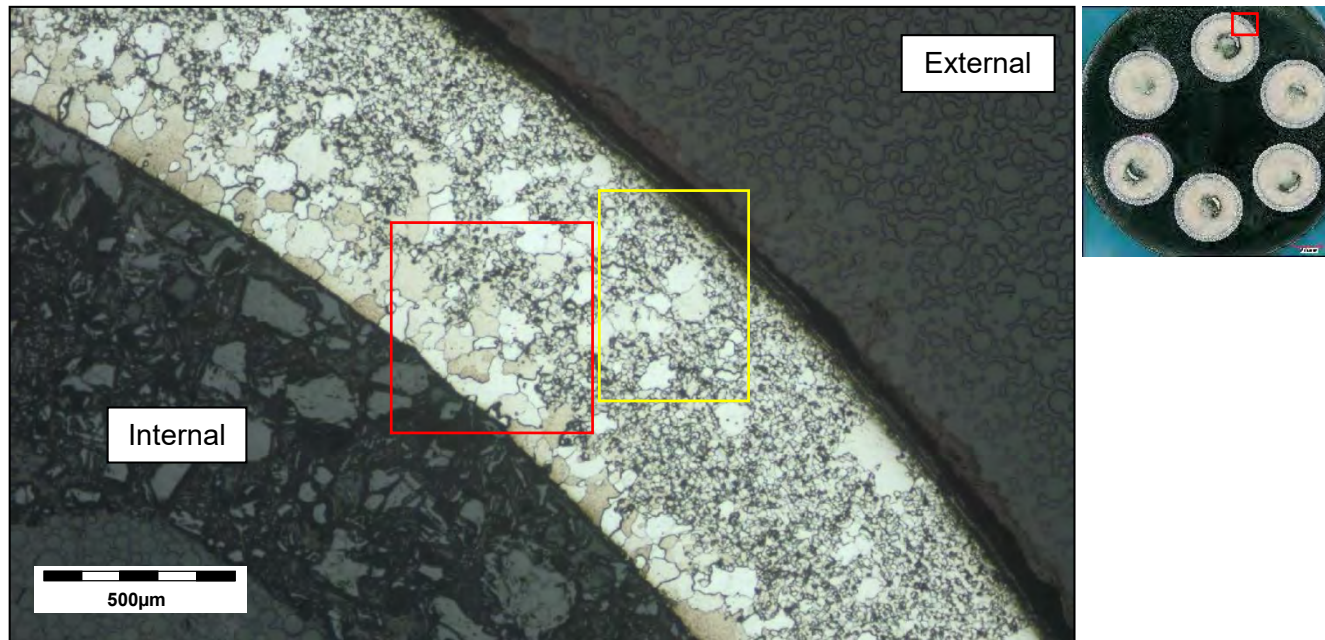
**Figure 191:** Micrograph of the metal tube at 50X magnification. All the metal tubes were generally similar in microstructure and had experienced grain growth starting from the internal surface up to about mid-wall thickness (compared with H New, Figure 203).

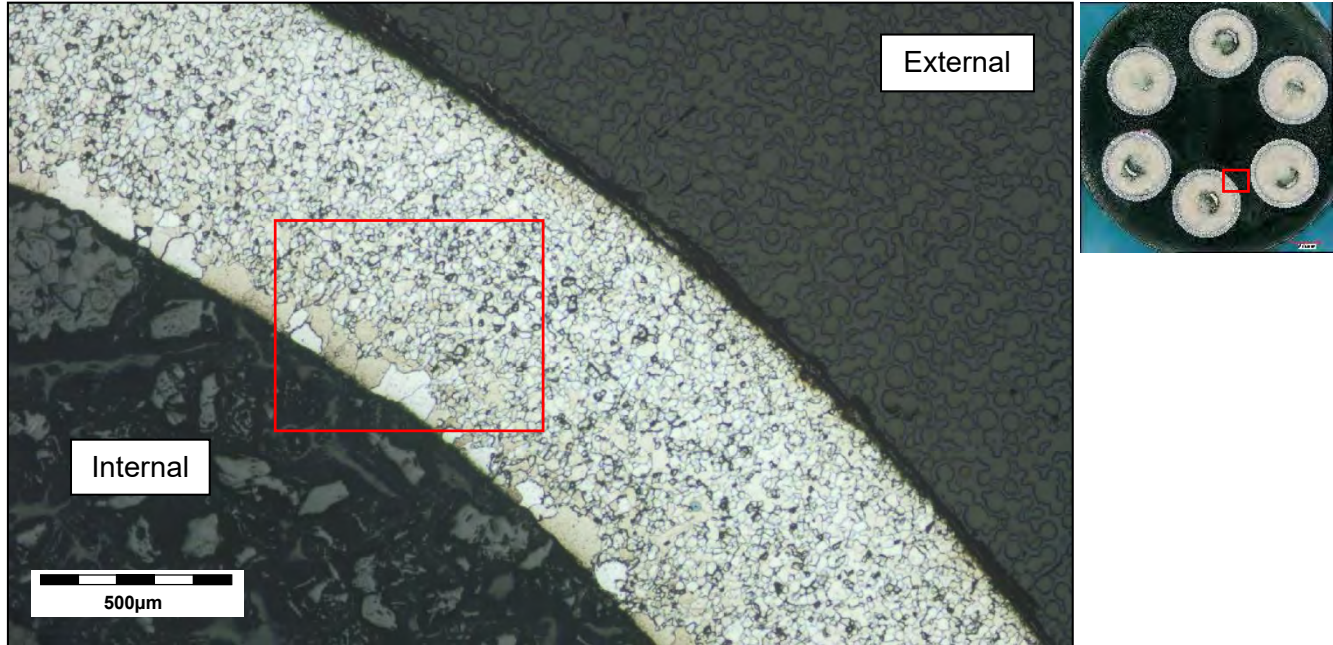
**Figure 193:** Micrograph of the metal tube at 50X magnification. All the metal tubes were generally similar in microstructure and had experienced grain growth starting from the internal surface (compared with H New, Figure 203).

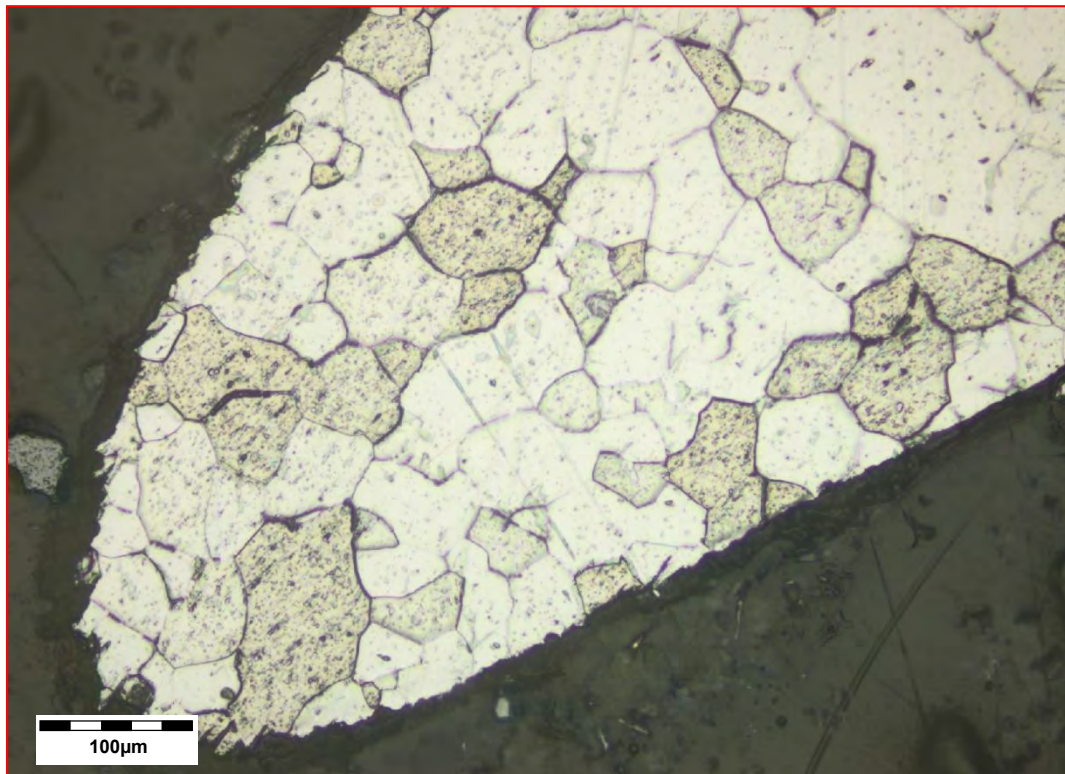
**Figure 196:** Micrograph of the resistance wire at 200X magnification. All the resistance wires within metal tubes were generally similar in microstructure had experienced grain growth (compared with H New, Figure 202).

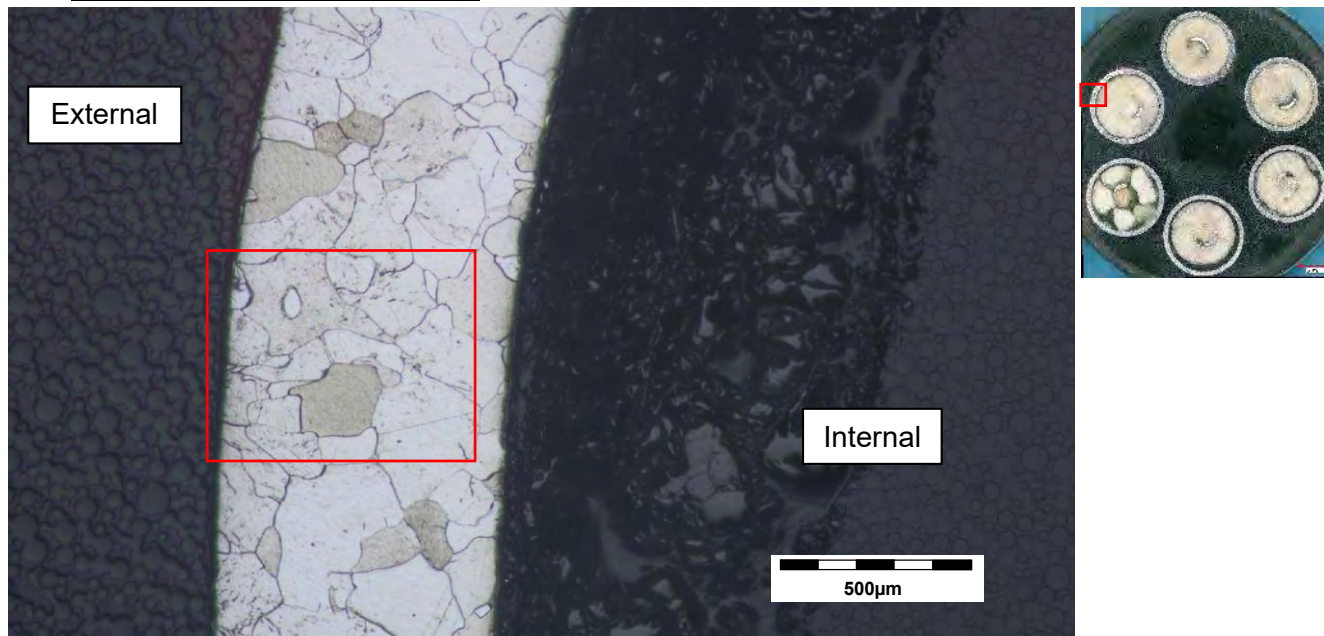
**Figure 197:** Micrograph of the metal tube at 50X magnification. All the metal tubes were generally similar in microstructure and had experienced grain growth (compared with H New, Figure 203).

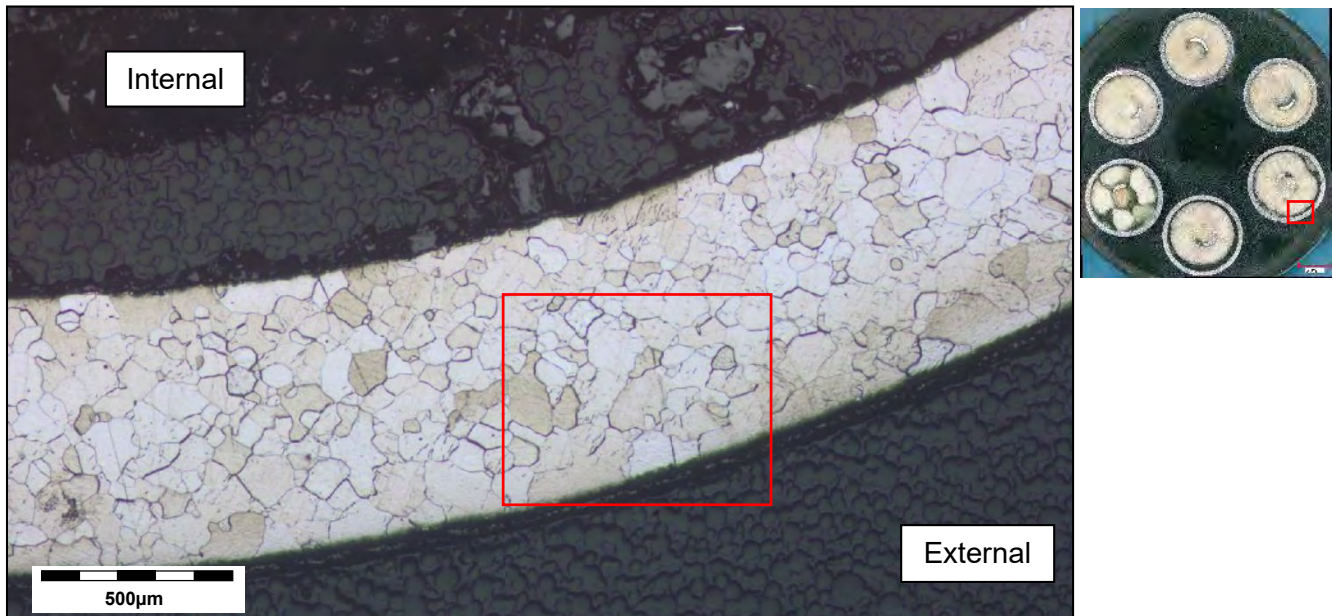
**Figure 199:** Micrograph of the metal tube at 50X magnification. All the metal tubes were generally similar in microstructure and had experienced grain growth (compared with H New, Figure 203).
