21 JANUARY 2022

# **Report of the Inquiry Committee for the accident at Stars Engrg Pte Ltd on 24 February 2021**

**(PART I – MAIN REPORT)**

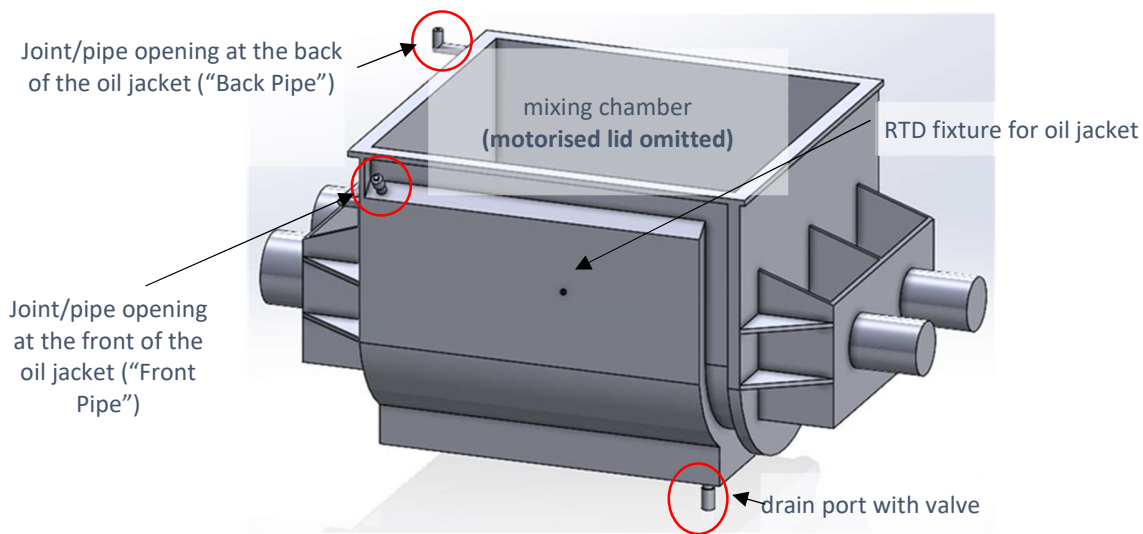
Figure 7: Front view of mixer machine with the three openings on oil jacket circled in red

50. Accompanying the mixer machine during the delivery was a control panel, one blue funnel, and nine spare heaters. One of the oil jacket’s top openings (the front pipe) also came sealed with an end cap. The front of the mixer machine was where the lid opened for access to the mixing chamber. The heaters were connected onto the jacket at the back of the mixer machine.
51. There were three openings on the oil jacket: one was located on the top front of the mixer machine, one was located at the top back of the mixer machine, and one was located at the bottom and operated as an oil drain. As the “NH Sigma Mixer User’s Guide” stated “An oil vapor vent is provided at the highest point behind the machine”, the opening at the top back of the mixer machine with an elbow bend was likely meant to function as the said vapor vent.

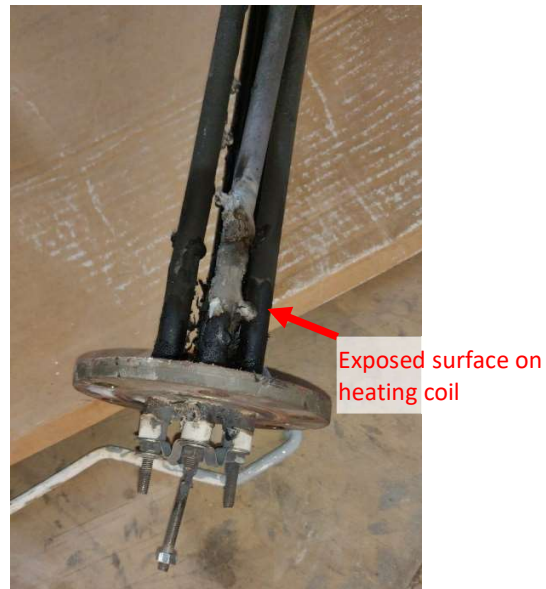
Figure 11: Heater #1 replaced on 8 August 2020

70. Imam then replaced heater #1 with a spare heater that another co-worker, Shohel, retrieved from the level 2 store within the premises. *Figure 11* above shows that the metal surface of the spoilt heater's heating element seemed melted with the interior exposed.

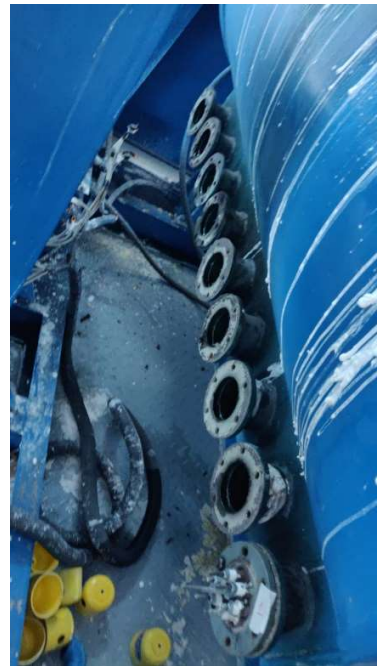
Figure 13: Photo taken on 28 August 2020 after checks and cleaning were carried out

77. Imam called Chua again and managed to update him on the issues involving the mixer machine. Chua told Imam to replace all the worn-out gaskets and instructed Imam to ask Nasim to make new gaskets. Mehedi and Shohel replaced the old gaskets with the new ones made by Nasim and Imam re-installed the heaters. The drained thermic oil, less the black sediments, was then returned to the jacket through the top opening with an elbow via the funnel, and the opening was thereafter resealed with the end cap. Operations of the mixer machine resumed and there were no problems with the heating when he used the machine the next day.

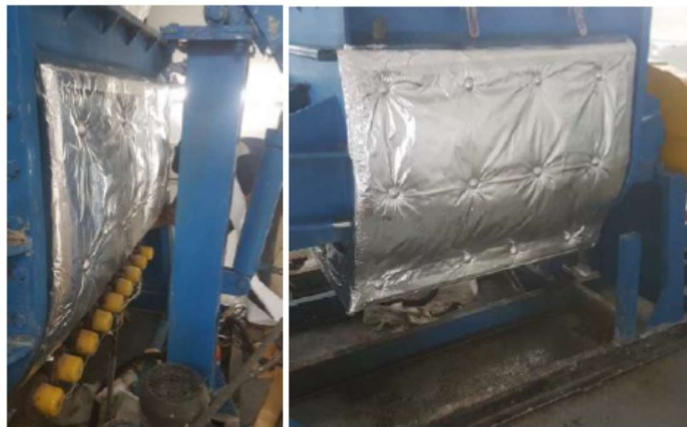
Figure 18: Photographs of the insulation on the oil jacket taken by Marimuthu on 6 February 2021

91. On 6 February 2021, on Chua's instructions, new insulation of ceramic fibre covered with aluminium sheet was installed around the shell of the mixer machine to prevent workers coming into contact with the hot oil jacket surface. The insulation was affixed onto welding pins which were tag-welded to the oil jacket without penetrating the surface.

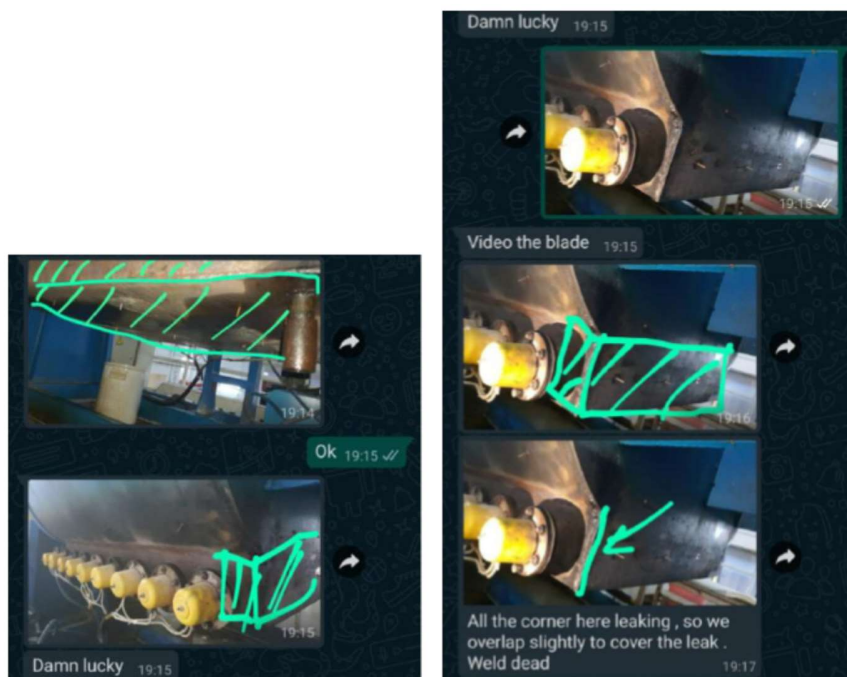
Figure 20: Screenshots from Murugan’s mobile phone of his WhatsApp messages with Chua on 12 February 2021

95. Chua also instructed Murugan to check on the condition of the mixer machine. Murugan took a photo of the front right bottom corner of the mixer machine where the fire originated. Murugan observed that there were oil stains around the corner and observed that the mixer machine and oil inside the jacket were very hot, because he could feel the heat and hear oil boiling sounds from inside the jacket. Murugan sent a video with “boiling” sounds to Chua. Chua replied that boiling sounds were common as the oil was heated up, similar to heating water over a stove. Chua then sent instructions to Murugan via WhatsApp to check the mixer, and to weld an additional layer of metal plate overlapping the bottom corners of the oil jacket “as they were leaking”. Murugan then conveyed Chua’s instructions to Nasim and said that Marimuthu would show him the leak areas. Chua conveyed the welding instructions to Murugan via the following marked photographs and accompanying instructions “All the corner here leaking, so we overlap slightly to cover the leak. Weld dead”.

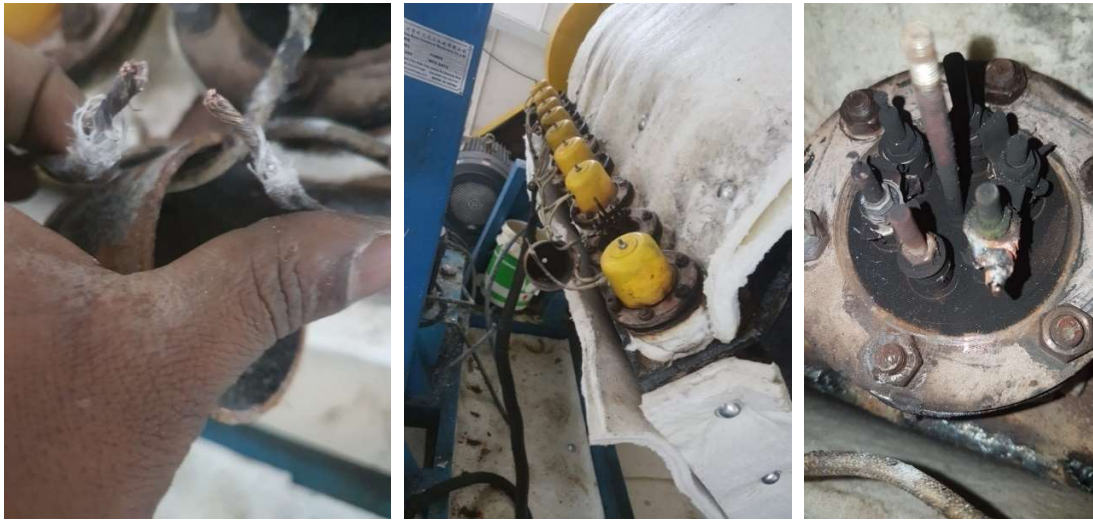
Figure 24: Pictures sent by Marimuthu to Chua between 1006hrs and 1012hrs

108. Chua gave Marimuthu a missed call at 0958 hrs. At 0959hrs, Marimuthu returned the call and told Chua that there was a fire and one of the heaters was faulty. Between 1006hrs and 1012hrs, Marimuthu sent the following pictures to Chua, including the earlier picture taken by Anis of the glowing flange on heater #2 in *Figure 22*.

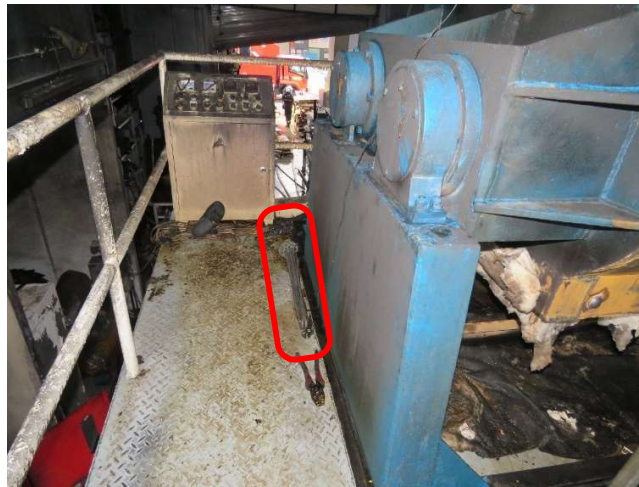
Figure 36: Heater found next to Mixer Machine, encircled in red

124. Some remains of the insulation that was originally placed around the oil jacket were found below the mixer machine. The control panel that was located close to the machine reeked a strong smell of remnant oil when opened. A replacement heater was found next to the mixer machine along with some tools (encircled in *Figure 36* below).

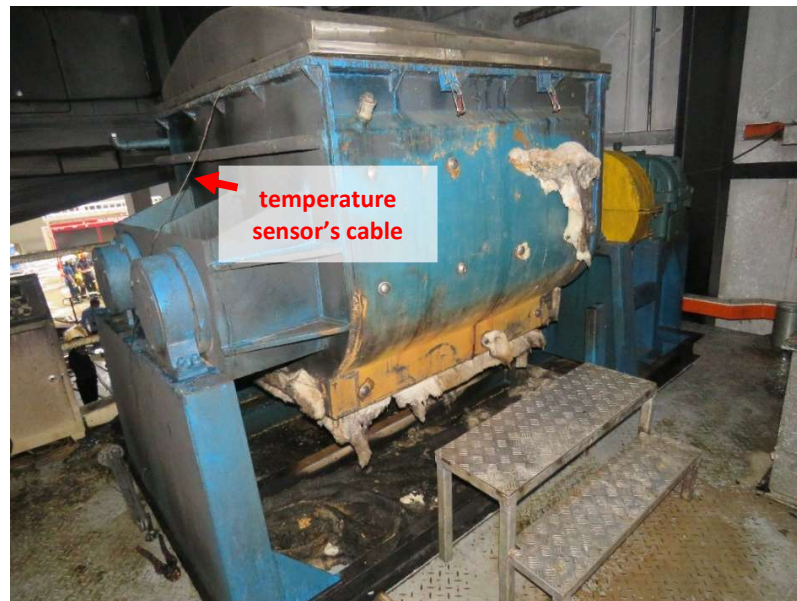
Figure 39: Temperature sensor in mixing chamber

126.A cable from the control panel was found connected to a RTD which was placed inside the mixing chamber of the mixer machine (*Figure 39*). Remnants of the insulation on the mixer machine were found with some soot on the exterior. All three openings on the oil jacket were found closed post-accident. Both openings at the top of the jacket had end caps that rendered them sealed, while the drain valve was found in a closed position (*Figure 40*).

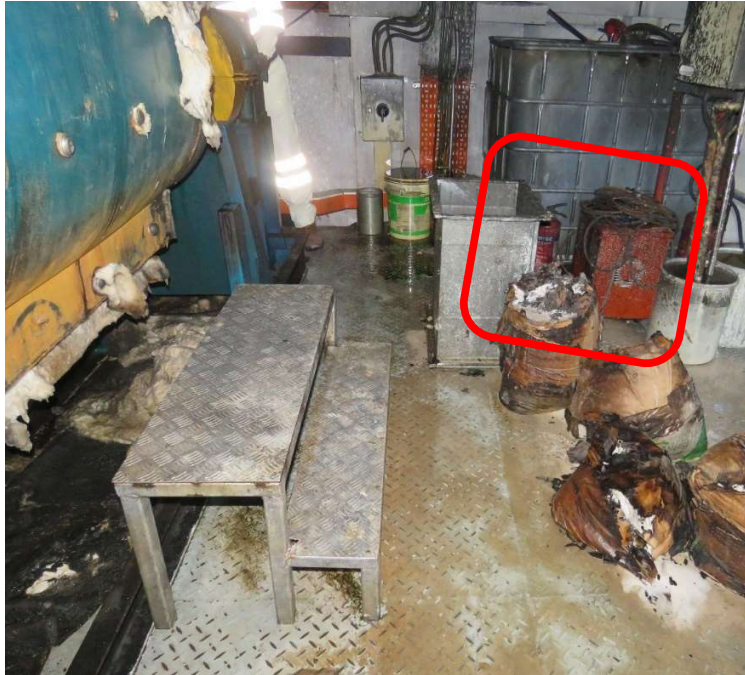
Figure 41: Welding set on platform, encircled in red

127. A welding set was found on the platform as shown below in *Figure 41*, along with an Intermediate Bulk Container, some bags of powder, buckets, and tools.

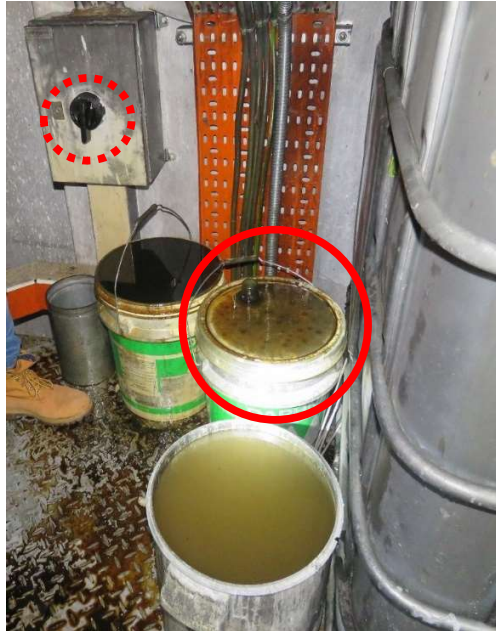
Figure 42: Covered bucket (circled in red) and mixer machine's isolator in the "ON" position (dotted circle in red)

128. Three buckets were found on the platform, one of which was covered (*Figure 42*, circled in red). The isolator located nearby which powered the mixer machine was found in the “ON” position (*Figure 42*, dotted circle in red).

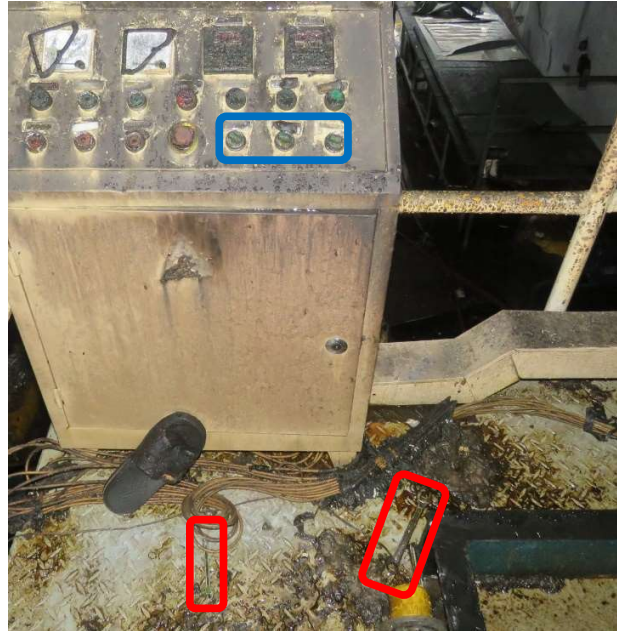
Figure 43: Spanners found close to the additional replacement heater (with yellow cap), encircled in red; heater switches on the control panel found in the "ON" position, encircled in blue

129. Two spanners and a black slipper, likely belonging to one of the workers working on the platform at the time of the accident, were found close to the replacement heater. The spanners are circled in red in *Figure 43* below<sup>6</sup>. The three heater switches on the control panel were found in the “ON” position, boxed up in blue in *Figure 43* below.

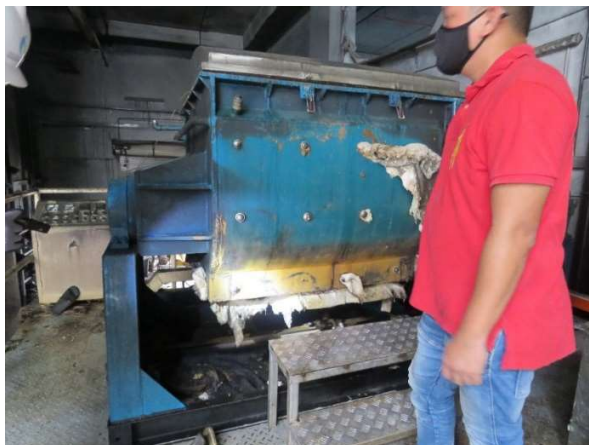
Figure 44: Upright mixing chamber with lid closed

130. The mixer machine's mixing chamber was found upright (i.e. not tilted) with the lid closed, as shown in *Figure 44* below. The inside of the mixer machine's mixing chamber was observed to be filled with water at the bottom as shown in *Figure 45* below.

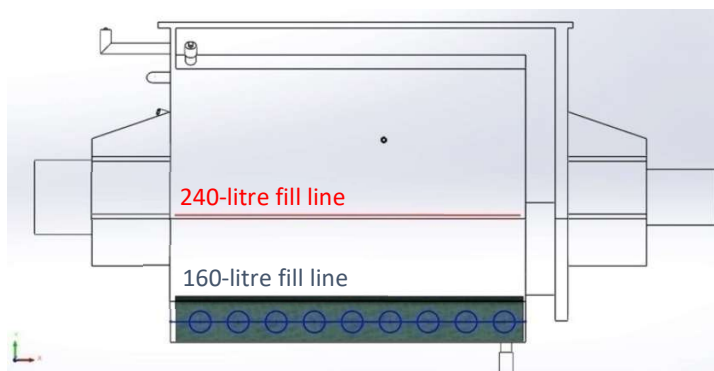
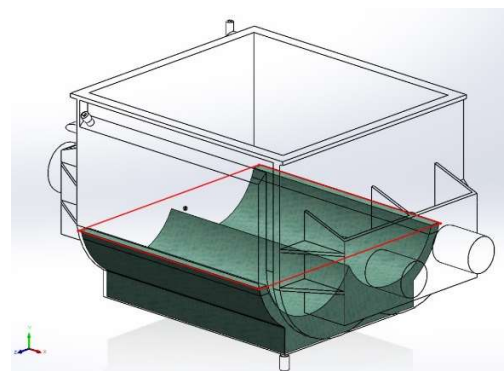
Figure 47: Matcor's 3D rendering showing the fill level corresponding to 160/240 litres in the oil jacket

138. A total of ten buckets of thermic oil, equivalent to 200 litres, was purchased by Stars Engrg for use in the oil jacket during the lifetime of the mixer machine. On 27 May 2021 post-accident as part of investigations, two unused buckets of thermic oil were found in the worksite in the vicinity of the platform's access ladder. Less these two buckets (or 40 litres) of oil, the maximum possible amount of oil that could have been added to the jacket in the mixer machine's lifetime was 160 litres. However, the actual maximum quantity of thermic oil in the oil jacket at any one point in time is very likely to have been much lower than 160 litres, as some would have been boiled off or undergone thermal decomposition.

139. From Matcor's 3D renderings in *Figures 47 and 48* below, a 160-litre oil level would only be just enough to immerse the heating coils, but would not be in contact with the lowest internal surface of the mixing chamber, compared to a much higher oil level if the jacket was filled with 240 litres of thermic oil.

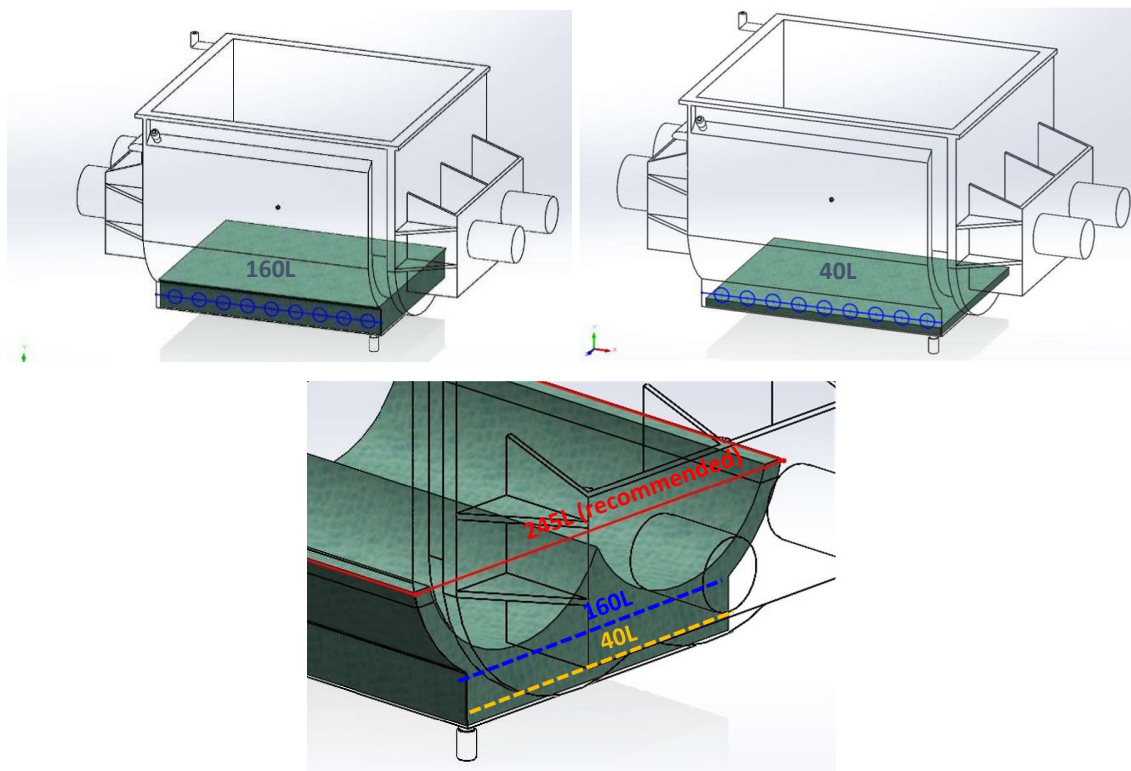
Figure 49: Fill levels corresponding to 40 litres, 160 litres and 245 litres in the oil jacket

140. *Figure 49* below shows the fill levels for 245, 160 and 40 litres of oil in the oil jacket.

141. When Stars Engrg started operating the mixer machine with thermic oil, only two buckets, or 40 litres, of oil were added to the oil jacket. As shown in *Figure 49* above, the heaters were not immersed in the thermic oil and there was a gap between the top of the 40 litres oil level (yellow dotted line) and the lowest point of the mixing chamber. The heaters were immersion type heaters which were meant to be completely immersed in the service medium. This gap created a layer of air insulation between the oil and the mixing chamber, causing inefficient heat transfers between the heated oil in the oil jacket and the water in the mixing chamber. Hence, more heat would need to be supplied by the heaters to the oil, to overcome the air insulation and attain the desired water temperature of 80°C to 90°C in the mixing chamber.

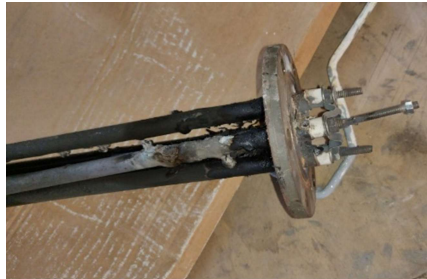
147. The thermic oil drained on 8 August 2020, 28 August 2020, and 1 October 2020 was observed to be darker in colour compared to fresh thermic oil, which was more translucent and lighter coloured. This implied that the thermic oil was subjected to temperatures beyond its recommended operating range and had undergone thermal degradation. This finding was supported by the decreased flash point of the darkened oil, taken as a post-accident sample by SCDF and tested by the Health Sciences Authority. The darkened oil had a reduced flash point of  $135\pm 4^{\circ}\text{C}$ , compared to the published  $220^{\circ}\text{C}$  flash point in the thermic oil's Safety Data Sheet.

148. One of the spoilt heaters examined by Matcor showed melted carbon steel sheath, as shown in *Figure 50* below. This heater was retrieved by MOM post-accident during its investigation on 27 May 2021, and was likely heater #1 that was replaced on 8 August 2020 (see *Figure 51*). For the carbon steel sheath to have melted, the temperature was likely to have been at the melting point

of around 1400°C, indicating that excessive heating had already occurred by 8 August 2020.

Figure 50: Photo showing replaced heater #1 (taken from Chua's phone pre-explosion)

151. From Matcor’s metallurgical structure examinations, the heater’s metal sheath was made of carbon steel. A loss of toughness in carbon steel can occur when subjected to temperatures above 427°C<sup>8</sup>. This form of metallurgical damage will have significant impact on the structural integrity, with possible localised corrosion or groove-like flaws. Matcor’s metallurgical examinations of the heating coils showed that the heaters were subjected to temperatures of 830°C to 1100°C over time, from the increase in grain size.
