# **Report of the Inquiry Committee for the accident at Stars Engrg Pte Ltd on 24 February 2021**

**(PART II – ANNEXES)**

| Report No:<br><b>M21091</b> | Subject Group:<br><b>11219</b> | Date:<br><b>10<sup>th</sup> September 2021</b> |
| Title of Report:<br><b>Failure Analysis of a Failed Mixer Machine Retrieved from Unit 32E of Platinum @ Pioneer Building involved in a Fire Explosion Incident</b> | | Date of Last Revision/Revision No: |

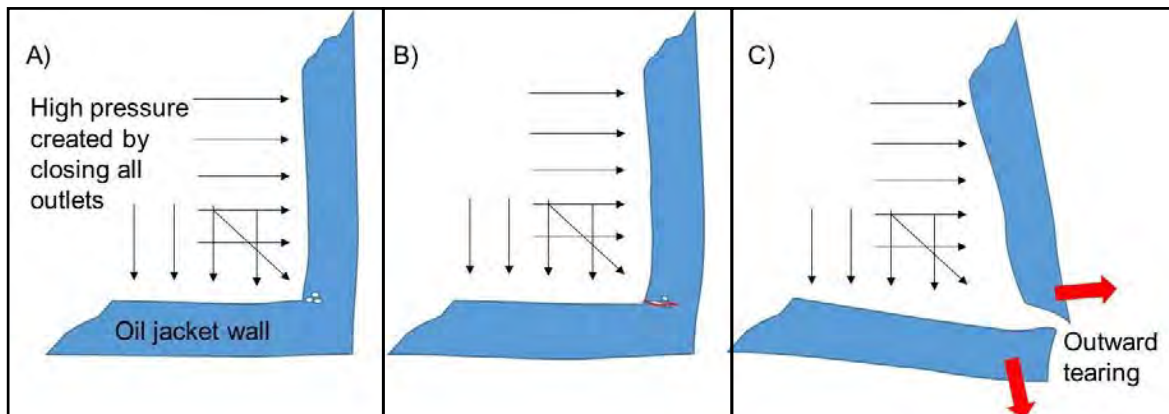
- The presence of dimples was evidence of overloading fracture. The locations of equiaxed and elongated dimples suggested that at regions adjacent to internal side (with equiaxed dimples) had cracked open with direction perpendicular to the fracture surface while the region adjacent to the external side (with elongated dimples) had torn apart in an outward direction at final instance of the rupture.

*Micro-mechanism of ductile fracture due to overload: A) High pressure from inside the oil jacket leads to deformation of wall, void nucleation and crack. Evidenced by equiaxed dimples. B) Wall deformed more with void growth and coalescence to deeper cracks. C) Oil jacket wall fractured/torn apart and severely deformed outward. Evidenced by elongated dimples.*

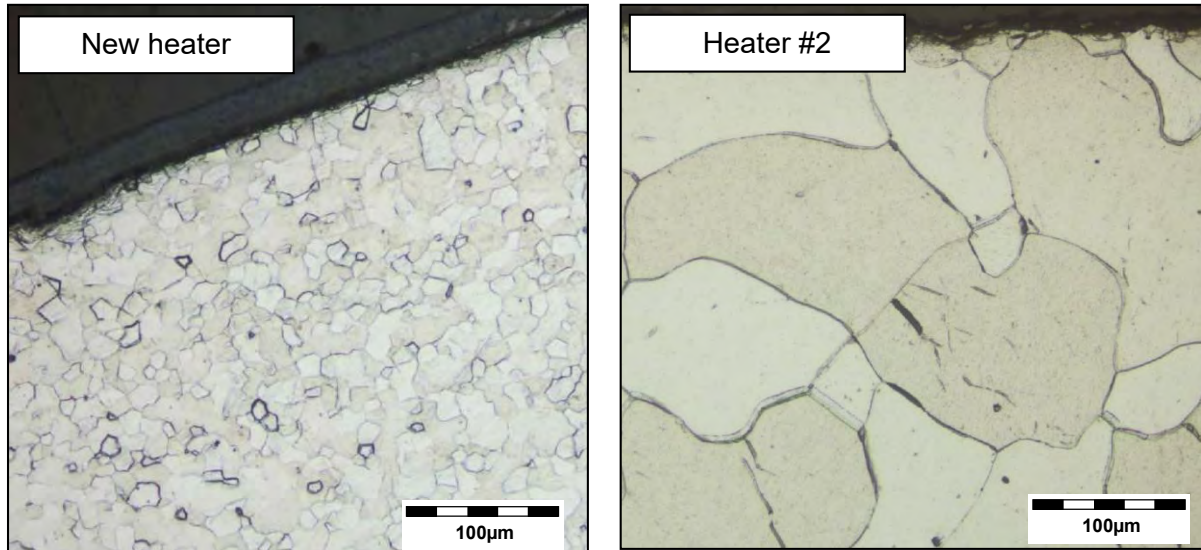
The grain growth (also known as grain coarsening) observed in the microstructures of the resistance wires and metal tubes were also evidence of high metal temperature experienced by the heating elements. For the metal tubes, increment in grain size in the range of ASTM number 0 to 4 indicates that they had been exposed to temperature 830°C to 1095°C based on API 579-1 Fitness-For-Service standards, Curve B<sup>10</sup> (see graph below).

Micrographs of metal tubes at 200X magnification, extracted from Figure 204 (left) and Figure 186 (right)

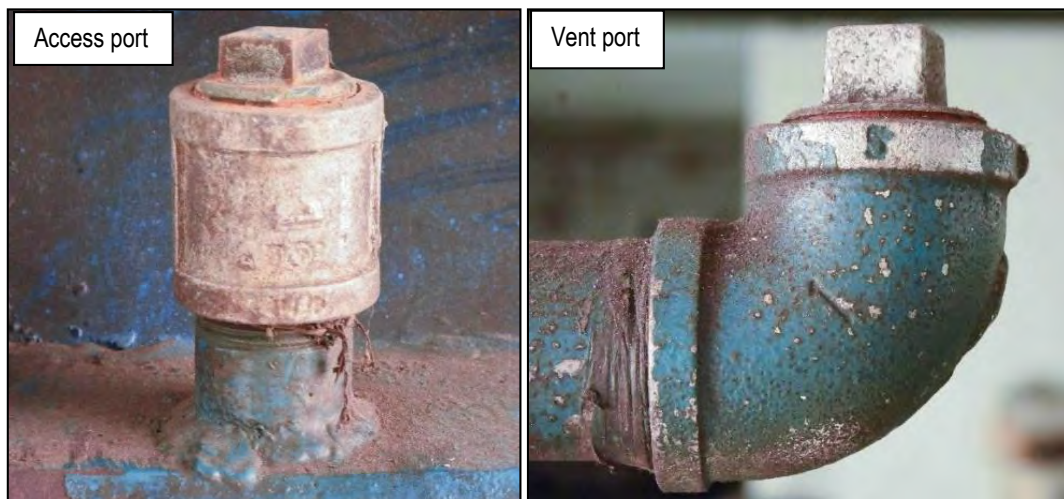
*Extracted from Figure 97 and Figure 98*

The rupture was essentially due to high pressure inside the oil jacket, resulting in cracks along the welds. The high pressure inside the oil jacket was caused by the boiling and evaporation of the heat transfer fluid, which arose from overheating, and the closure of all openings/ports.

- 34 ➤ Both access and vent ports were plugged by square head plugs. Along with the closed drain port, all three of the oil jacket openings were closed (Figure 97 and Figure 98).
- 36 ➤ The oil funnel was not in use and was found at the ground floor of the Factory during the retrieval of the Mixer Machine onsite (Figure 99).
- 38

14 The boiling and evaporation of oil increased the (oil vapour) pressure inside the oil  
jacket. With all the oil jacket's openings/ports blocked, the oil jacket was highly  
pressured from inside and the applied load on the weld joint increased.

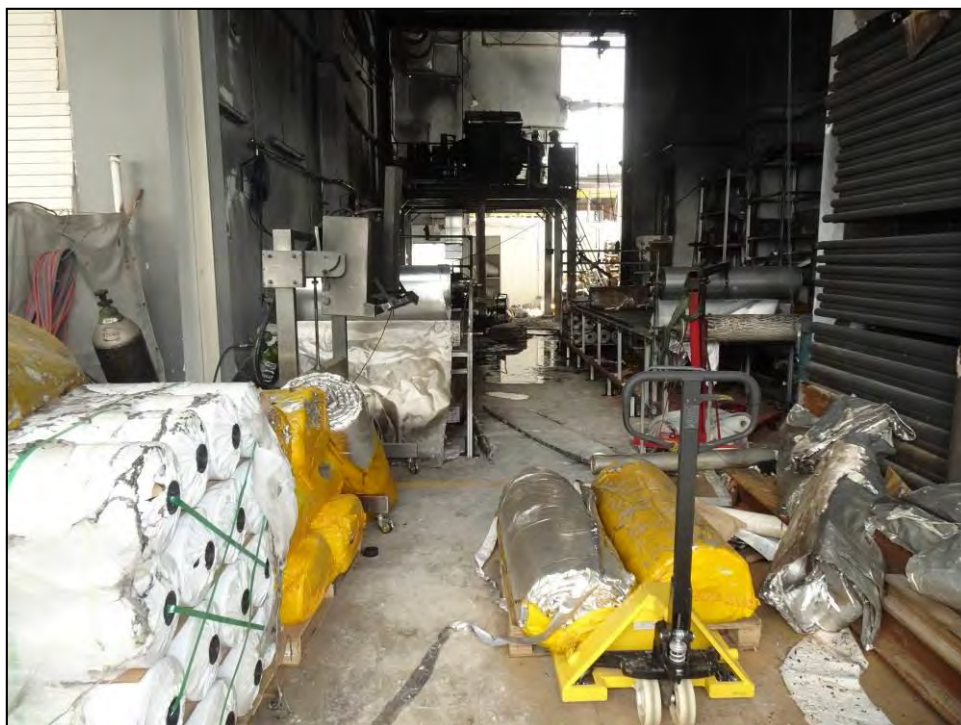
Front end of the incident unit

- 6 ➤ The front of the unit had a shutter door and was facing the common driveway.  
8 Several rolls of fire rated products, either in white packaging or aluminium foils,  
were found stacked on the open space area immediately outside the unit  
(Figure 1).

**Figure 1:** **Front End of Unit.** The front of the unit had a shutter door and was facing the common driveway. Several rolls of fire rated products, either in white packaging or aluminium foils, were found stacked on the open space area immediately outside the unit.

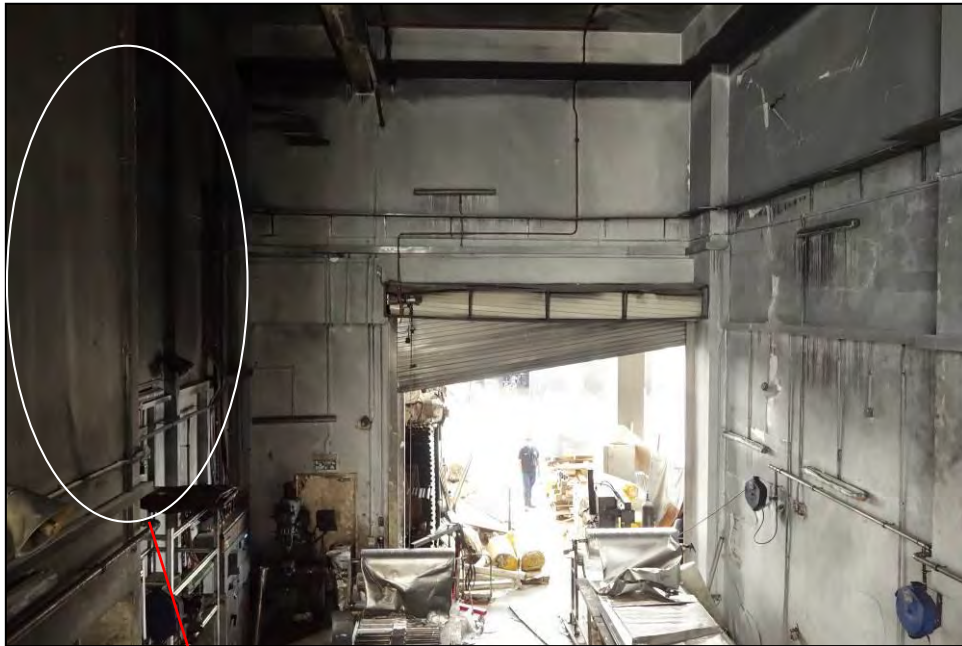
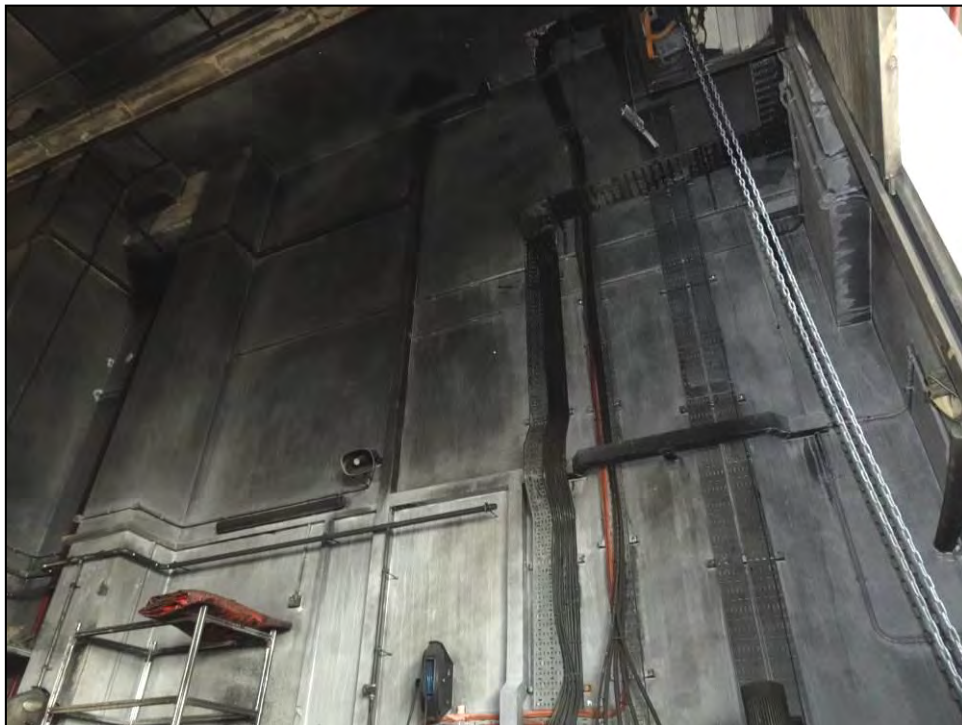
Charred walls towards the front of the unit

- 10 ➤ The internal walls of the unit revealed varying extent of charring, with the upper  
half of the wall appearing more severe (Figure 2 to Figure 4).

**Figure 2:** Interior of the Unit. The internal walls of the unit revealed varying extent of charring, with the upper half of the wall appearing more severe.

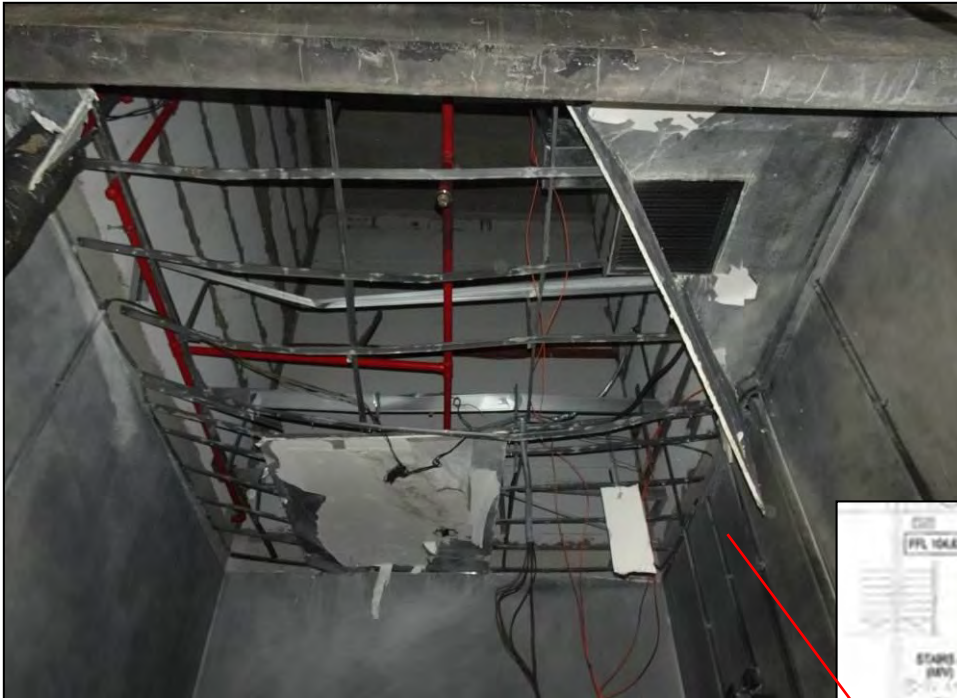
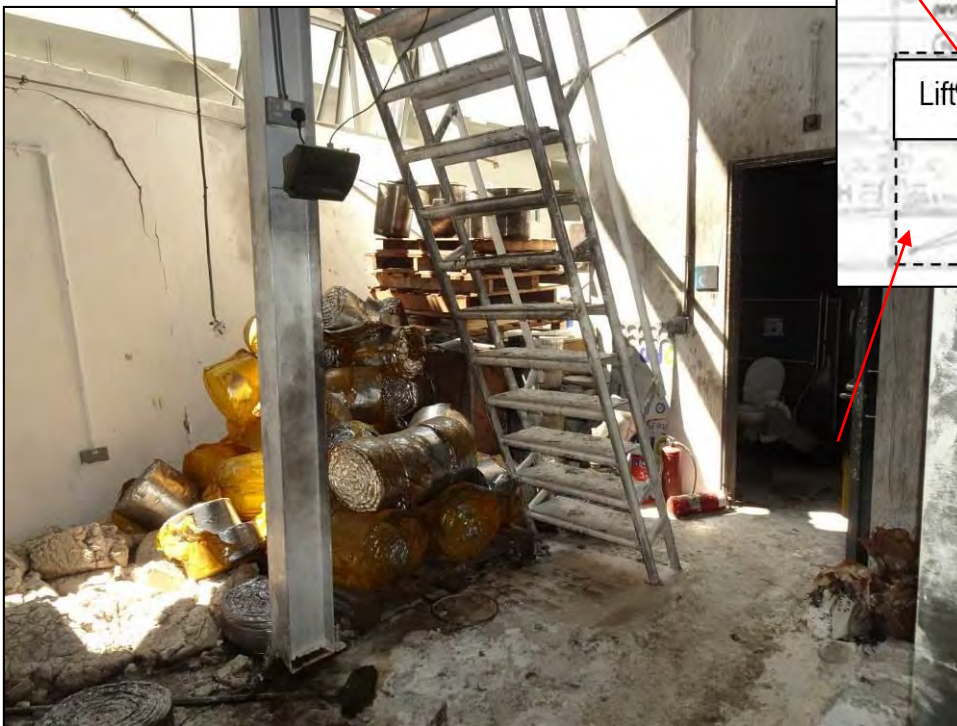
Top of the area near the lift

- 16 ➤ Cracks were also observed on the side walls next to the lift near to the Platform  
floor (Figure 4).
- 18 ➤ The lighting fixtures in the vicinity of the Platform floor were observed to be  
more thermally deformed as compared to the ones towards the front of the unit  
(Figure 3 and Figure 4).

**Figure 4:** **Interior of the Unit.** The internal walls of the unit revealed varying extent of charring, with the upper half of the wall appeared to be more severe. Cracks were observed on the side walls next to the lifts near to the Platform floor. The lighting fixtures in the vicinity of the Platform floor were more thermally deformed as compared to the ones further away.

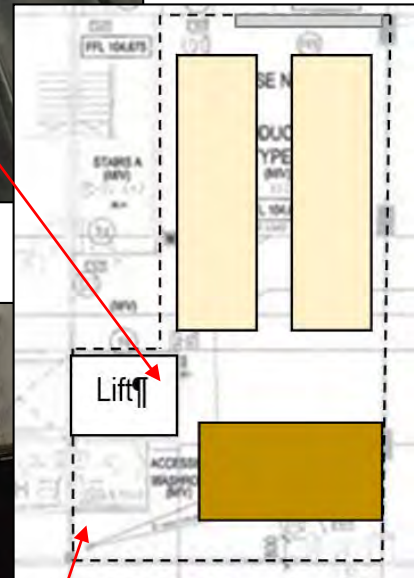
- 12 ➤ The explosion at the time of incident had cracked and punctured through the  
14 side wall in the vicinity of the Platform floor as well as top half of the rear walls  
(Figure 3 to Figure 7).

**Figure 5:** **Rear End of Unit.** The top partition wall of the lift area was also damaged in the fire explosion incident. The rear walls were cracked and punctured through, especially for the top half sections.

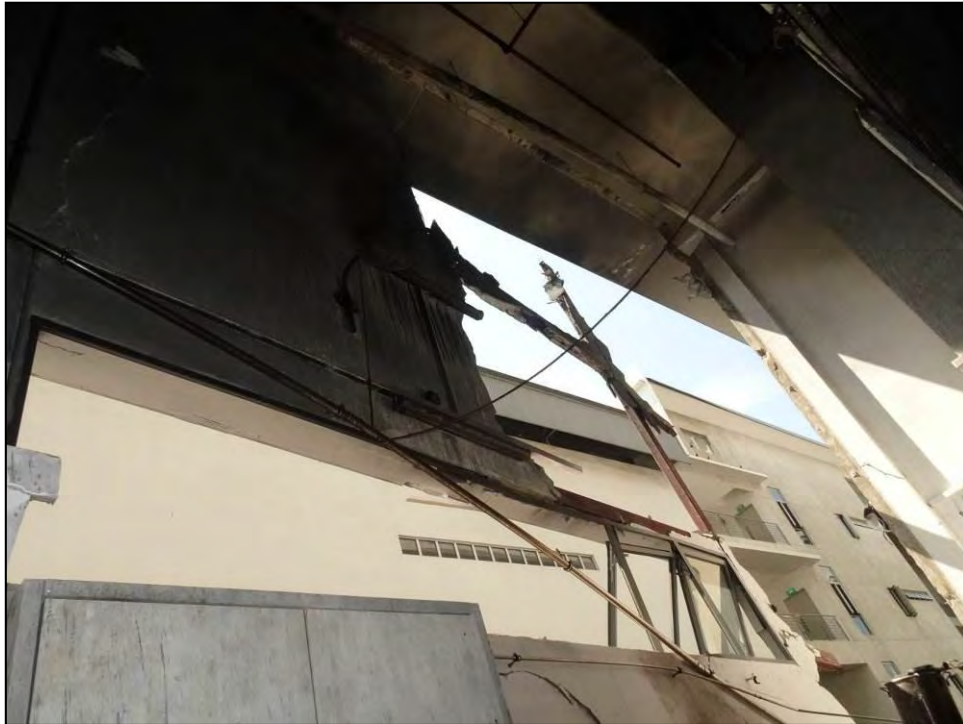
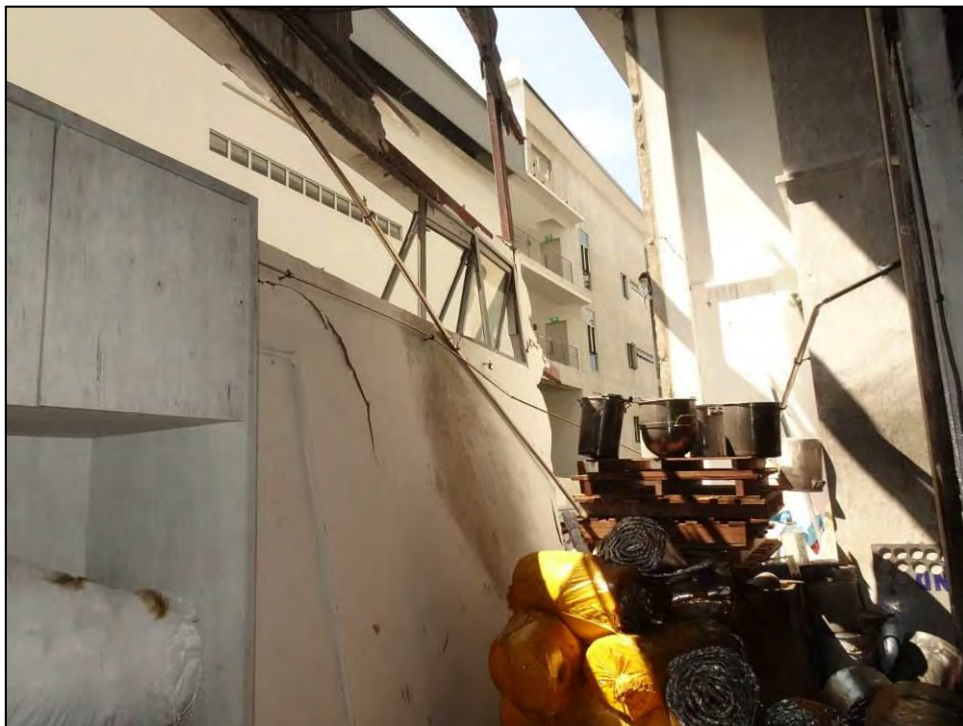
Punctured wall at the rear end of the unit

**Figure 6:** **Rear End of Unit**. The rear walls were cracked and punctured through, especially for the top half sections.

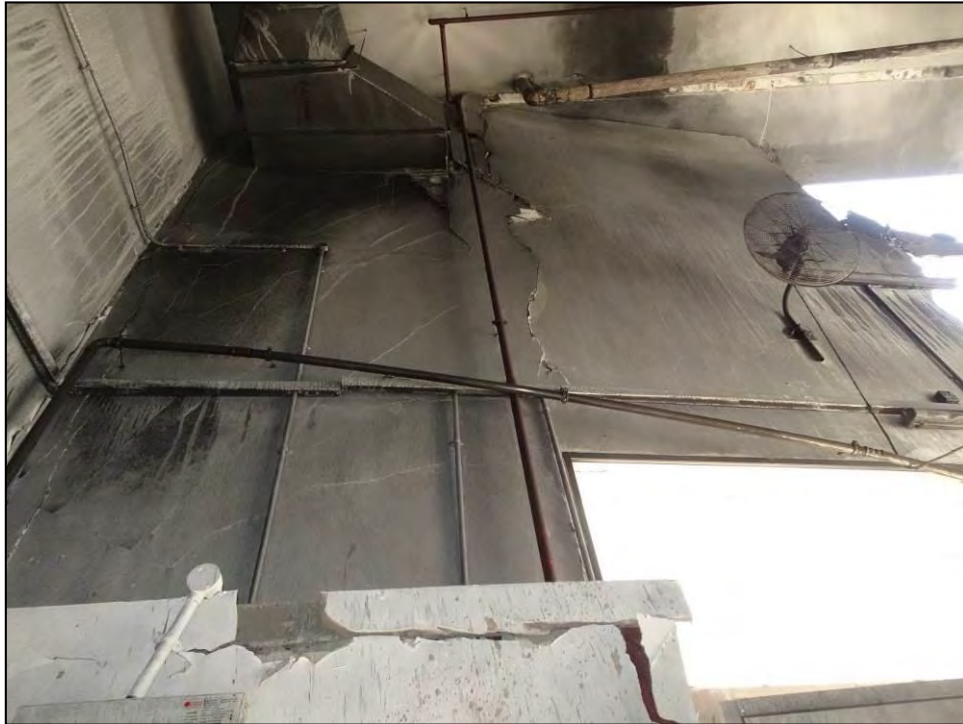
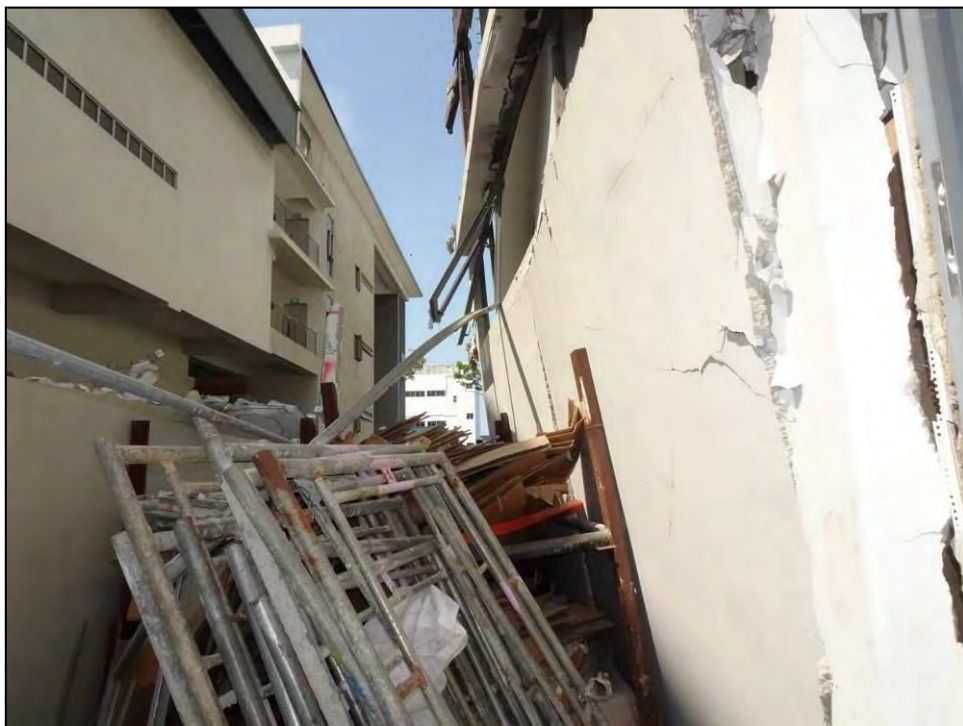
Cracked wall at the rear end of the unit

**Figure 7:** **Rear End of Unit.** The rear walls were cracked and punctured through, especially for the top half sections.

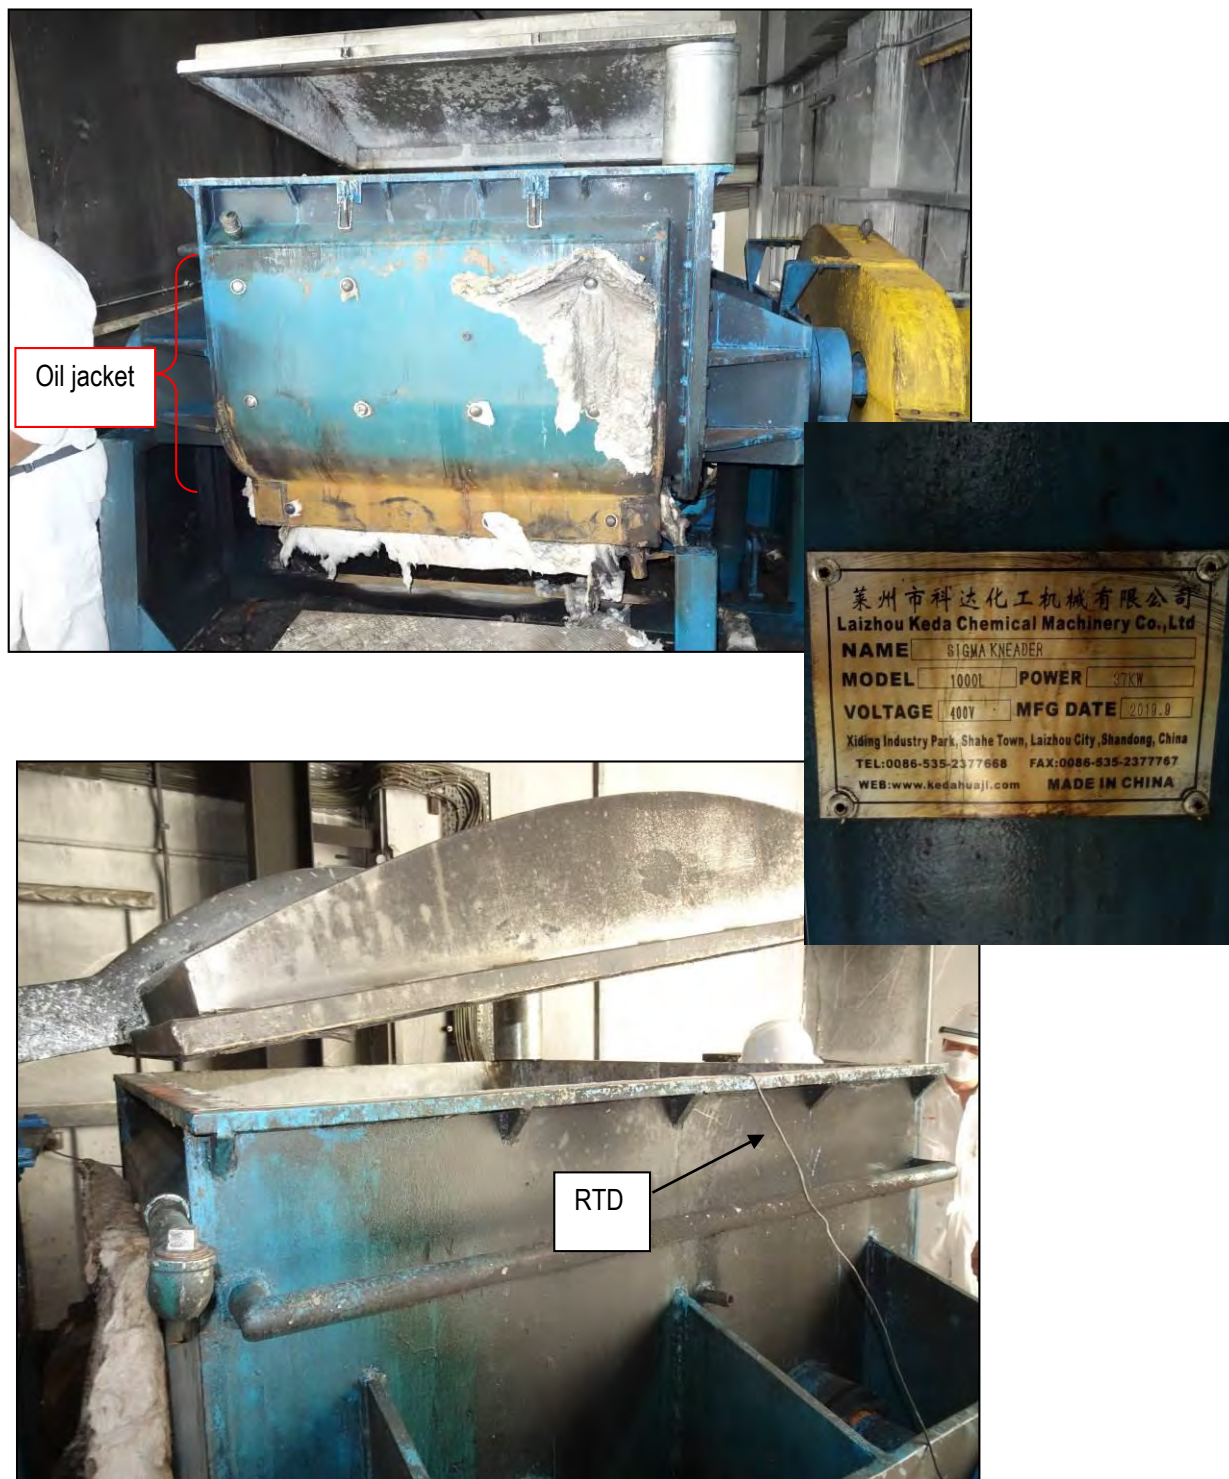
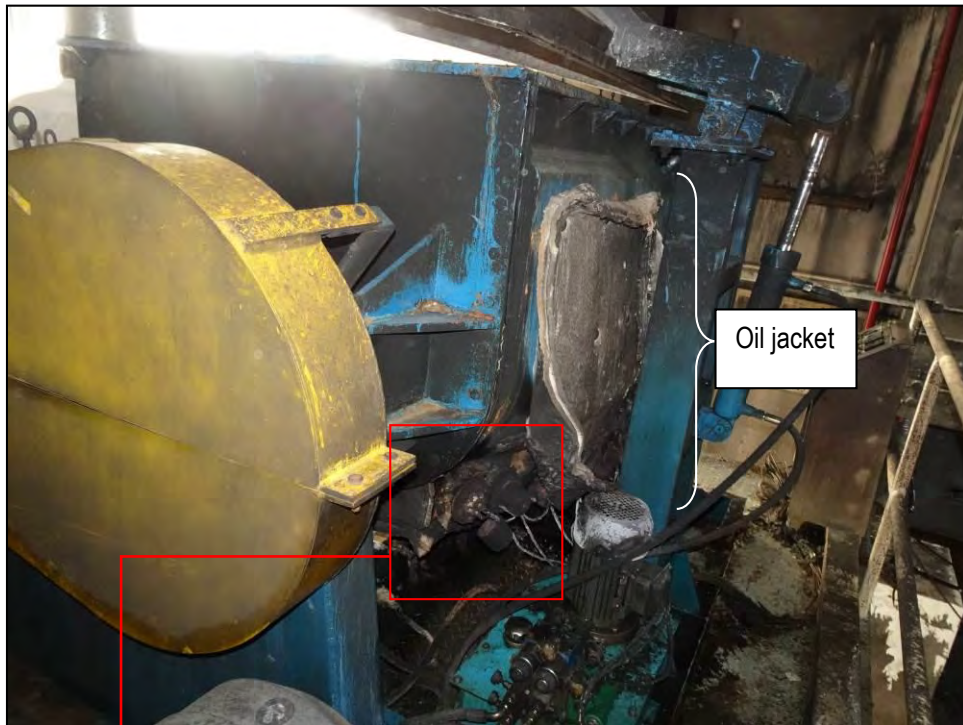
Front side of Mixer Machine

- 34 ➤ Remnant whitish insulation wool was observed to remain attached to the front  
and rear sides of the oil jacket (Figure 8 and Figure 9). A resistance temperature  
detector/sensor (RTD) was observed in the mixing tank, but not in the oil jacket.

**Figure 8:** **Mixer Machine.** Remnant whitish insulation wool was observed to remain secured to the front and rear sides of the Mixer Machine. A RTD sensor was observed in the mixing tank, but not in the oil jacket.

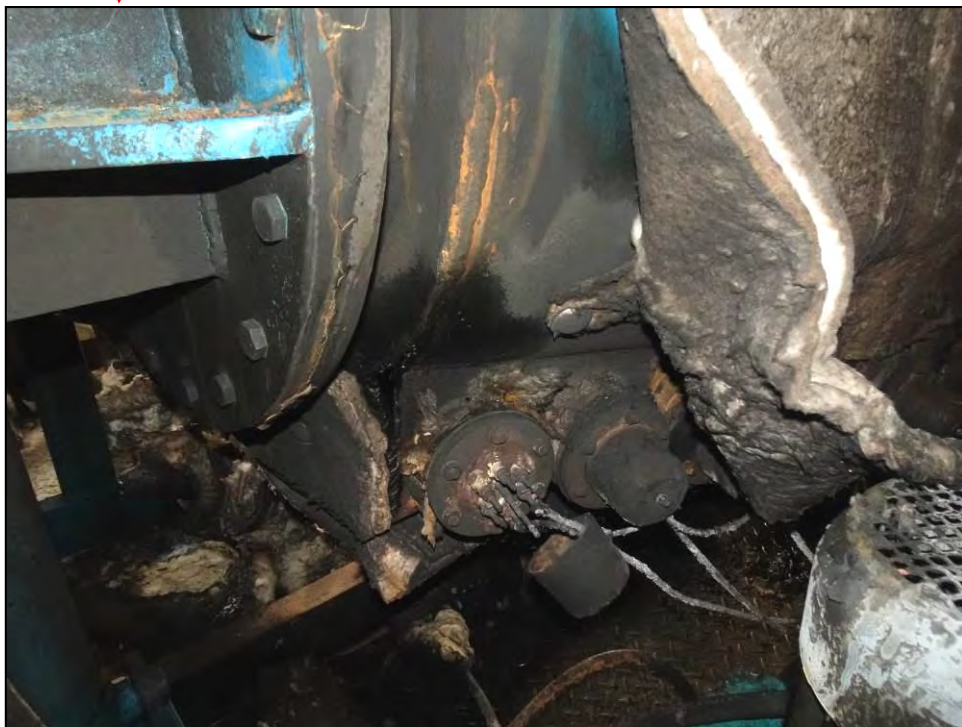
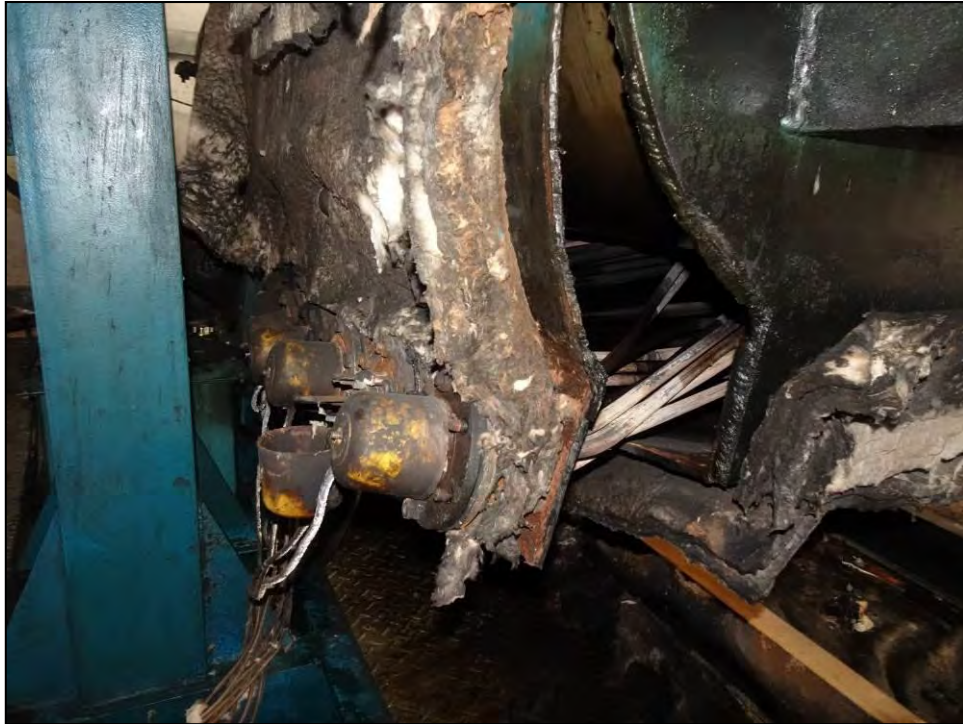
Tearing along the weld joint of the oil jacket around the heater

- 36 ➤ Close examination of the oil jacket revealed tearing damage along the bottom-  
38 rear corner weld joints, adjacent to the heaters (Figure 9 and Figure 10). The  
fractured bottom-rear corner weld joint configuration appeared different from  
the original weld joints further away, suggesting that the fractured joints were  
40 weld repair areas.

**Figure 9:** **Mixer Machine, Oil Jacket Around Heater.** Close examination of the oil jacket revealed tearing damage along the bottom-rear corner weld joints, adjacent to the heaters. The fractured bottom-rear weld joint configuration appeared different from the original weld joints further away.

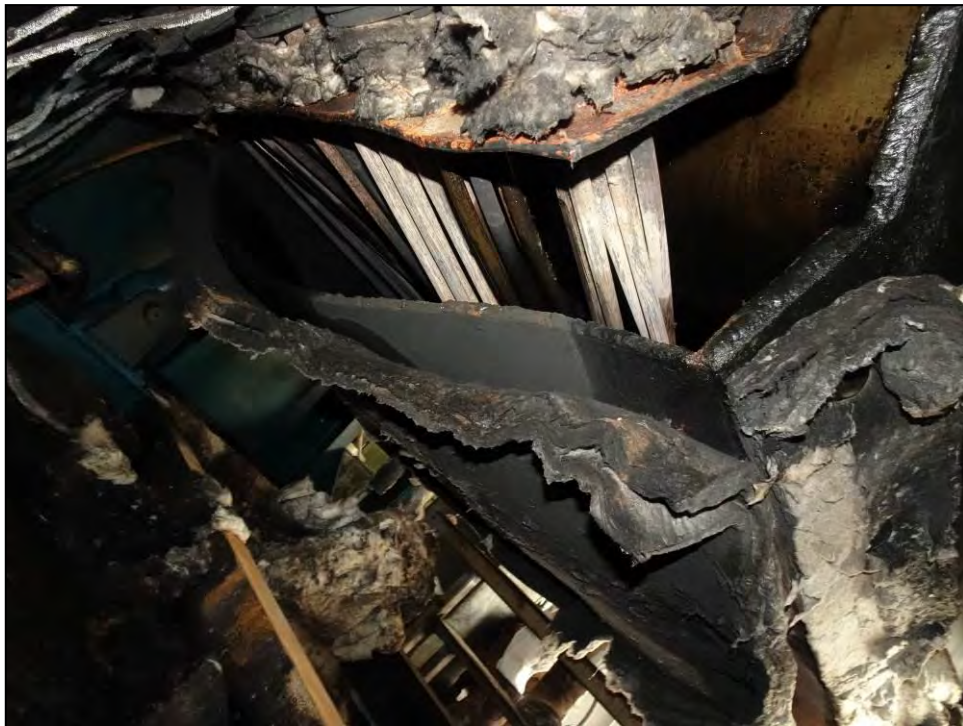
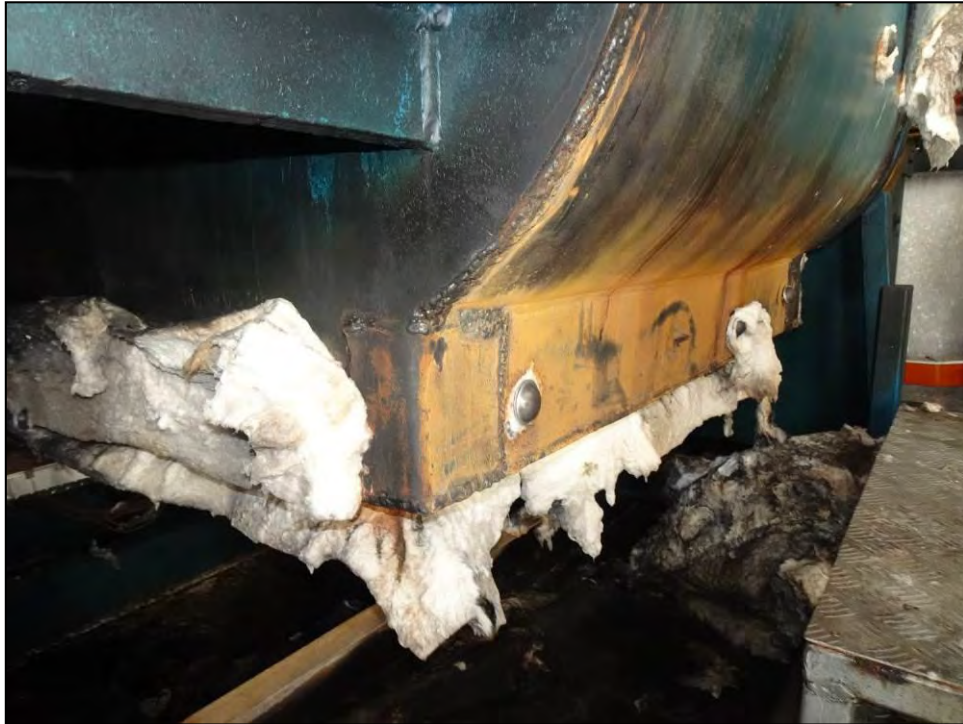
Tearing of oil jacket along the weld joint around the heater on the other end of the Mixer Machine

Over time, the high internal pressure caused cracks to initiate at the weld roots. Improper weld repairs at those cracks may have stopped the leakages temporarily but with poor weld quality and unresolved high internal pressure, a failure at the oil jacket was bound to occur.

**Figure 10:** **Mixer Machine, Oil Jacket Around Heater**. Close examination of the oil jacket revealed tearing damage along the bottom-rear corner weld joints, adjacent to the heaters. The fractured bottom-rear weld joint configuration appeared different from the original weld joints further away.

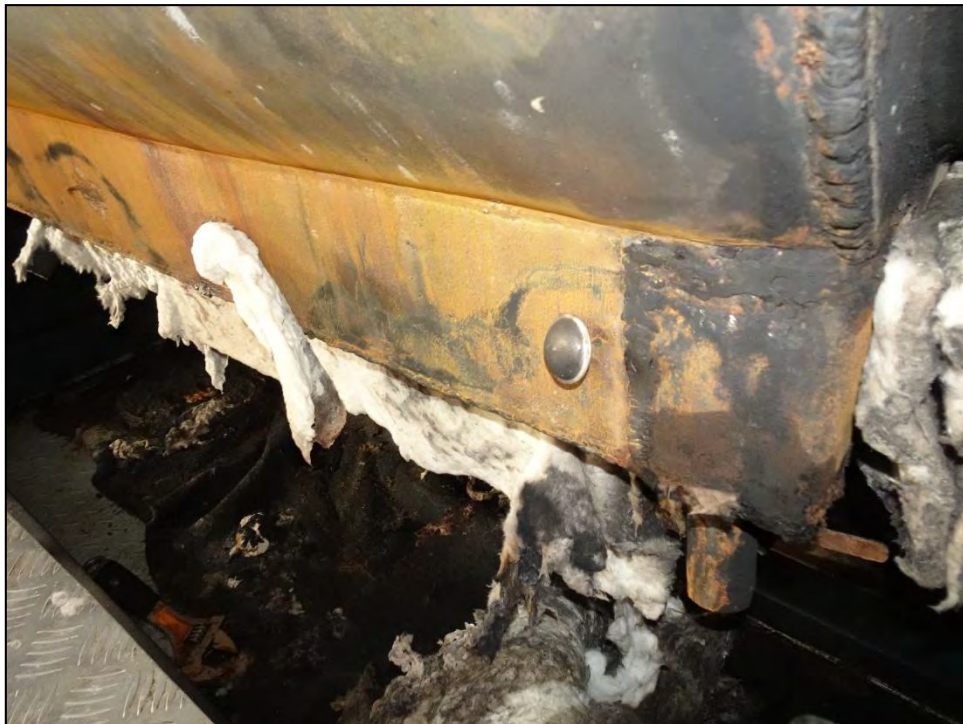
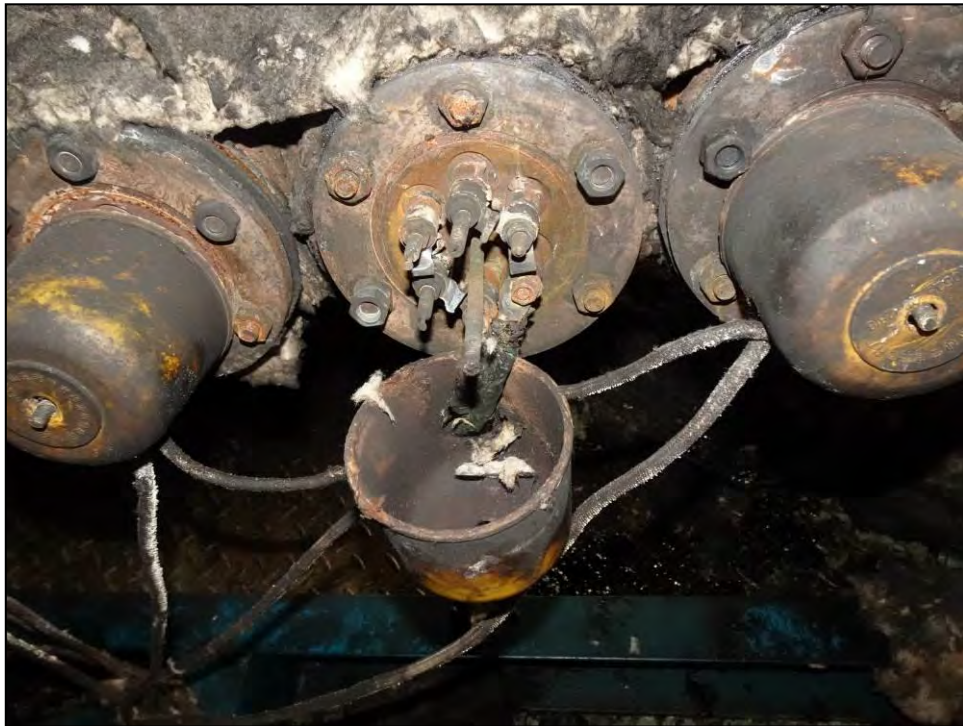
Weld repair area on the oil jacket at the front of the Mixer Machine

- 42 ➤ Further examination of the weld joints on the front side of the oil jacket revealed  
that the bottom-front corner weld joints were weld repaired prior to the fire  
explosion incident (Figure 11).

**Figure 11:** **Mixer Machine, Oil Jacket at the Front Side.** Examination of the weld joints on the front side of the oil jacket revealed that the bottom-front corner weld joints were weld repaired prior to the fire explosion incident.

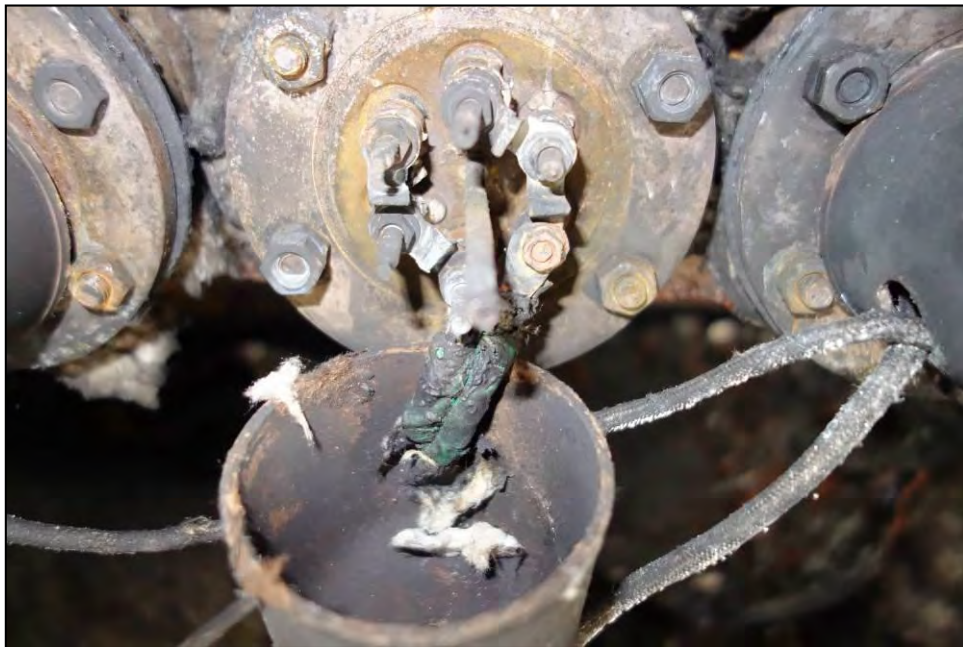
Faulty heater

- 4 ➤ Examinations of the heaters revealed faulty connections on the second coil set (Figure 12). A new heater, that was placed next to the Mixer Machine, appeared  
6 relatively unaffected by the fire explosion (Figure 15).

**Figure 12:** **Mixer Machine, Faulty Heater.** Examination of the heaters revealed faulty connections on the second heater.

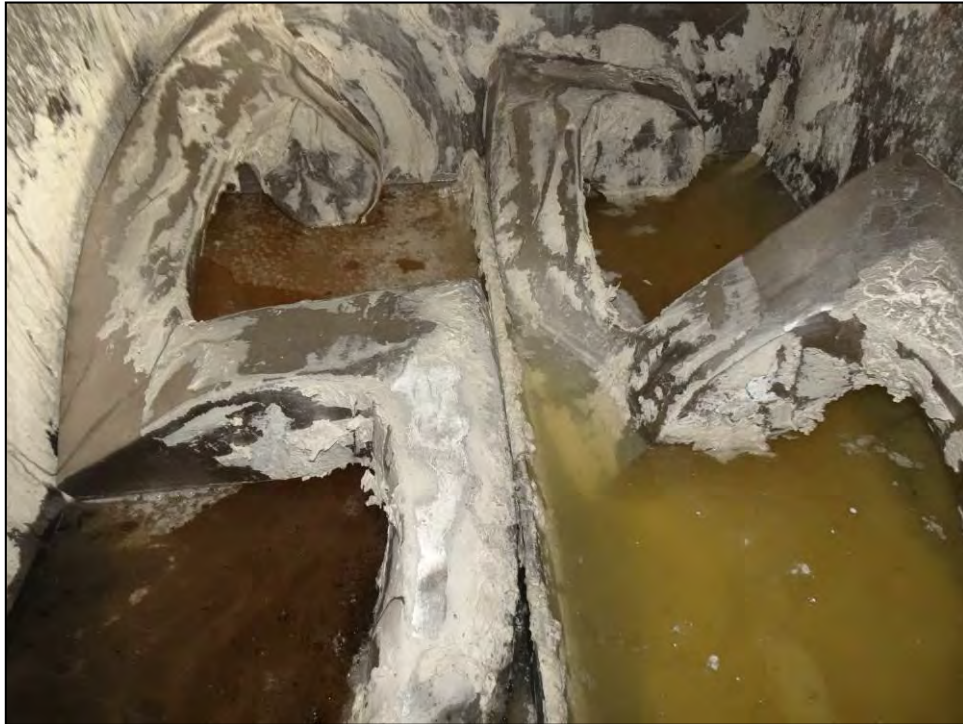
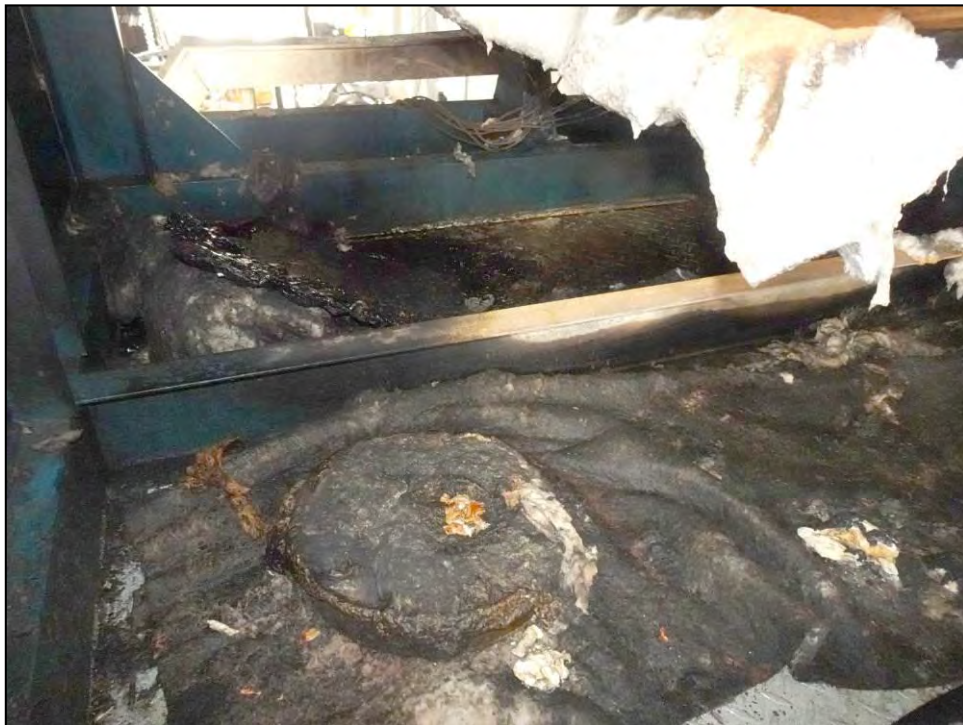
Internal condition of mixing tank

- 8 ➤ The interior of the mixing tank was partially filled with water and dough-form  
10 product mixture, apart from the sigma blades (Figure 13). Some remnant  
insulation wools at the bottom of the Mixer Machine on the Platform floor were  
12 charred at the time of inspection (Figure 13).

Charred insulation wools on the Platform floor under the oil jacket

**Figure 13:** **Mixer Machine, Internal Condition and Bottom Area.** The interior of the mixing tank was partially filled with water and dough-form product mixture, apart from the sigma blades. Some remnant insulation wools at the bottom of the Mixer Machine on the Platform floor were charred.

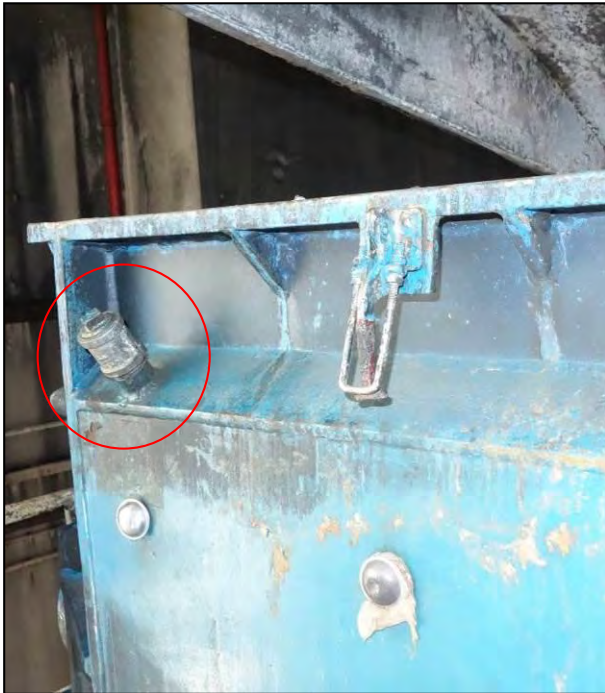
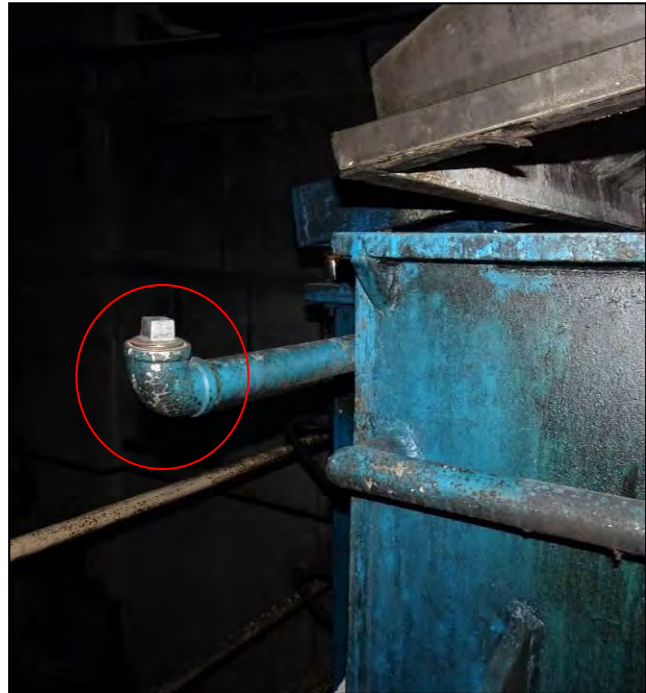
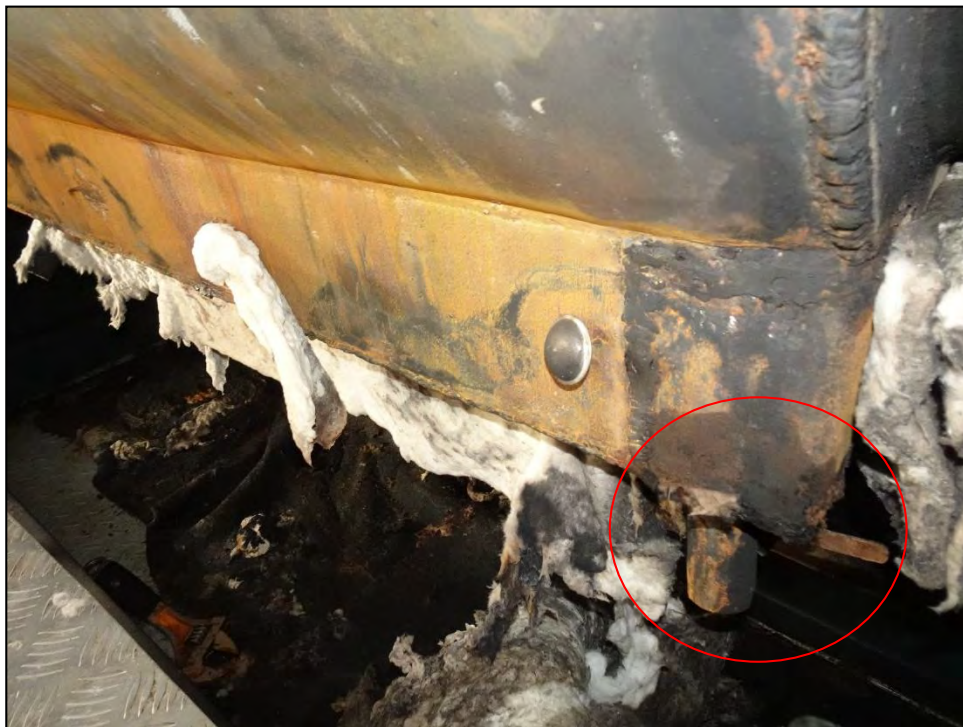
Access port to top up oil (circled, left) and vent port of oil jacket at the rear side (circled, right)

- 14 ➤ The access and vent ports of the oil jacket were in closed mode at the time of  
inspection (Figure 14). The drain port at the bottom of the oil jacket was also in  
16 a closed state.

Drain port for oil jacket (circled)

**Figure 14:** **Mixer Machine, Access, Vent and Drain Ports for Oil Jacket.** The access and vent ports of the oil jacket were in closed mode at the time of inspection. The drain port at the bottom of the oil jacket was also in closed state.

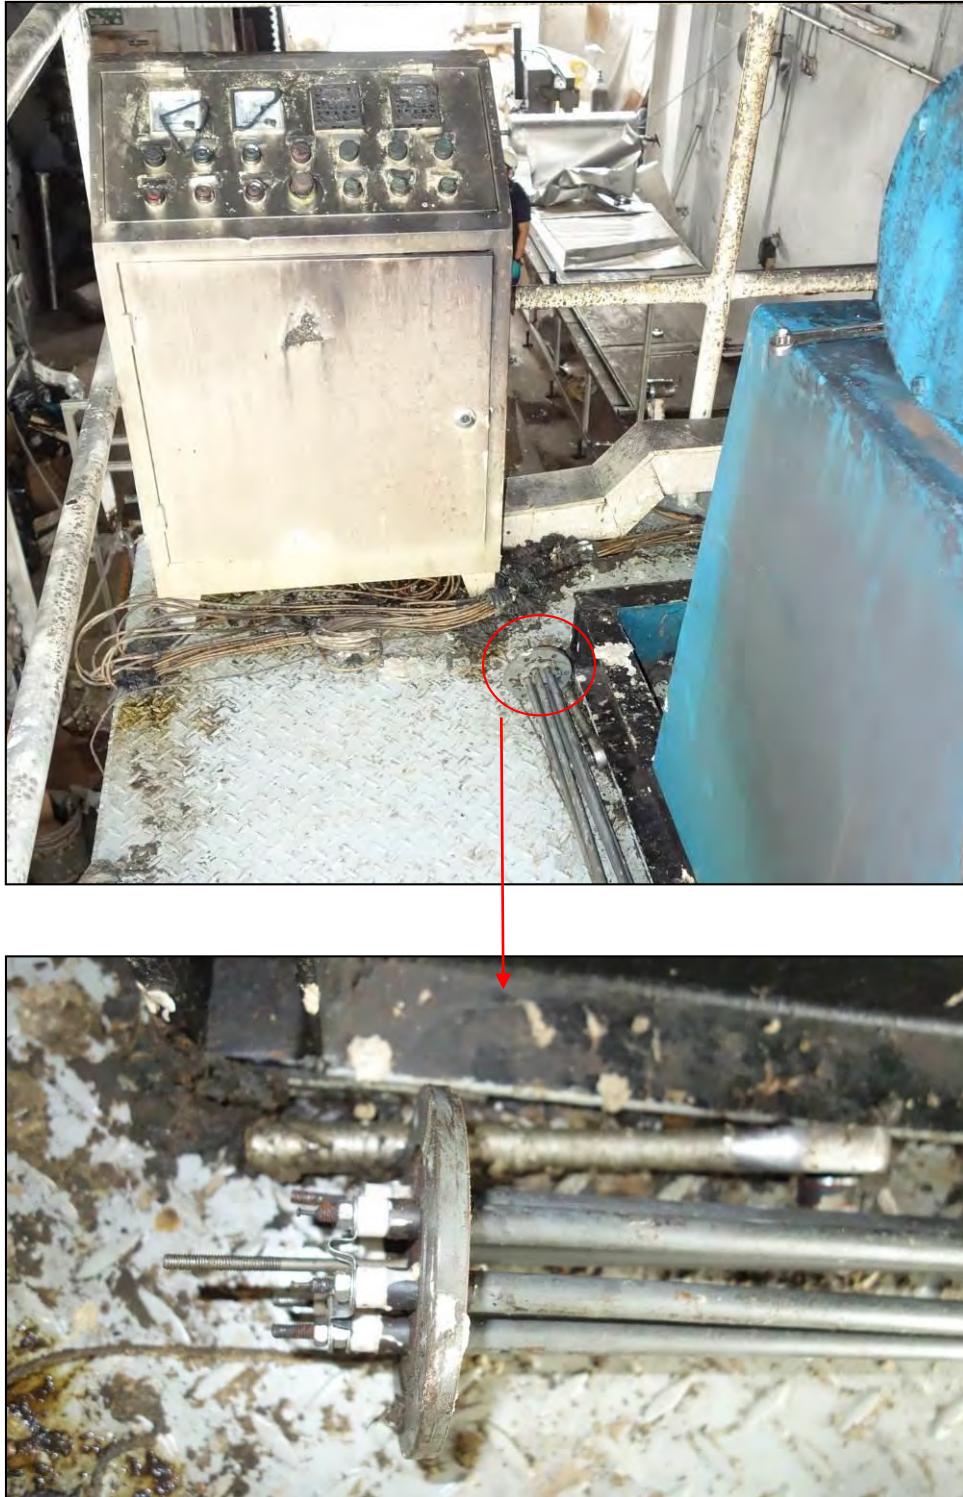
Electrical panel box (top, left) and new heater (circled)

- 18 ➤ The electrical switches and buttons as well as the display screens on the  
electrical panel were damaged by the fire explosion (Figure 15 and Figure 16).

**Figure 15:** **Electrical Panel Box and New Heater.** A new heater, that was placed next to the Mixer Machine, appeared relatively unaffected by the fire explosion. The electrical switches and buttons as well as the display screens on the electrical panel box were damaged by the fire explosion.
