# **Report of the Inquiry Committee for the accident at Stars Engrg Pte Ltd on 24 February 2021**

**(PART II – ANNEXES)**

| Report No:<br><b>M21091</b> | Subject Group:<br><b>11219</b> | Date:<br><b>10<sup>th</sup> September 2021</b> |
| Title of Report:<br><b>Failure Analysis of a Failed Mixer Machine Retrieved from Unit 32E of Platinum @ Pioneer Building involved in a Fire Explosion Incident</b> | | Date of Last Revision/Revision No: |

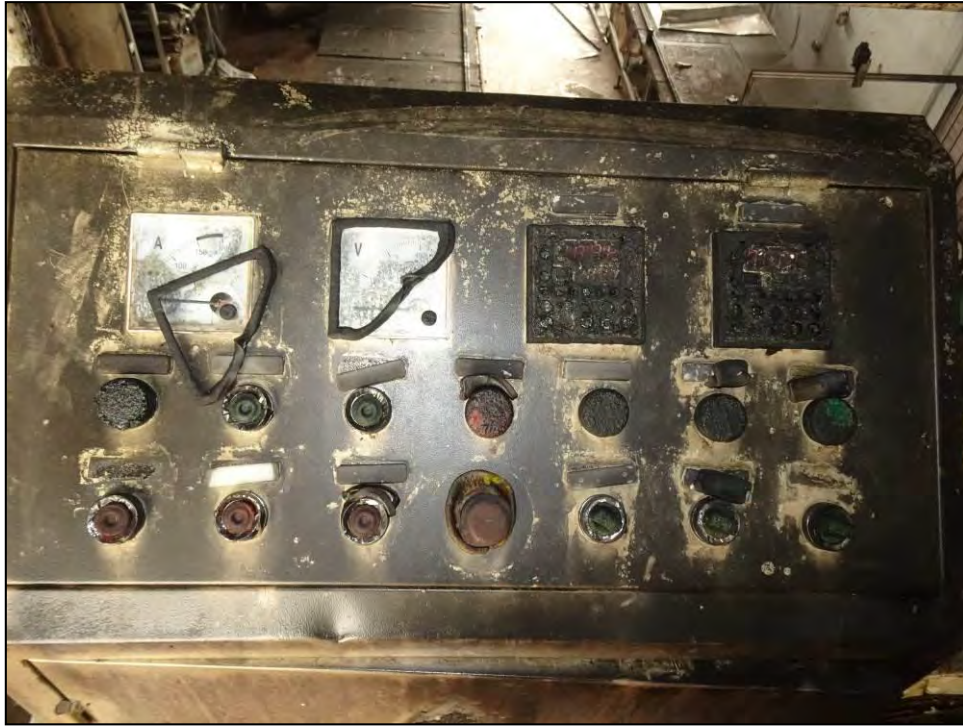
- 18 ➤ The electrical switches and buttons as well as the display screens on the  
electrical panel were damaged by the fire explosion (Figure 15 and Figure 16).

Electrical panel box (top, left) and new heater (circled)

**Figure 15:** **Electrical Panel Box and New Heater.** A new heater, that was placed next to the Mixer Machine, appeared relatively unaffected by the fire explosion. The electrical switches and buttons as well as the display screens on the electrical panel box were damaged by the fire explosion.

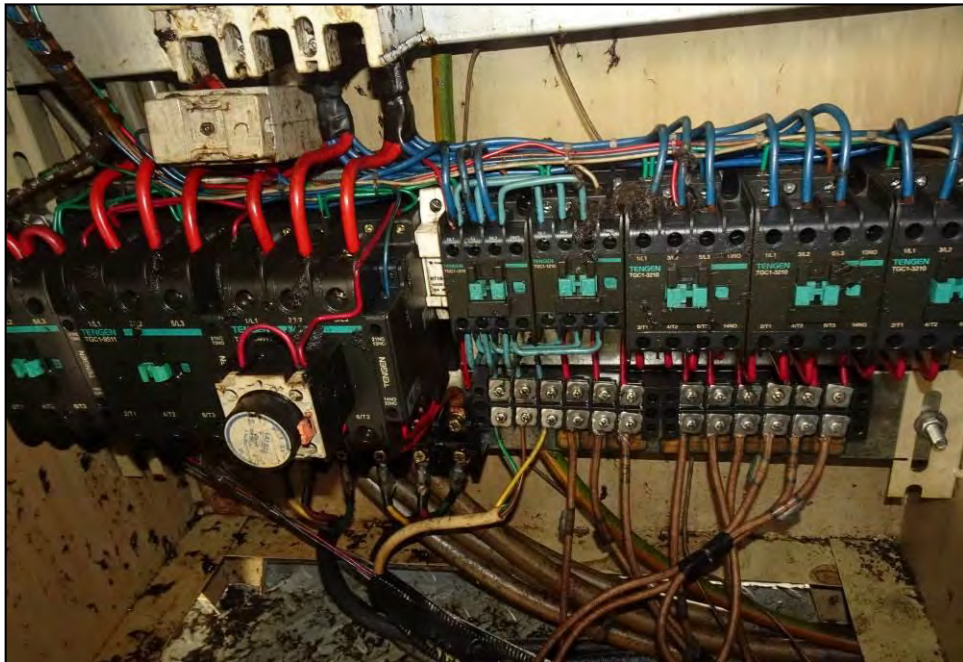
- 20 ➤ The electrical circuit system within the panel box appeared relatively intact  
(Figure 16).
- 22 ➤ Three oil tubs, which were contaminated by water, were found on the Platform  
floor next to the hopper (Figure 17).

Partially melted electrical switches and buttons

Intact electrical wiring within the panel box

**Figure 16: Electrical Panel.** The electrical switches and buttons as well as the display screens on the electrical panel were damaged by the fire explosion. The electrical circuit system within the panel box appeared relatively intact.

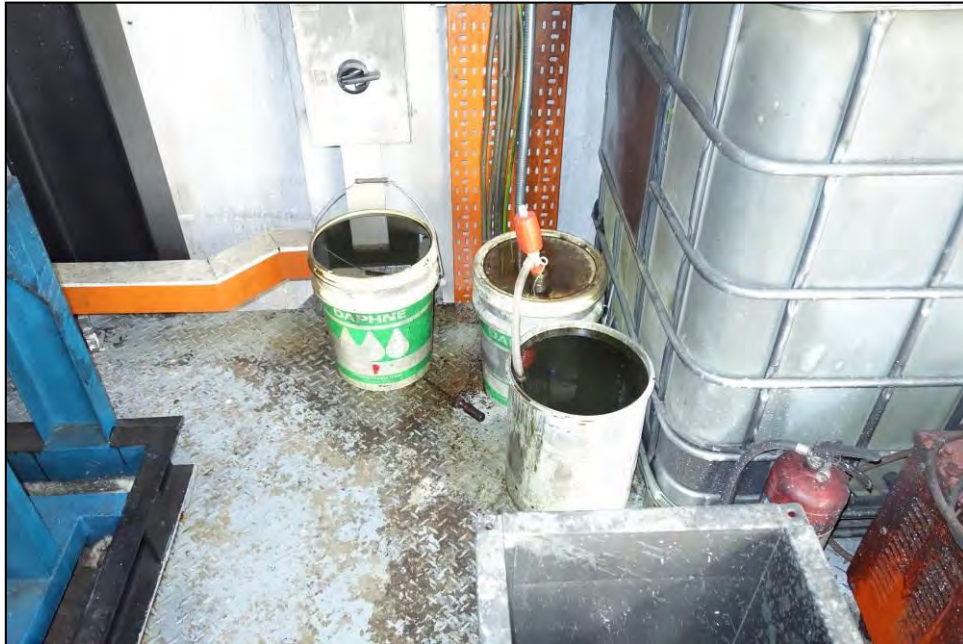
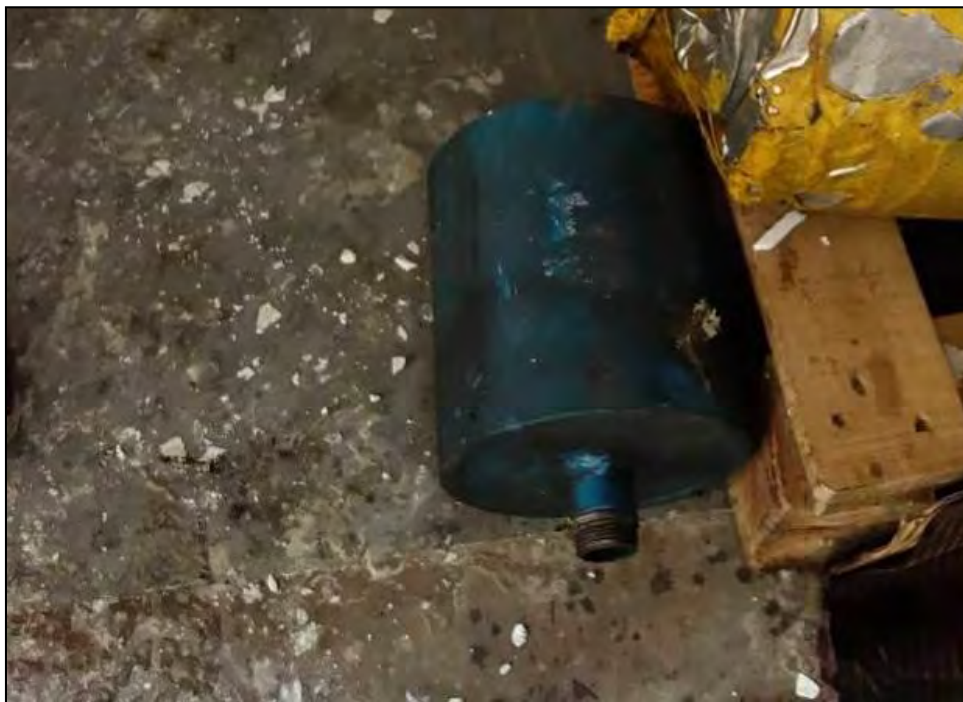
- 24 ➤ The oil funnel, which was used to top up oil in oil jacket, was found on the  
ground floor at the time of inspection (Figure 17).

Oil pails on Platform floor

Oil funnel

**Figure 17: Oil Pails and Funnel.** Three oil tubs, which were contaminated by water, were found on the Platform floor next to the hopper. The oil funnel was found on the ground floor at the time of inspection.

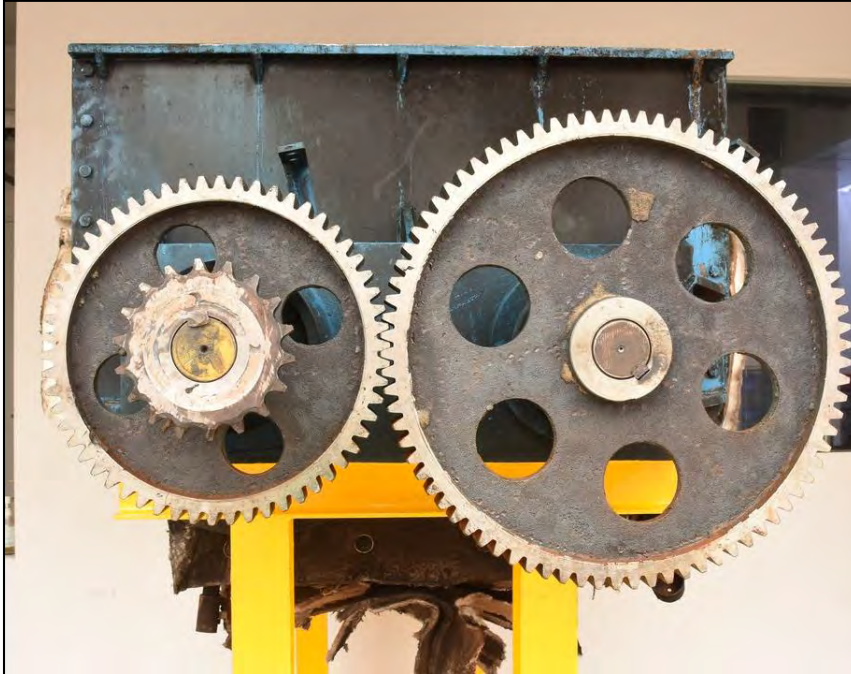
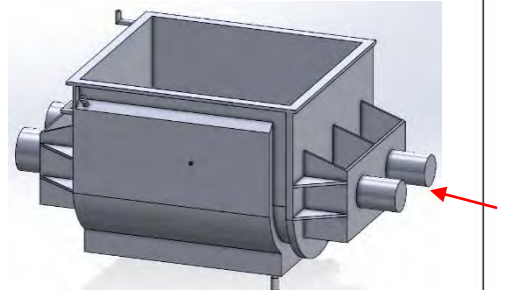
**Figure 19:** As-received condition of the Mixer Machine as viewed from the side away from the Platform stairs.

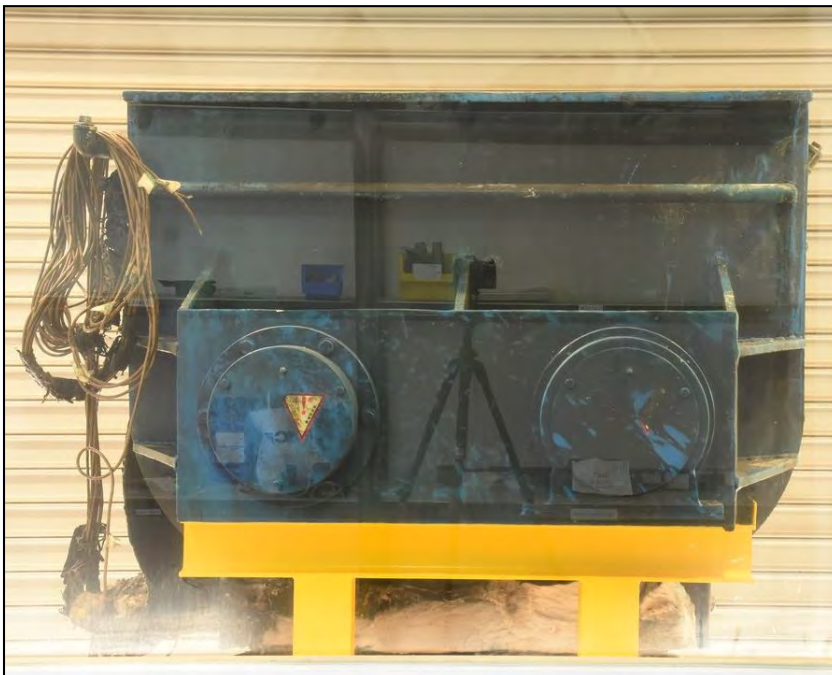
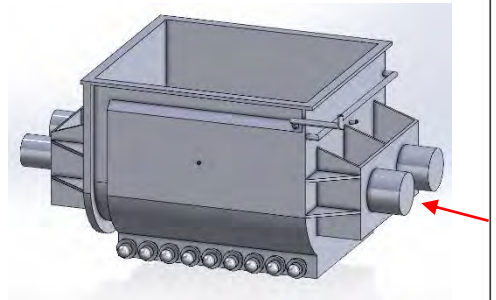
**Figure 20:** As-received condition of the Mixer Machine as viewed from the side nearest to the Platform stairs.

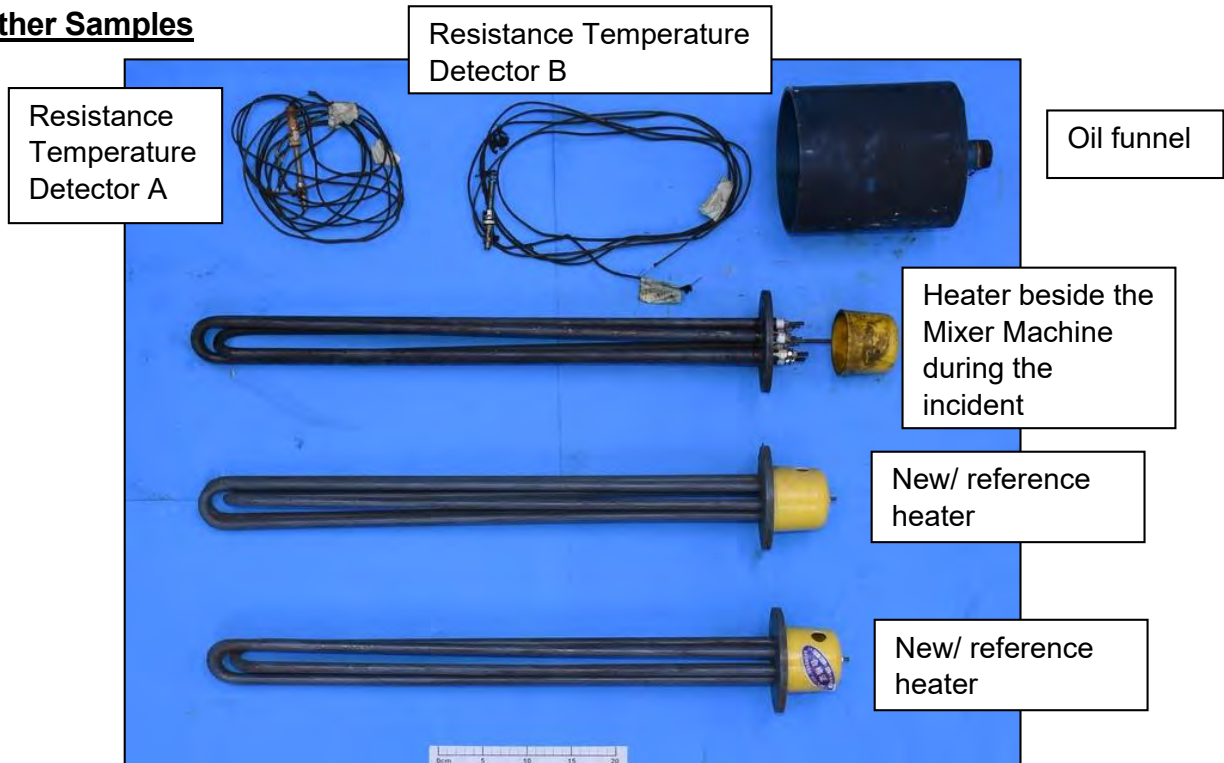
- 38 ➤ Mixer Machine (Figure 19 to Figure 32)
- 40 ➤ Oil funnel (Figure 33)
- Resistance Temperature Detector/Sensor (RTD) A (Figure 33)
- 42 ➤ RTD B (Figure 33)
- Heater found beside the Mixer Machine after the incident (Figure 33)
- 44 ➤ Two new heaters from the storeroom at level 2 (Figure 33)
- Electrical panel, also known as local control panel of the Mixer Machine (Figure  
34)

**Figure 33:** As-received condition of the additional samples.

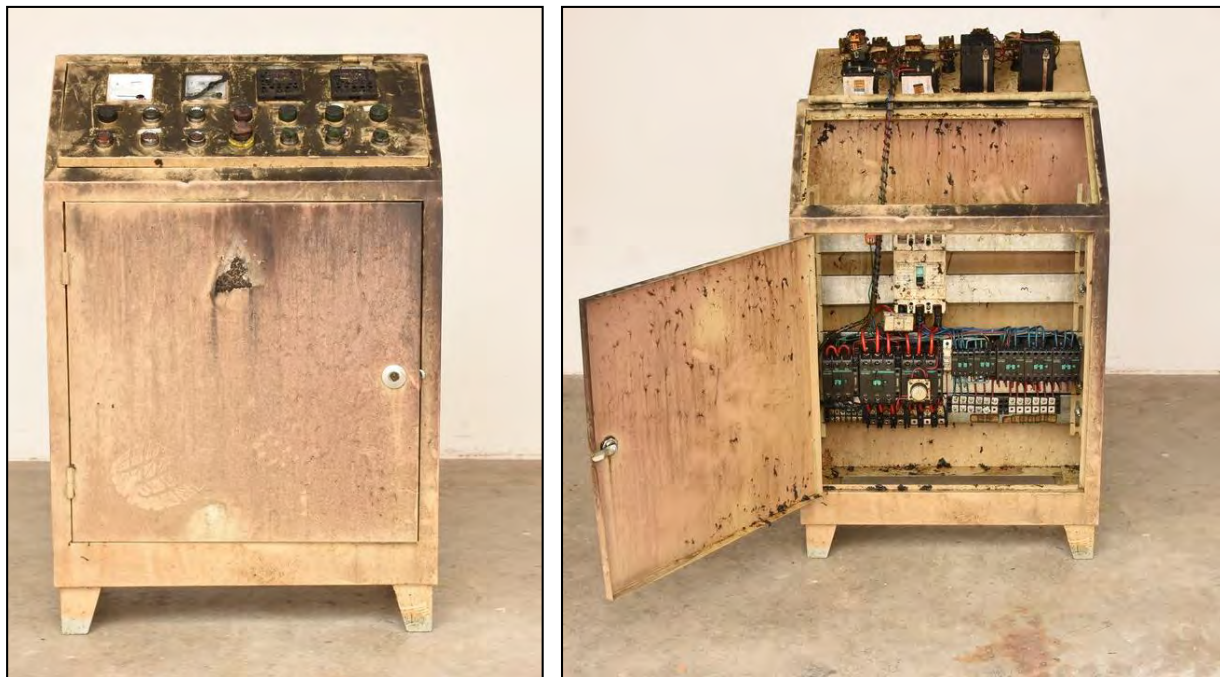
**Figure 34:** As-received condition of the electrical panel.

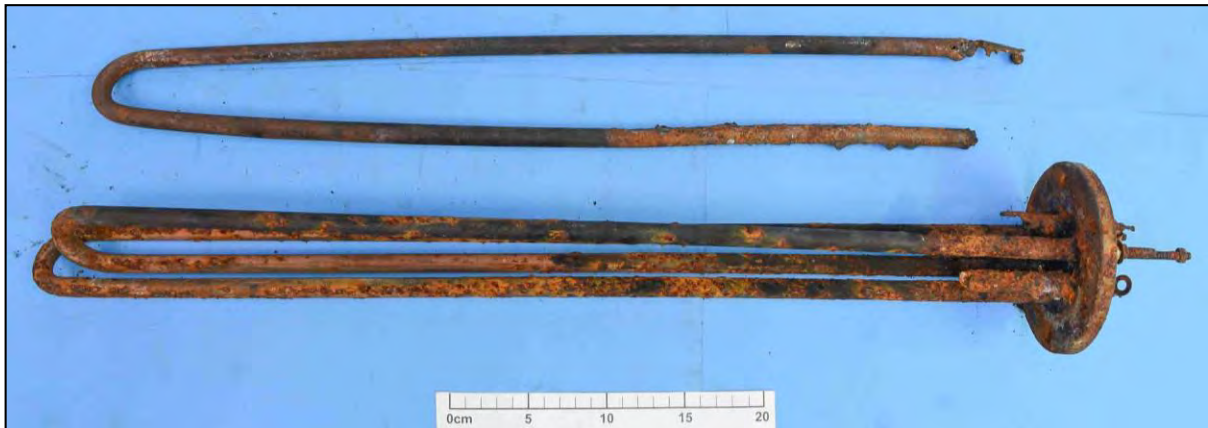
**Figure 35:** Used heater received on 28<sup>th</sup> May 2021.

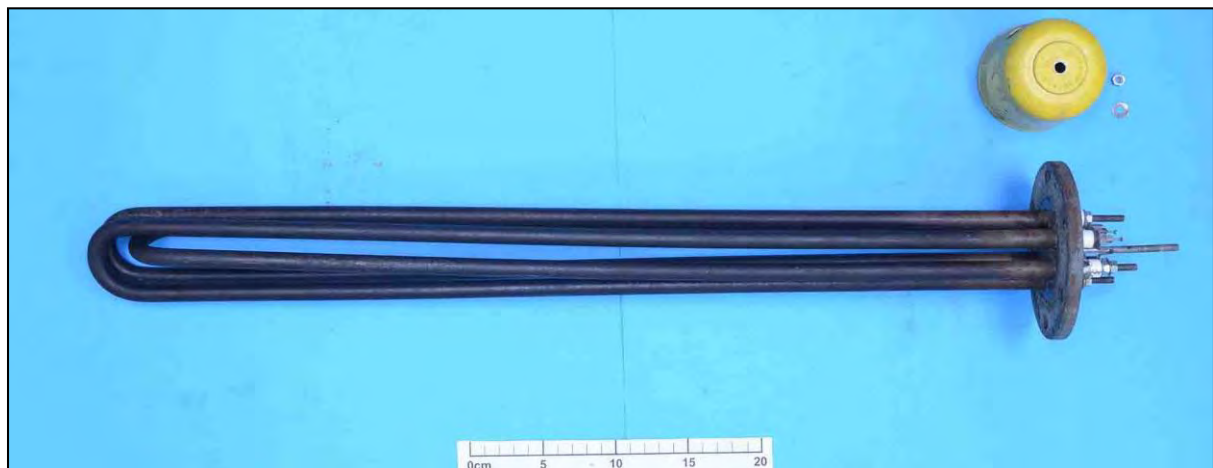
**Figure 36:** Used heater received on 1<sup>st</sup> June 2021.

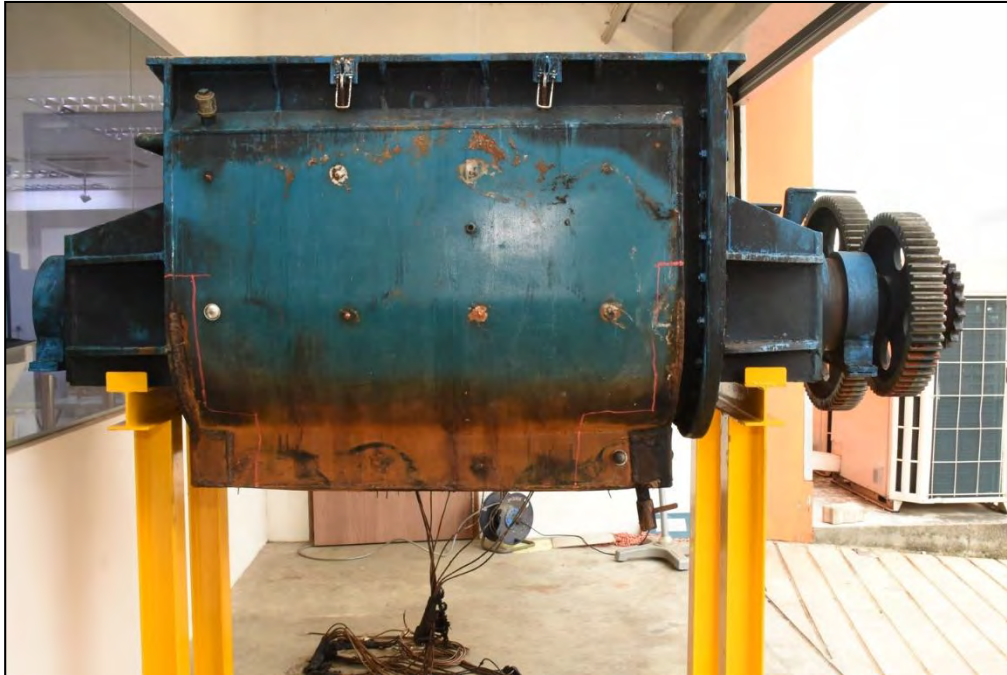
**Figure 37:** Marked out locations on the front for detailed examination.

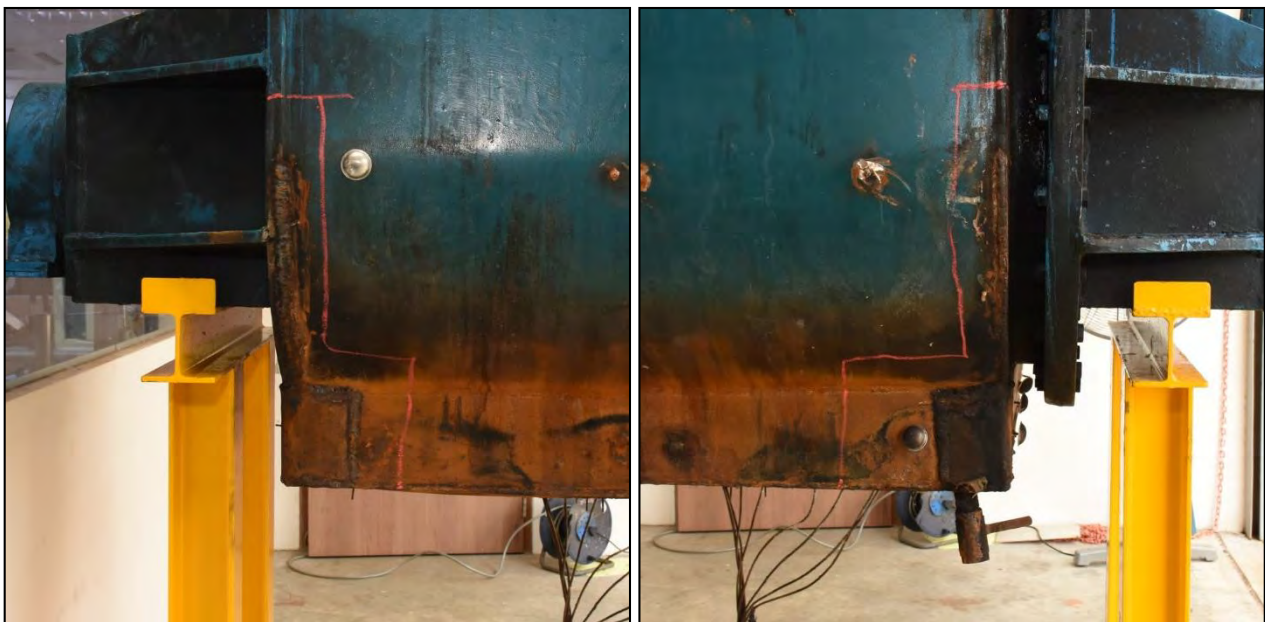
**Figure 38:** Marked out locations on the front corners for detailed examination.

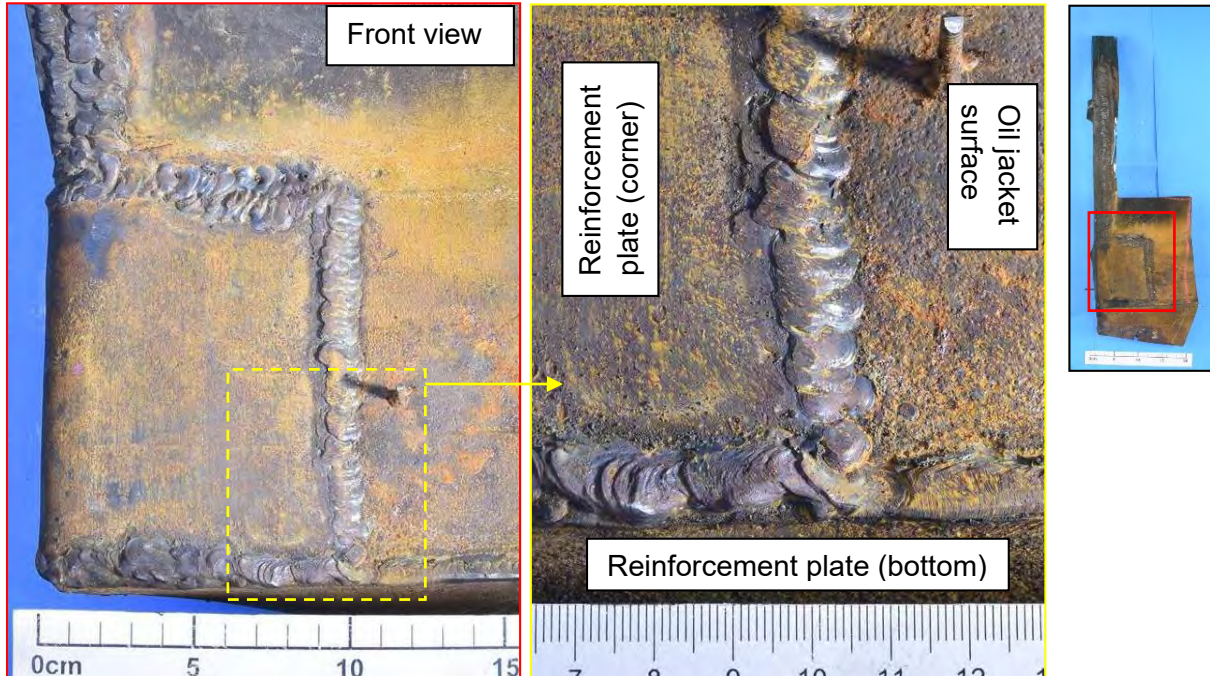
**Figure 44:** Close up view of bottom corner. The reinforcement plate was added at the corner by welding.

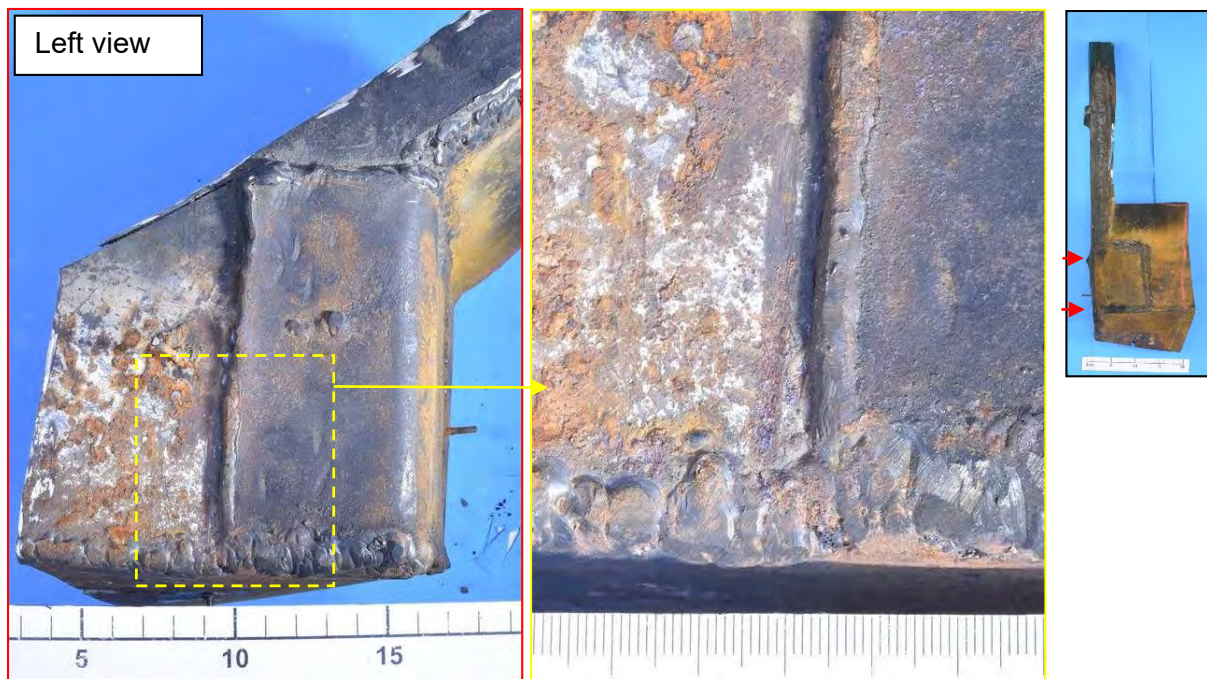
**Figure 45:** Close up view of bottom corner from another angle. Similar welding done to the oil jacket wall to add the reinforcement plate.

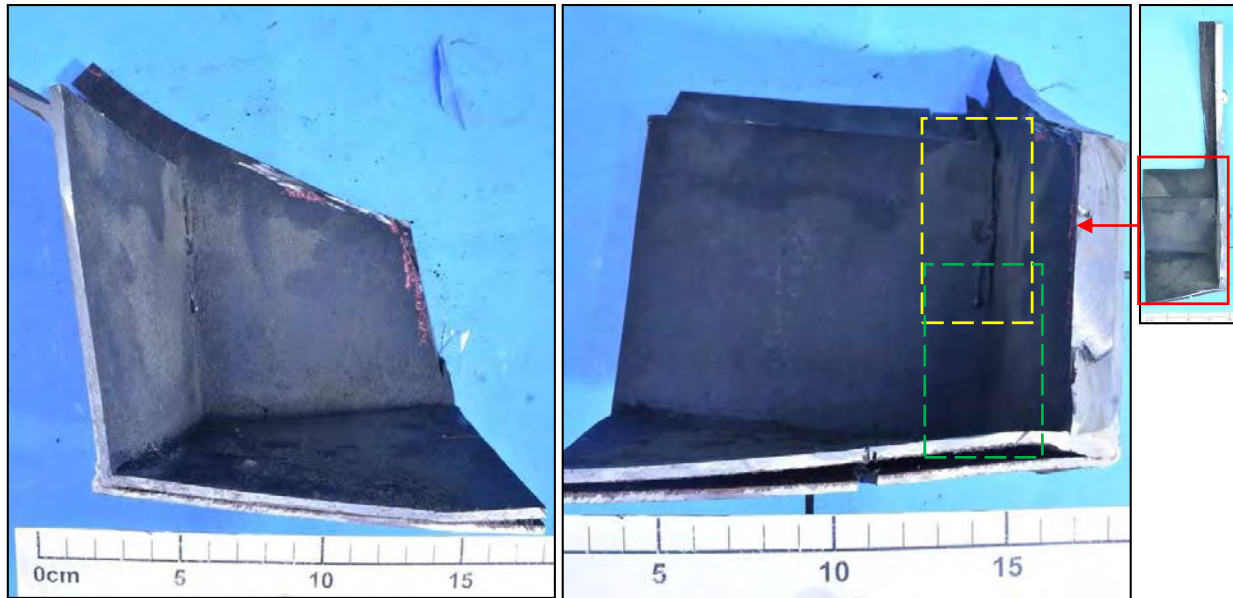
**Figure 48:** Condition of the internal surface of oil jacket corner. Close up views presented below with their respective colour borders.

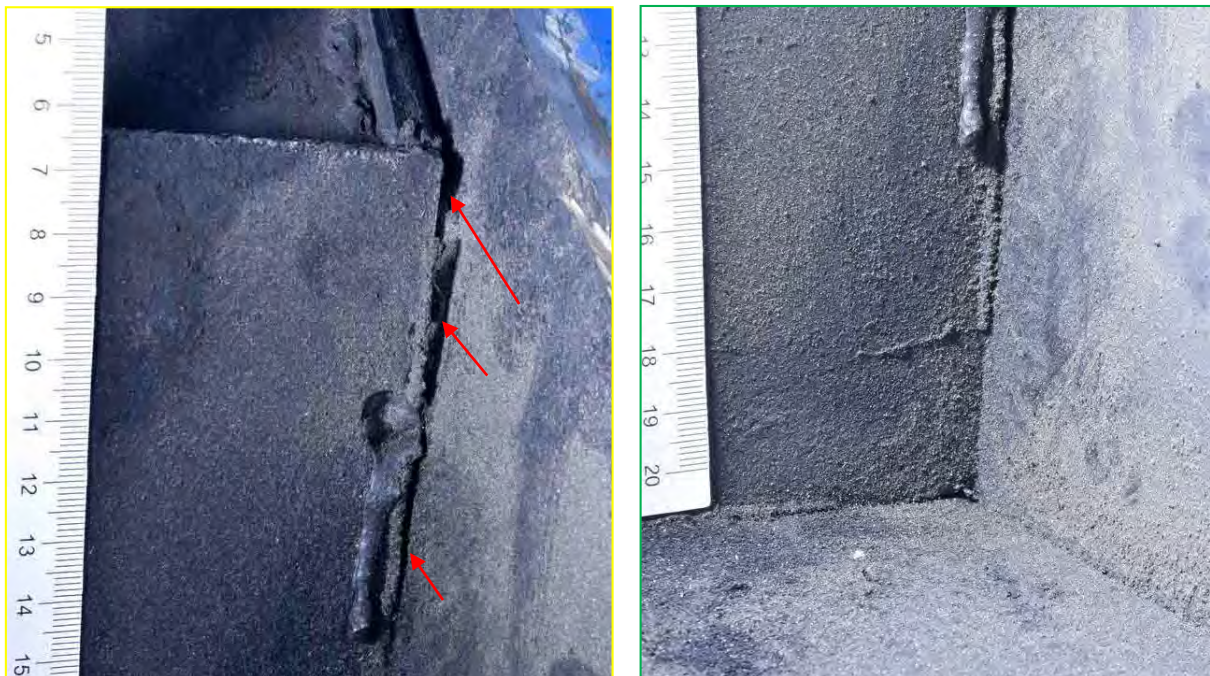
**Figure 49:** Close up view of the corner from inside the oil jacket. Gaps were observed between the walls (indicated with red arrows). The gap narrowed and stopped towards the bottom corner.

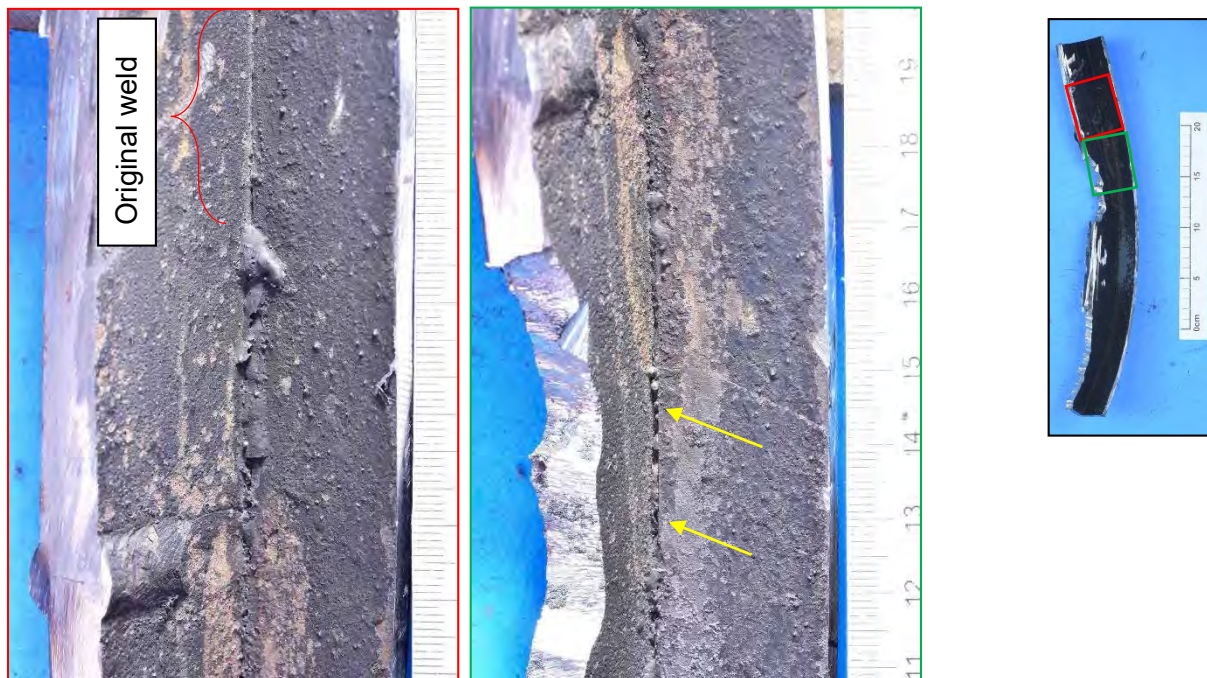
- At the front side, right edge weld, the face width of the repair weld face was up to about 20 mm. The weld root was smaller and had signs of lack of root penetration at some areas (Figure 51 and Figure 52).
- The bottom reinforcement plate was found to be folded over the original weld and welded to the side wall (side away from Platform stairs) (Figure 54).
- Cross sections made across the corner reinforcement plate revealed voids in the weld metal of reinforcement plate (Figure 56).

**Figure 52:** Condition of weld from inside the oil jacket. Part of the original weld is indicated (in red) in the left figure. The original weld root was small. The rest of the weld was repaired and had signs of lack of root penetration at some areas (indicated with yellow arrows).

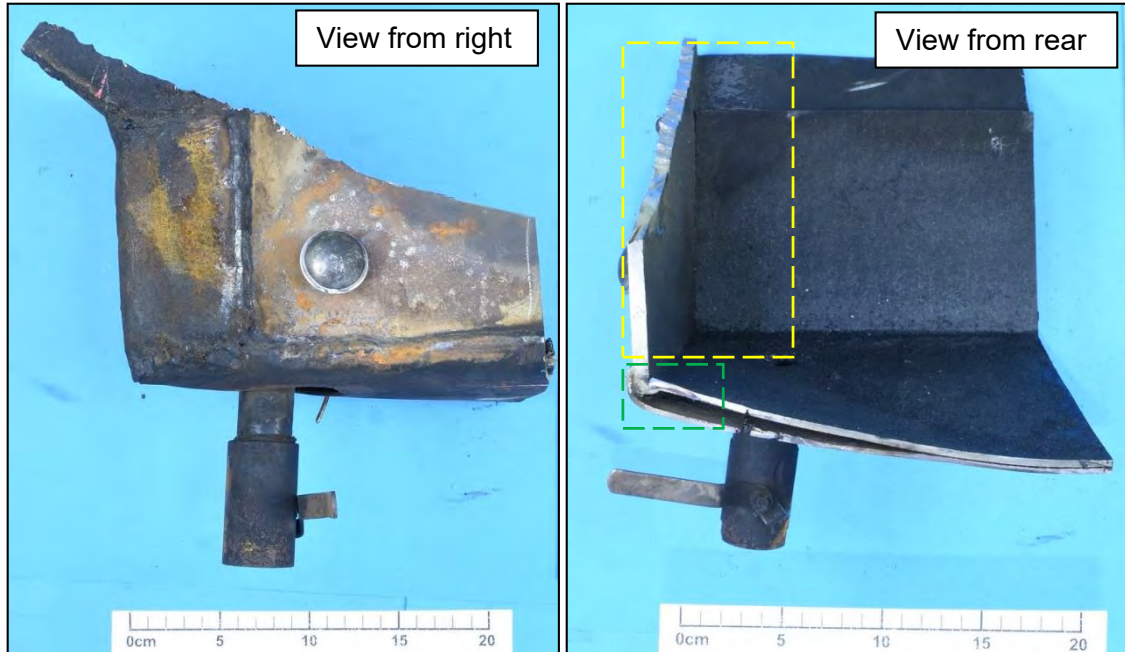
**Figure 53:** Condition of the internal surface of oil jacket corner. Close up views presented below with their respective colour borders.

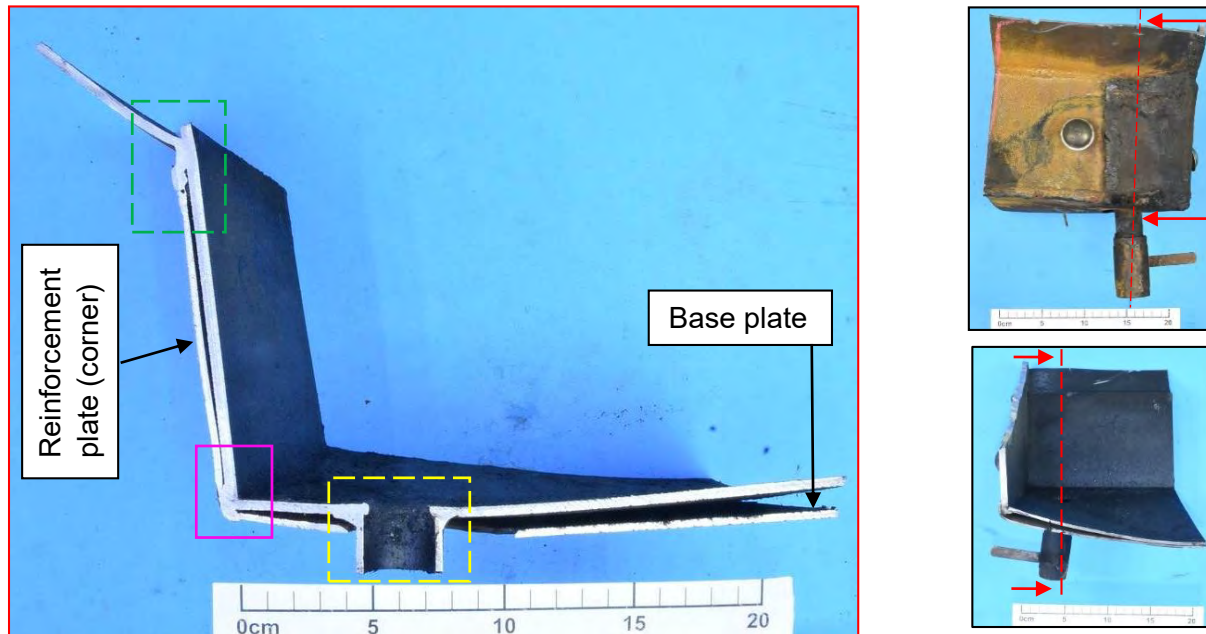
**Figure 55:** A cross section was made vertically across the drain port, revealing the weld configuration of the corner plate, base plate and the drain port weld. Close up views presented below with their respective colour borders.

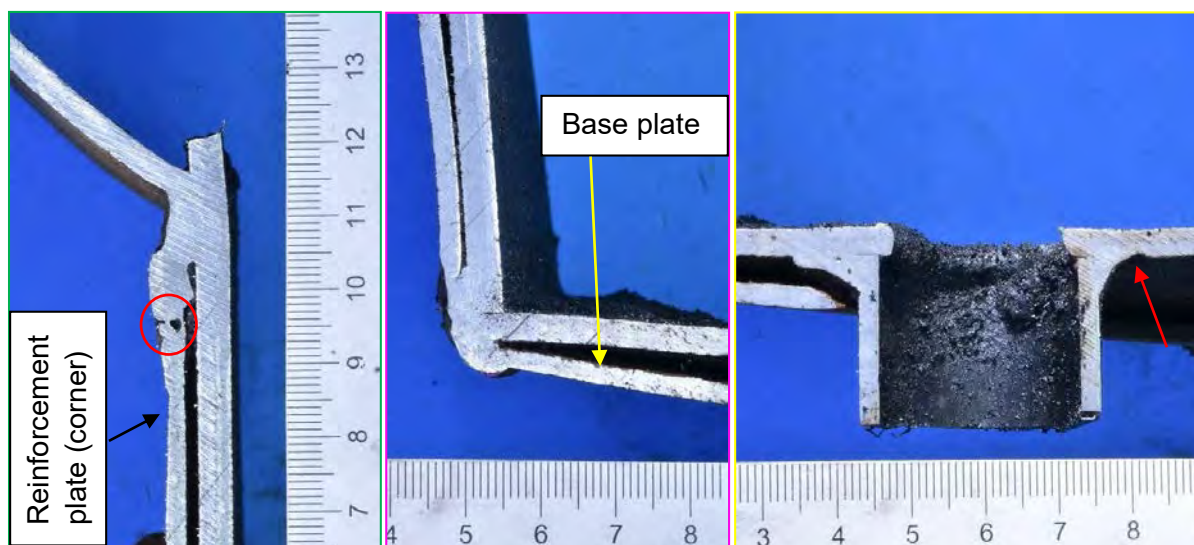
**Figure 56:** Cross section revealed the corner and base plates were welded together at the bottom edge of the oil jacket (middle figure). Void was visible at the corner reinforcement plate weld (left figure). The drain port weld had an undercut at the weld toe (right figure).

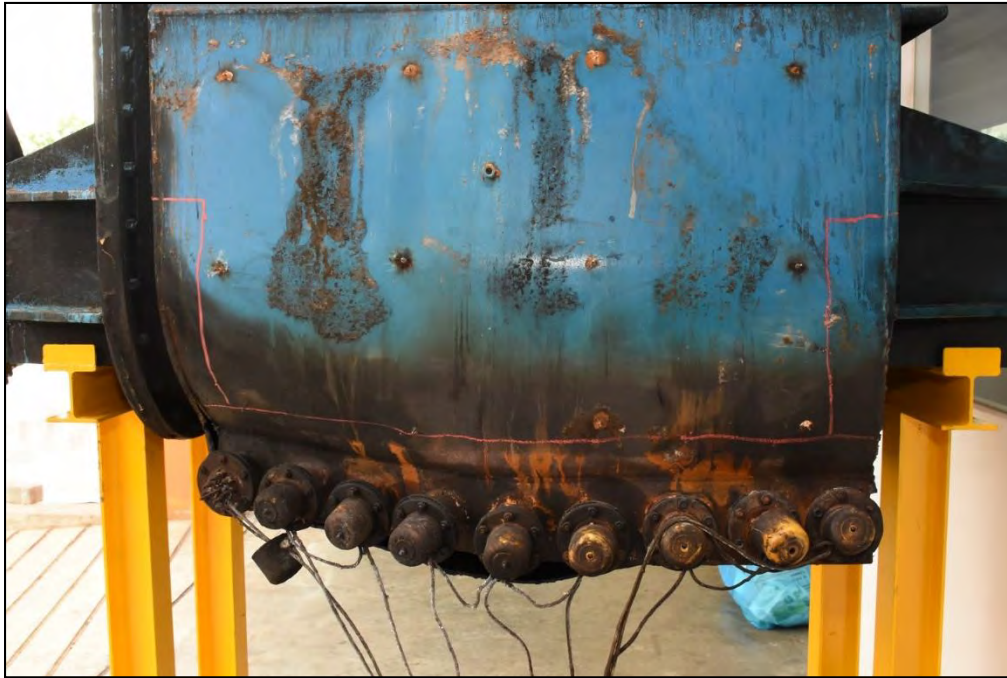
**Figure 57:** Marked out locations on the front for detailed examination.

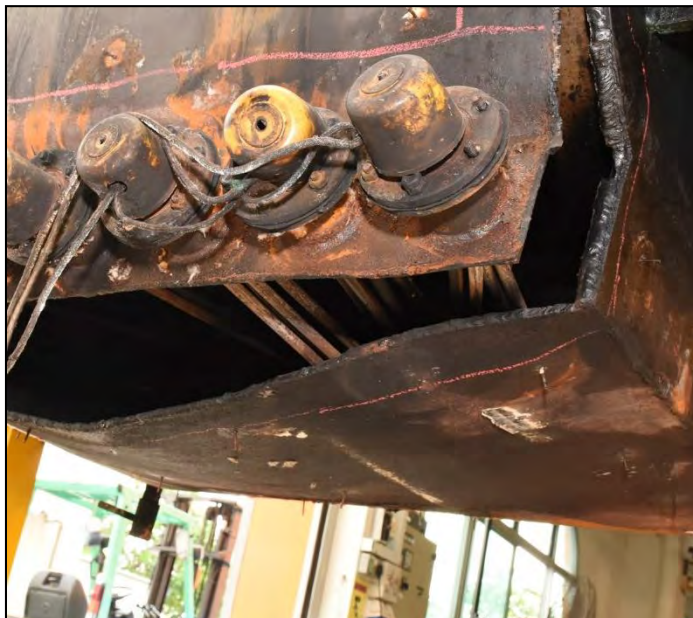
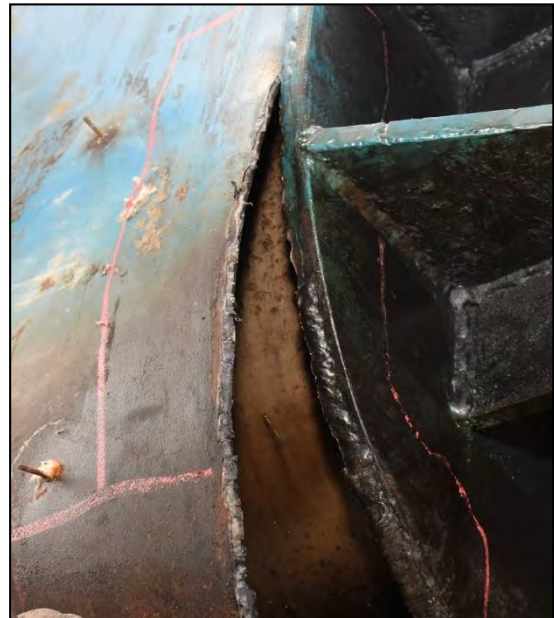
**Figure 58:** Marked out locations on the rear edges and corners for detailed examination.

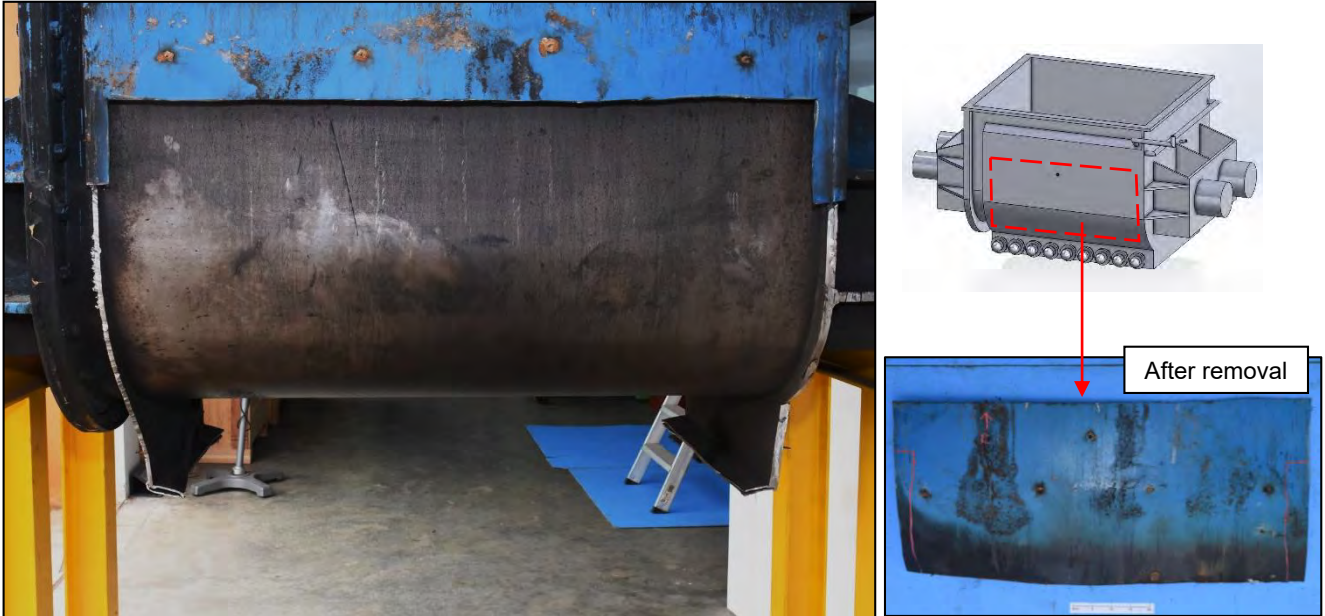
**Figure 59:** Internal condition of the oil jacket from the rear side. The internal surface was generally covered by black soot.

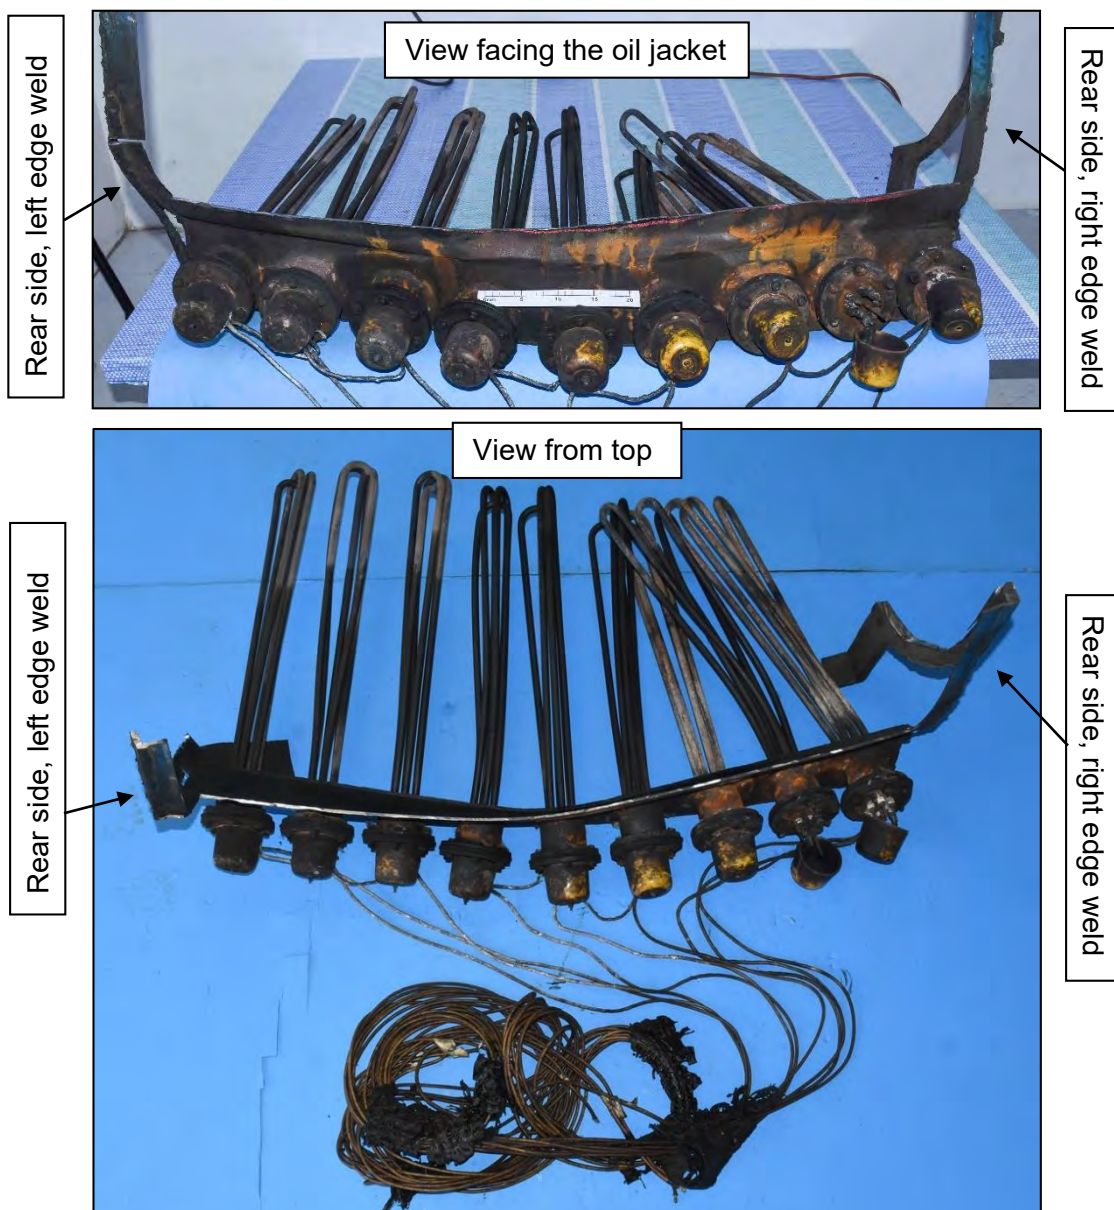
**Figure 61:** Cut out section consisting of the side welds and heaters. The side welds are referenced as rear side, left edge and rear side, right edge welds.

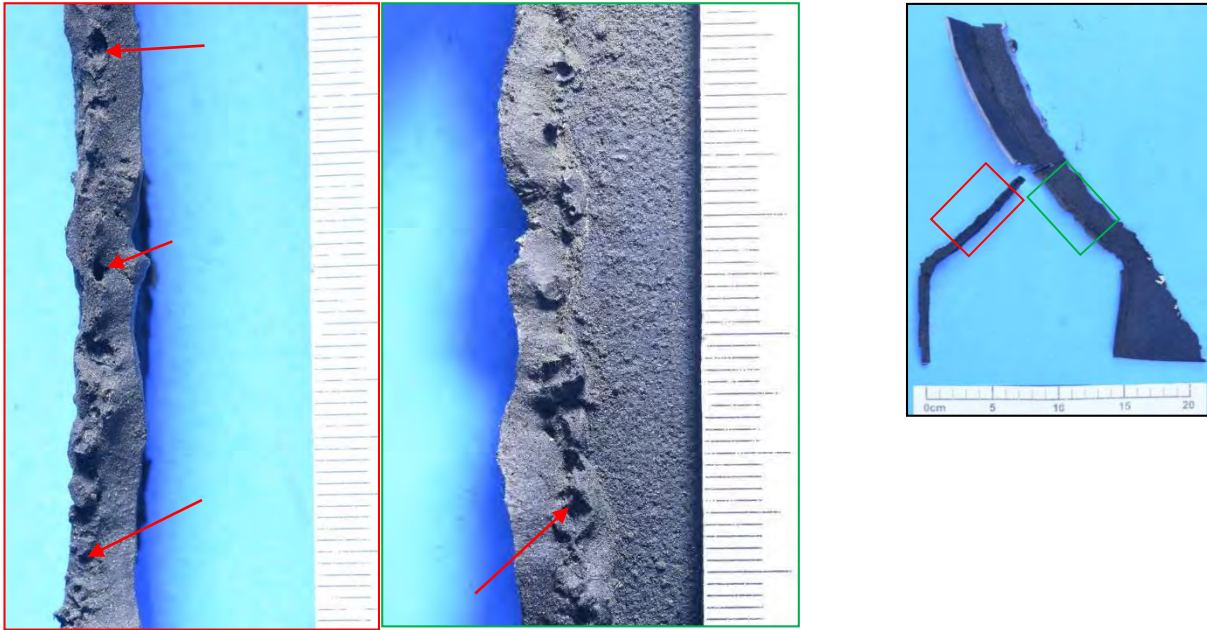
**Figure 63:** Close up view of side weld fracture surface at the curved part. Voids were visible along the fracture surface. (see also Figure 119)

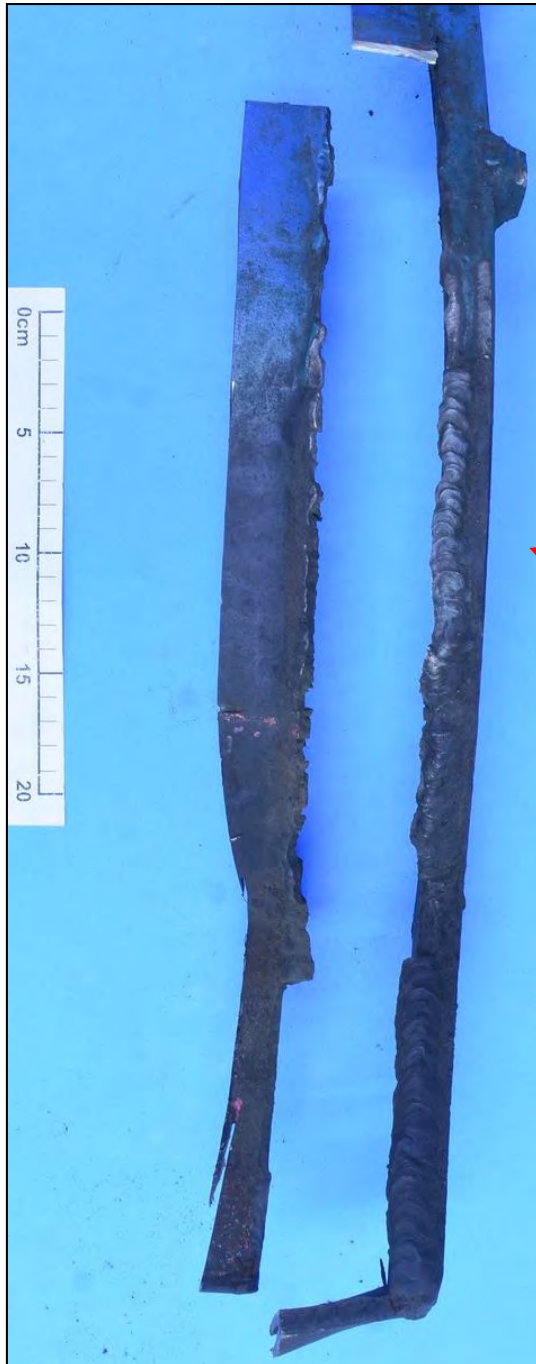
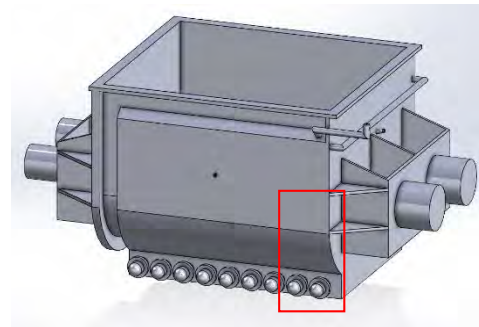
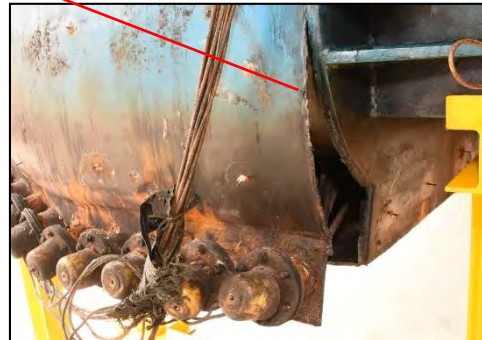
**Figure 65:** Cut out section of the rear side, right edge weld. The observations made in the following figures were generally similar to the rear side, left edge weld. (see also Figure 62)

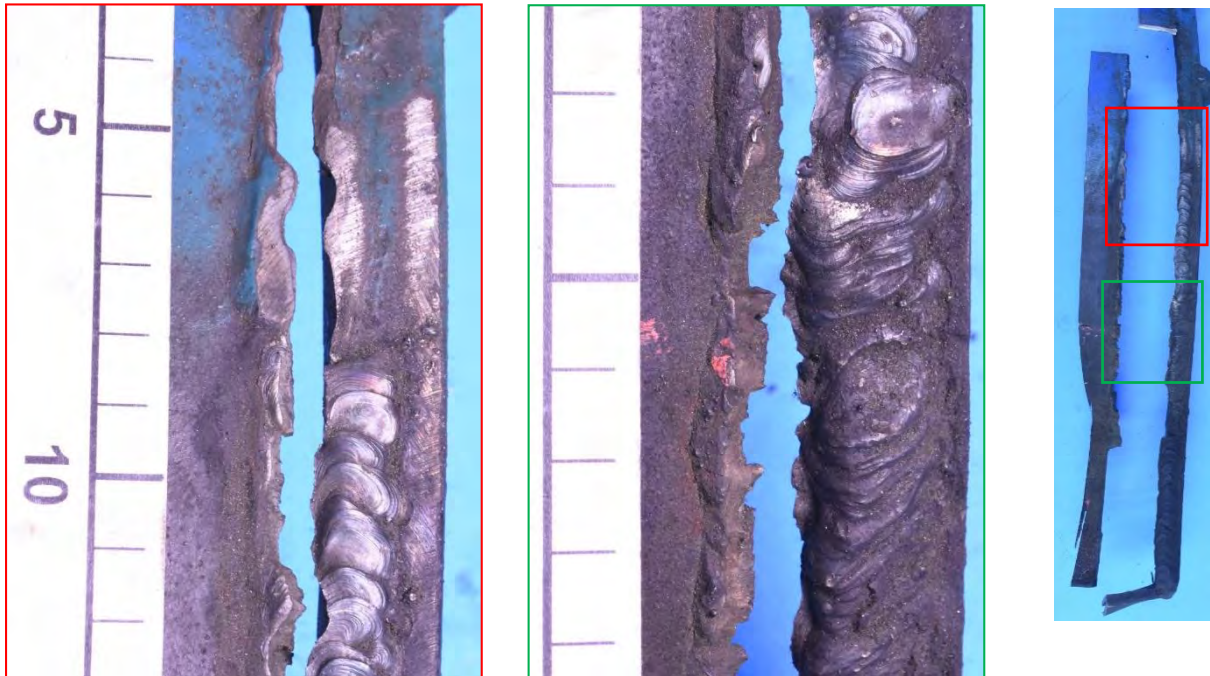
- The fracture at the rear side, right edge weld had a similar fracture path at the repair weld. The fracture path was slightly off-centred along the weld face at the curved part of the oil jacket and along the weld toe at the vertical plane of the oil jacket (Figure 66 and Figure 67).

**Figure 66:** Close up view of side weld fracture surface at the curved part. The fracture path was slightly off-centred along the weld face at the curved part of the oil jacket.
