# **Report of the Inquiry Committee for the accident at Stars Engrg Pte Ltd on 24 February 2021**

**(PART II – ANNEXES)**

| Report No:<br><b>M21091</b> | Subject Group:<br><b>11219</b> | Date:<br><b>10<sup>th</sup> September 2021</b> |
| Title of Report:<br><b>Failure Analysis of a Failed Mixer Machine Retrieved from Unit 32E of Platinum @ Pioneer Building involved in a Fire Explosion Incident</b> | | Date of Last Revision/Revision No: |

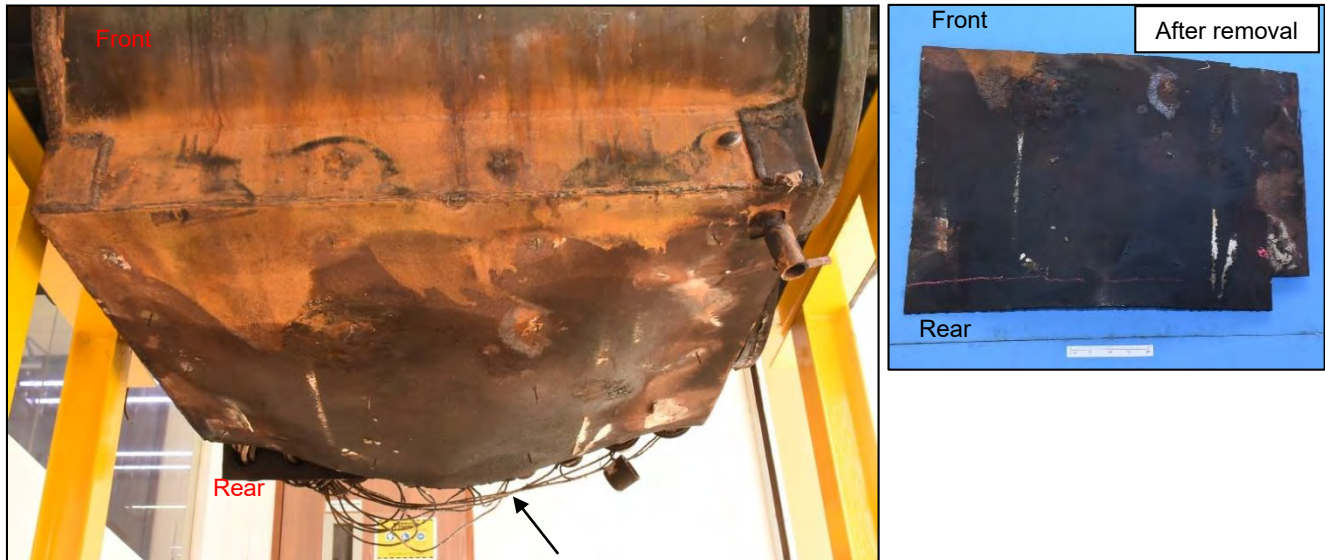
**Figure 69:** Bottom view of the Mixer Machine. The rear side bottom had bulged outwards.

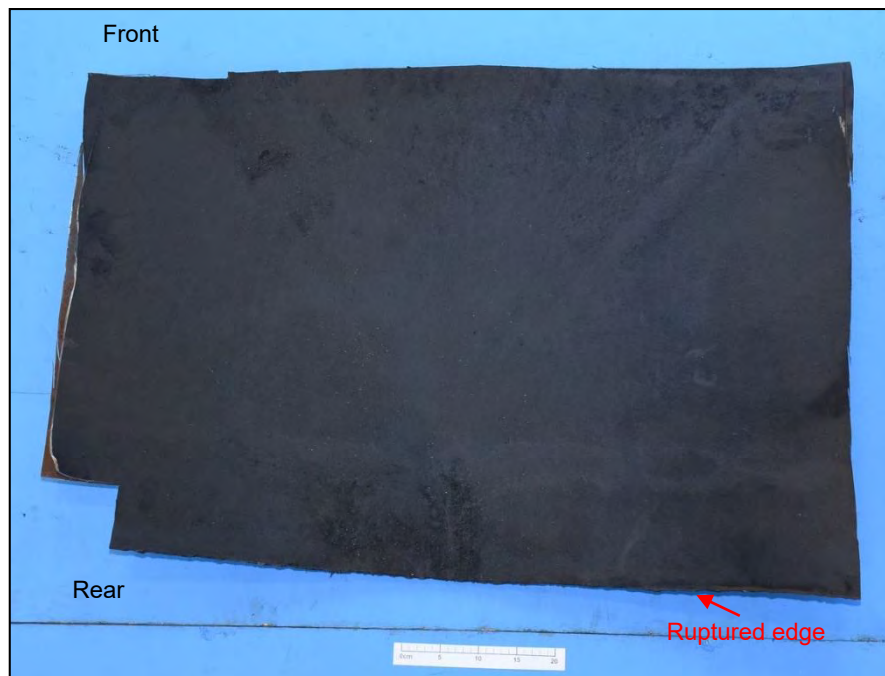
**Figure 70:** Internal condition of the bottom face. The internal surface was generally covered in black soot.

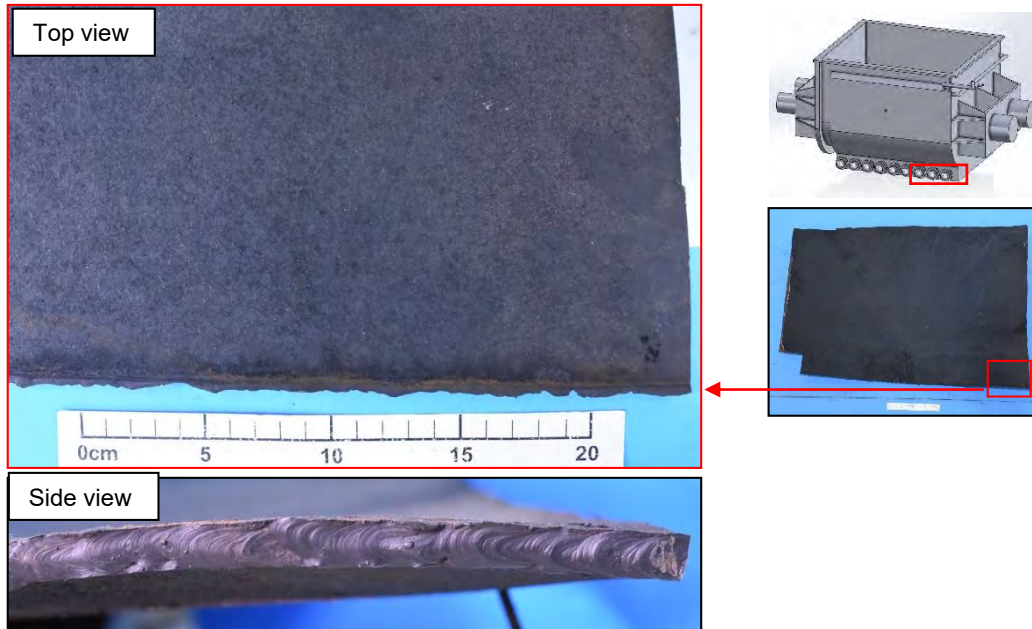
**Figure 71:** Close up on weld condition of the bottom plate. The fracture was generally along the weld toe.

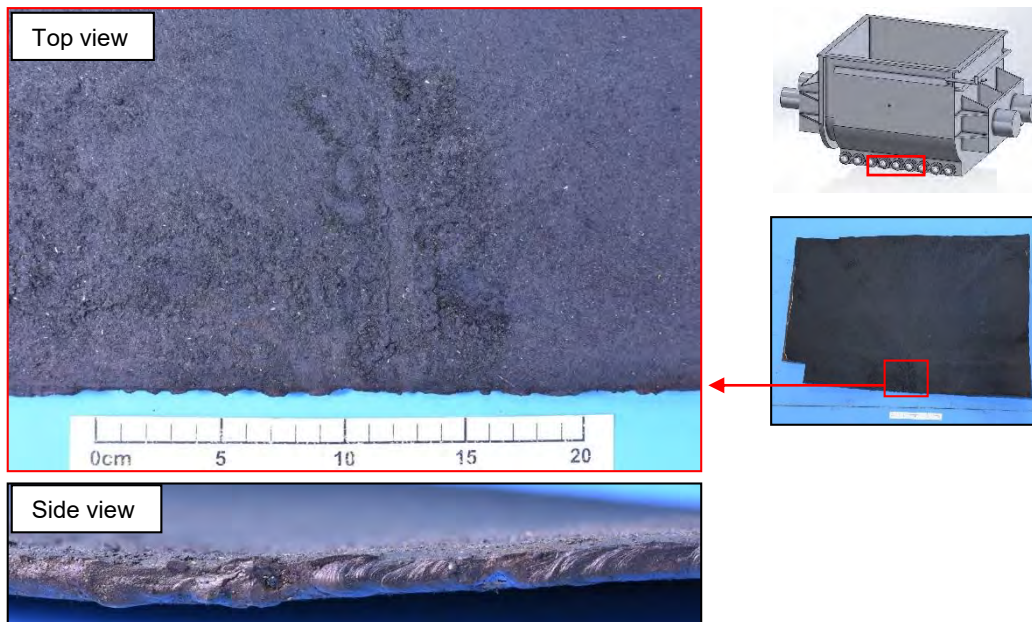
**Figure 72:** Close up on weld condition of the bottom plate. The fracture was generally along the weld toe.

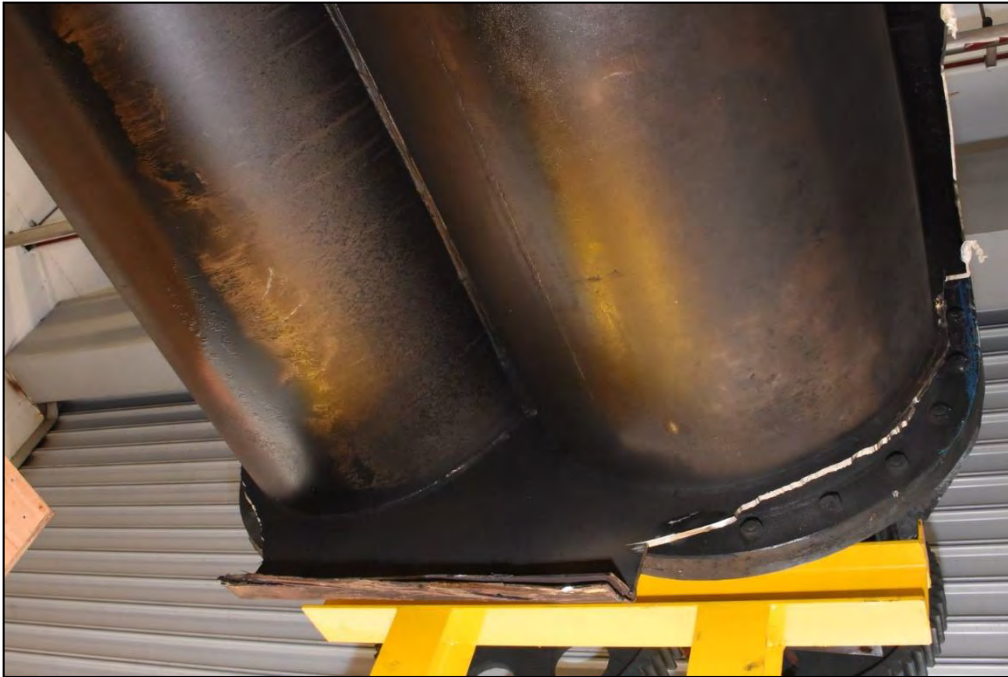
**Figure 73:** Internal condition of the oil jacket surface, view from the bottom showing the “W” shape of the mixing chamber formed by joining two half cylinders. Surface was generally covered with soot and oil remnant.

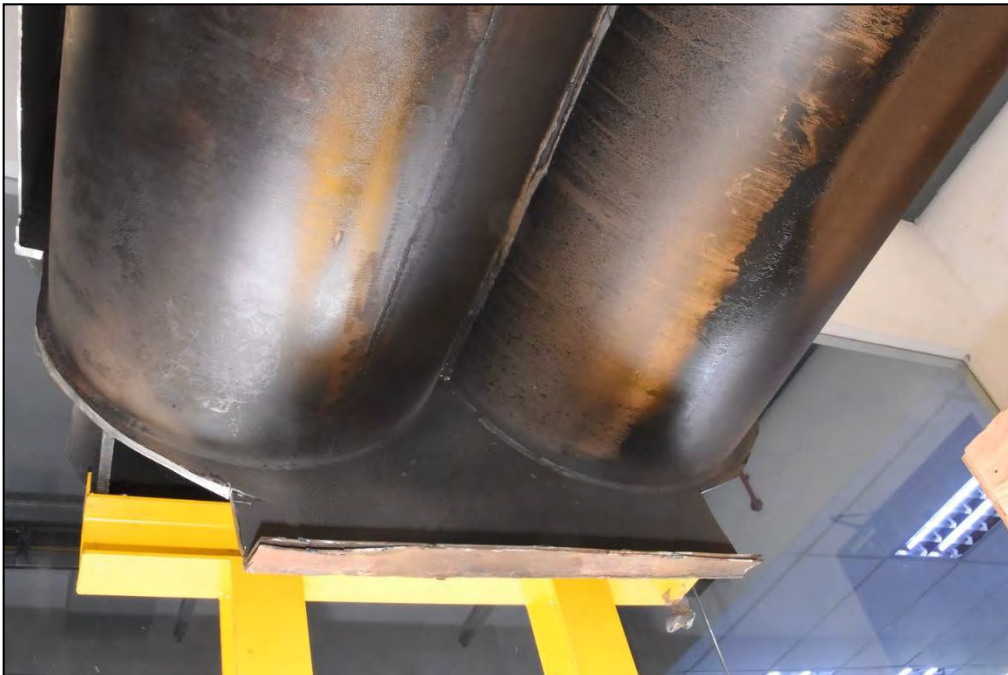
**Figure 74:** Internal condition of the oil jacket surface, view from the bottom. Surface was generally covered with soot and oil remnant.

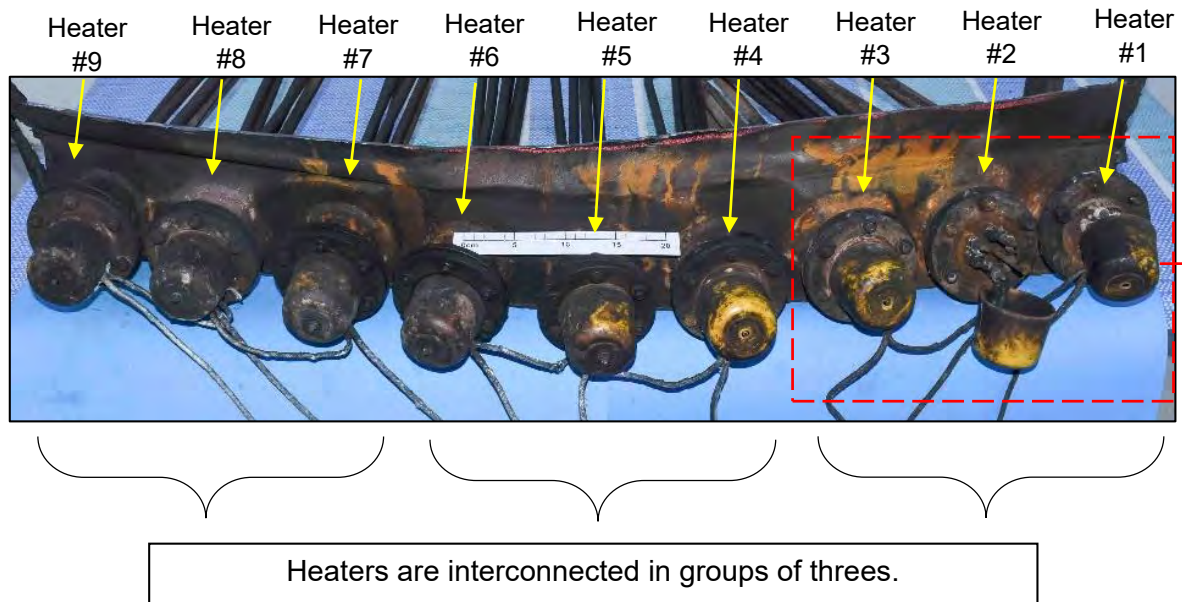
**Figure 75:** From right, heaters are referred to as heater #1 to #9.

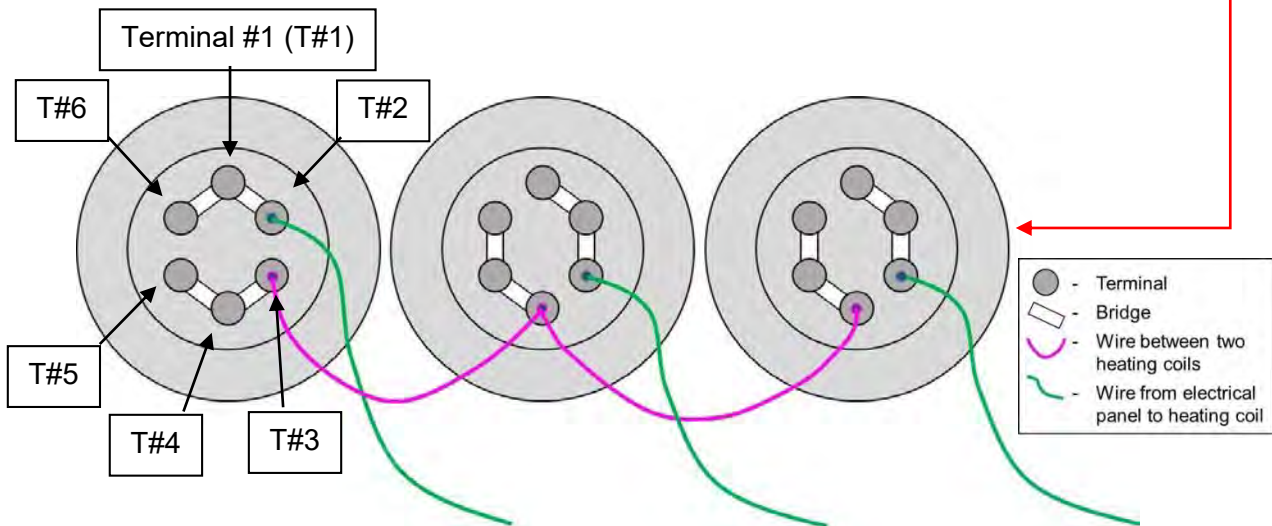
- 28 The wire connections in a group of heaters are shown in Figure 76 (extracted in the  
following page). For ease of reference, the terminals were numbered clockwise in  
30 increasing order, starting from the topmost terminal as terminal #1. Each heater is  
connected in two ways. First, each heater is connected to the electrical panel by a wire  
32 between the electrical panel and one of its terminals. Second, within each group of  
three heaters, two wires connect the middle heater to each of the heaters on its left  
34 and right side by one of their terminals (Figure 76 and Figure 77). The position of the  
connected terminals and terminal bridges vary depending on the flange orientation  
36 during bolting.

**Figure 76:** For ease of reference, the terminals are numbered clockwise in increasing order, starting from the topmost terminal as terminal #1. Each heater is connected in two ways. First, each heater is connected to the electrical panel by a wire between the electrical panel and one of its terminals. Second, within each group of three heaters, two wires connect the middle heater to each of the heaters on its left and right side by one of their terminals. The position of the connected terminals and terminal bridges vary depending on the flange orientation during bolting.

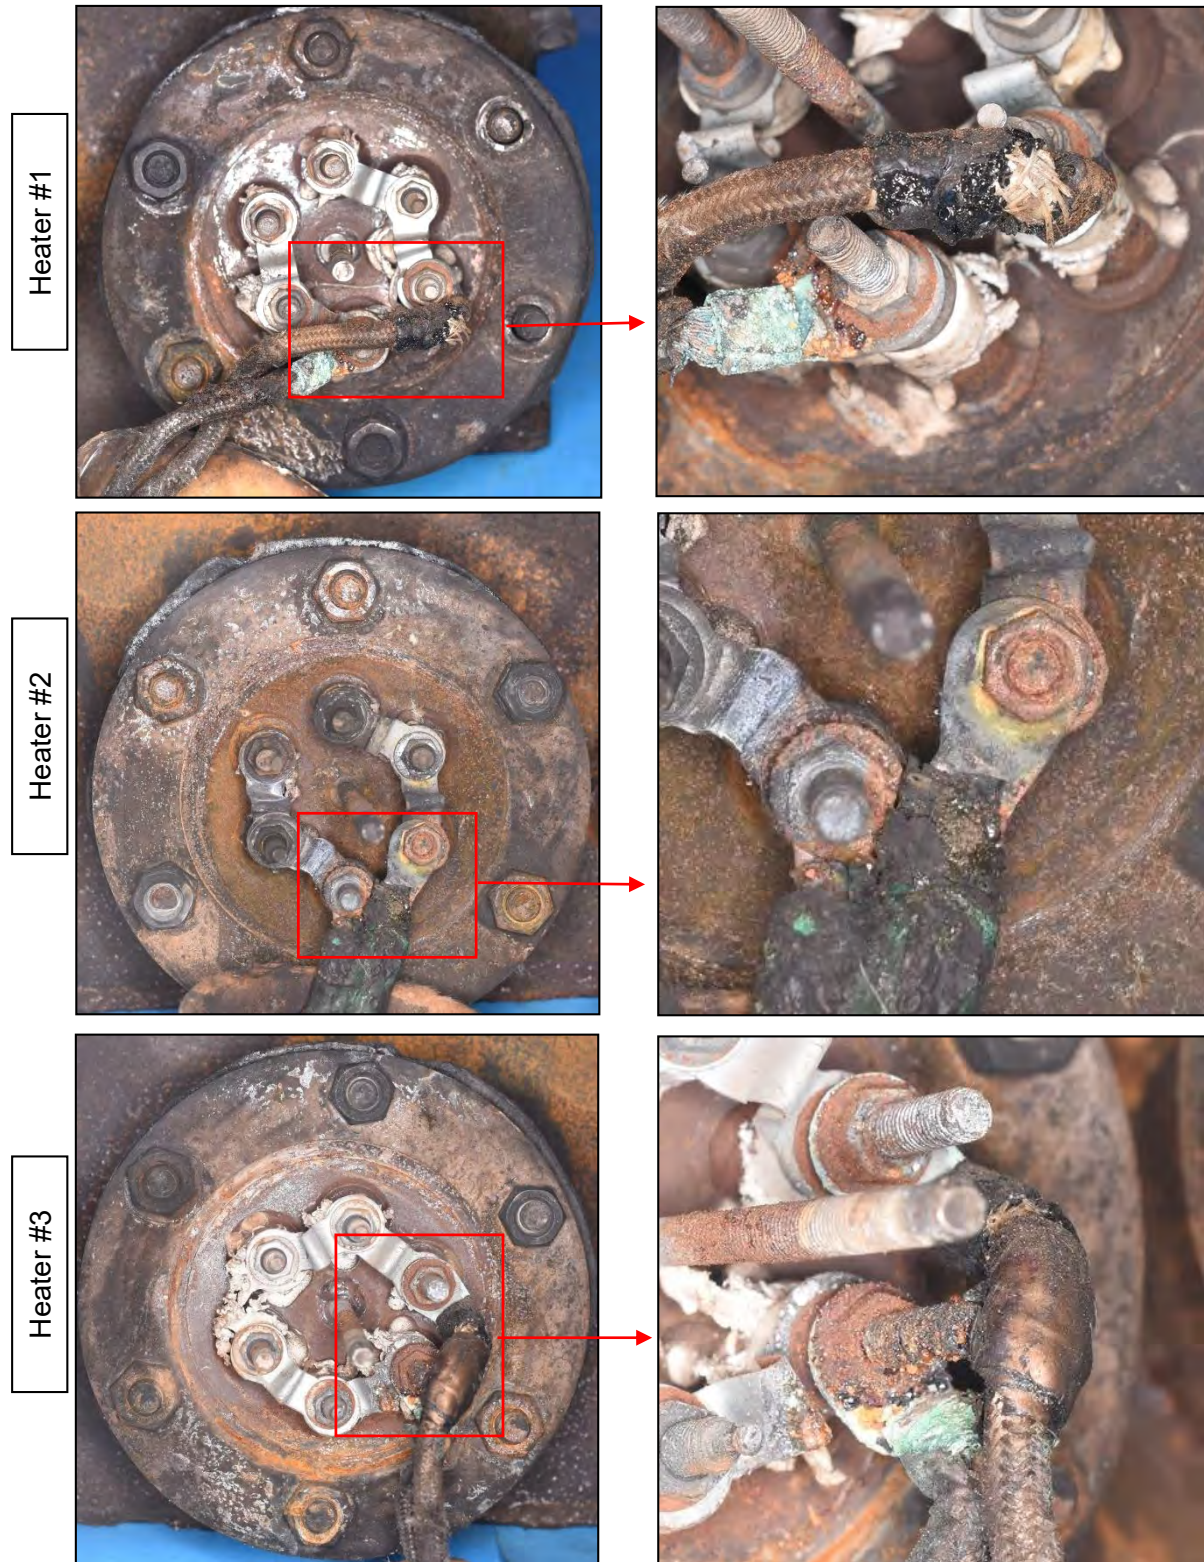
**Figure 78:** From top, heaters #1, #2 and #3, with close up view of their terminals.

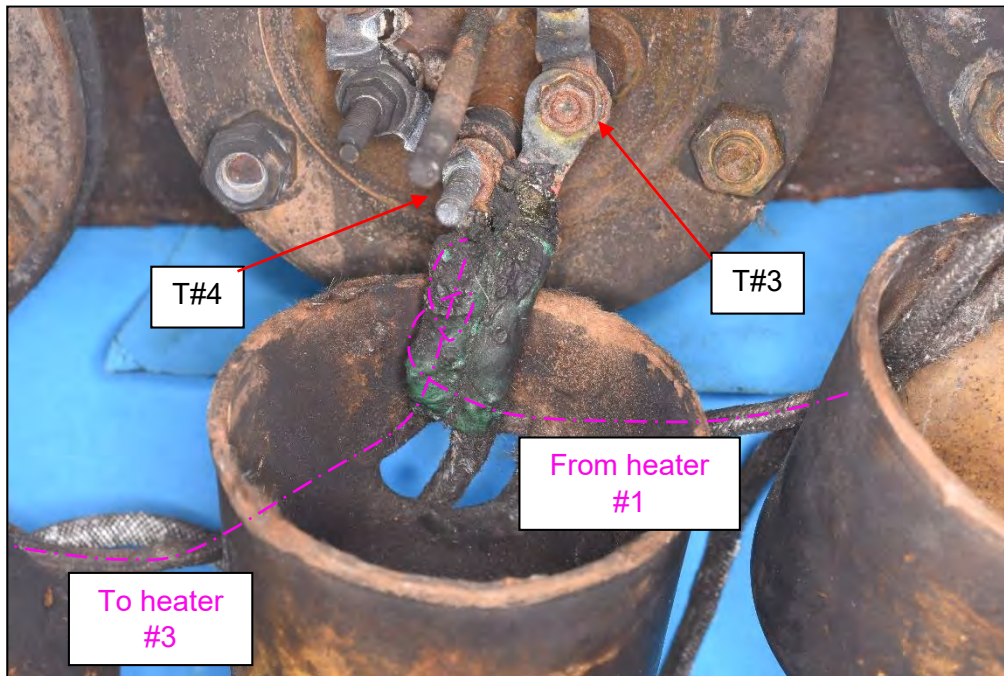
- 8 ➤ The terminals of heater #2 also had a blacker appearance compared to the terminals of the rest of the heaters (Figure 77).
- 10 ➤ Green tapes were observed wrapped around the wires of both terminal #3 and terminal #4 of heater #2. The tapes on each of the aforementioned wire, had likely melted and adhered together. The position of both wire lugs were close together. Beneath the green tape wrapped around the wires at terminal #4 was a yellow clip tab that bound the end of the wire from heater #1 to the wire to heater #3 (Figure 79 and Figure 80).

**Figure 79:** Green tapes were observed wrapped around the wires of both terminal #3 and terminal #4 of heater #2. The position of both wire lugs were close together.

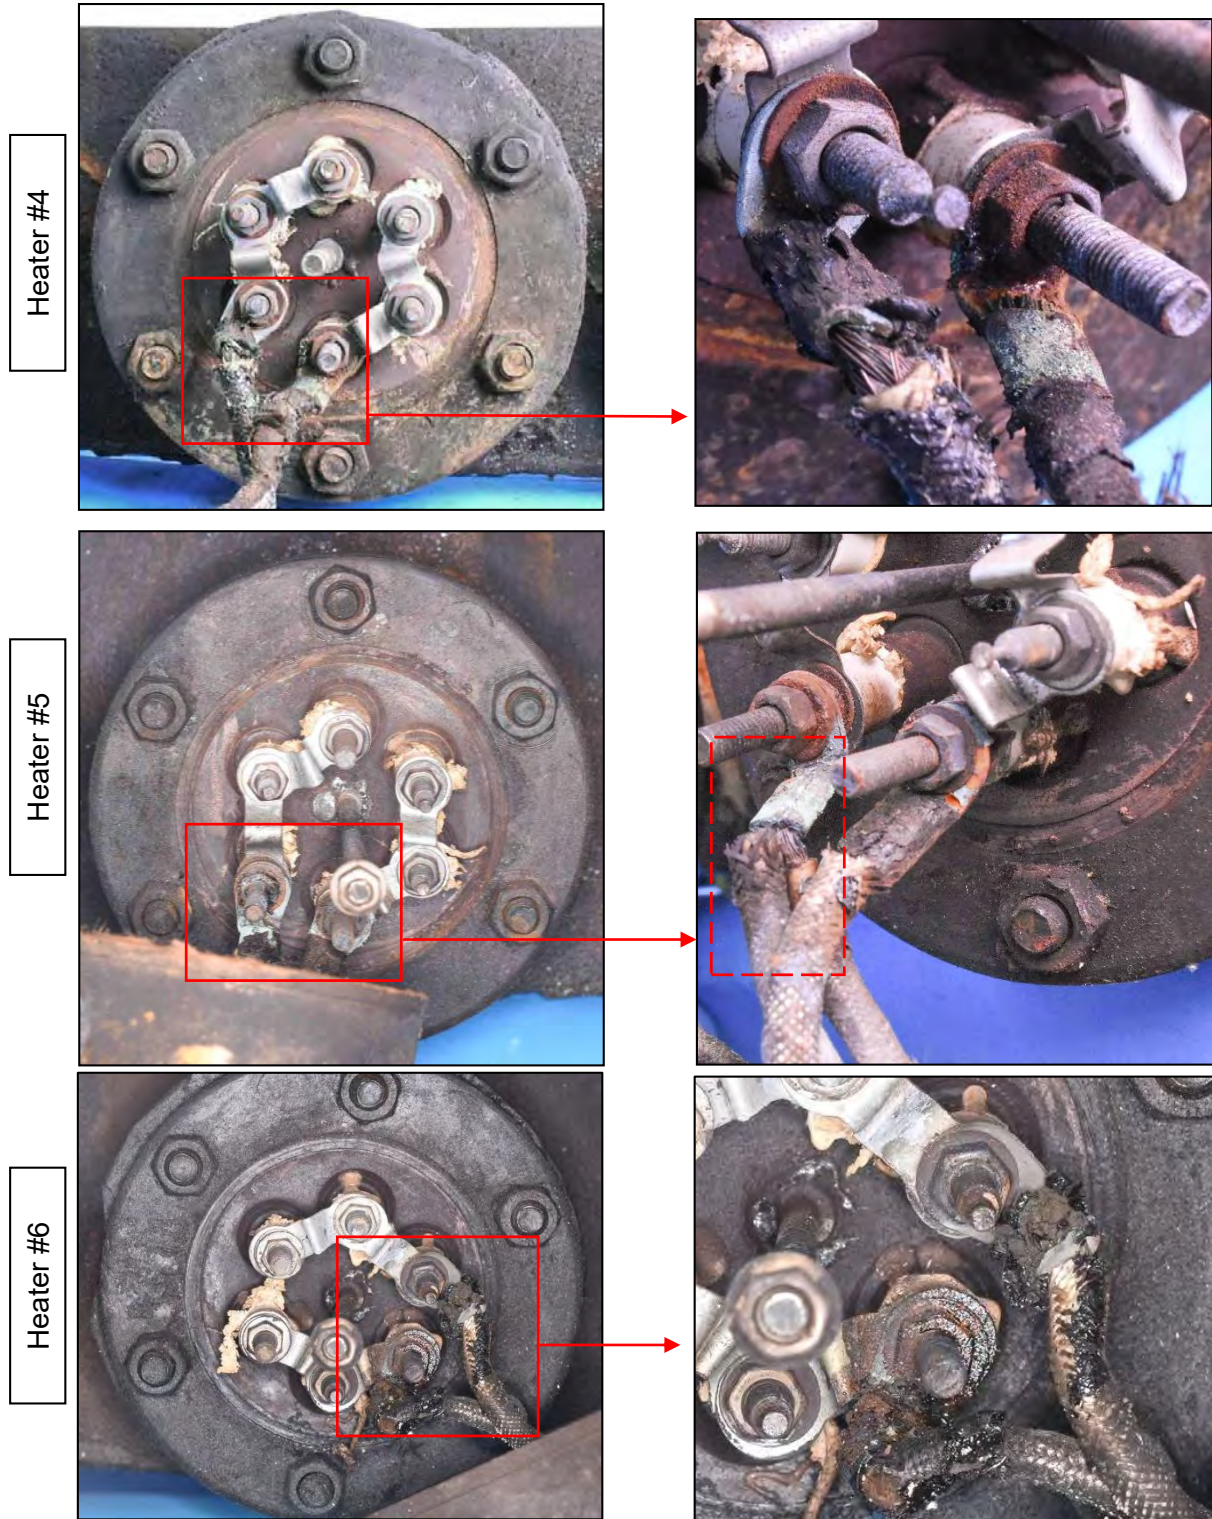
- 12 ➤ Taking heater #5 as reference for how the wires were connected to the lugs, the end of the wires from/to heater #4 and heater #6 were clamped together by a single lug (Figure 82).

**Figure 82:** From top, heaters #4, #5 and #6, with close up view of their terminals. For heater #5, the wires from/to heaters #4 and #6 were clamp together by the lug (see red dotted line).

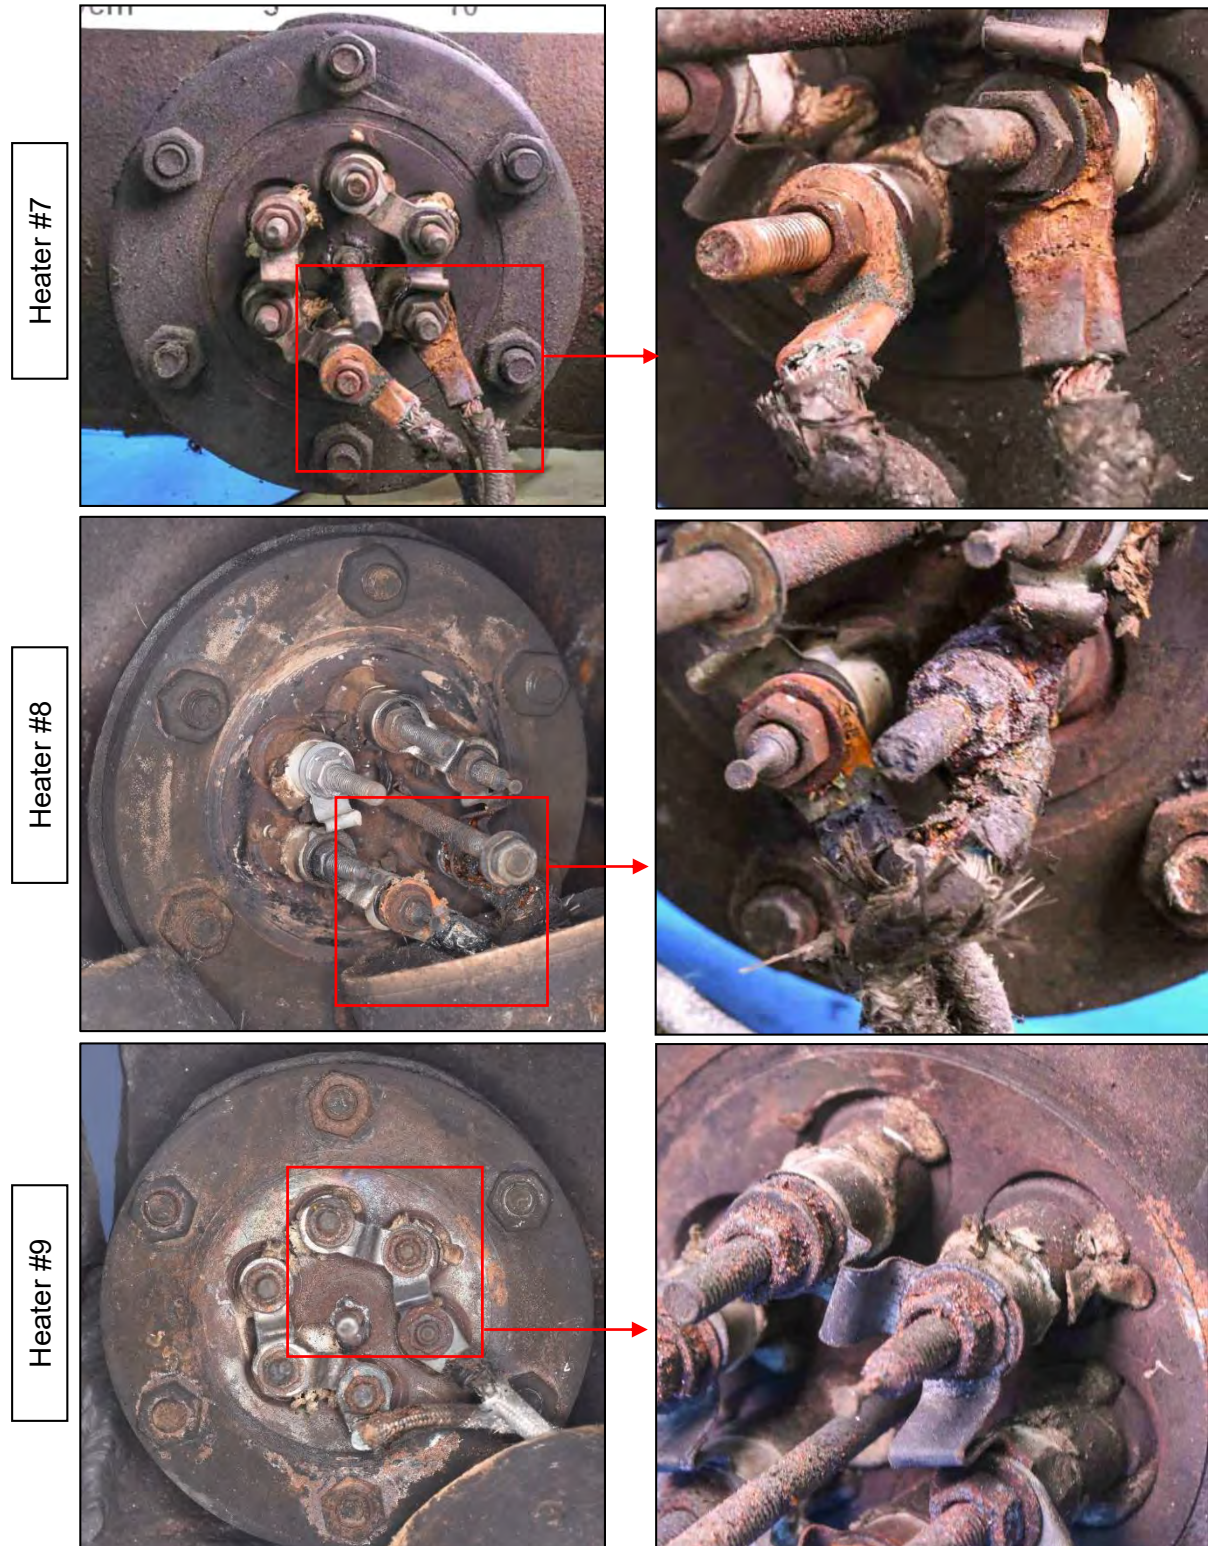
**Figure 84:** From top, heaters #7, #8 and #9, with close ups of their terminals.

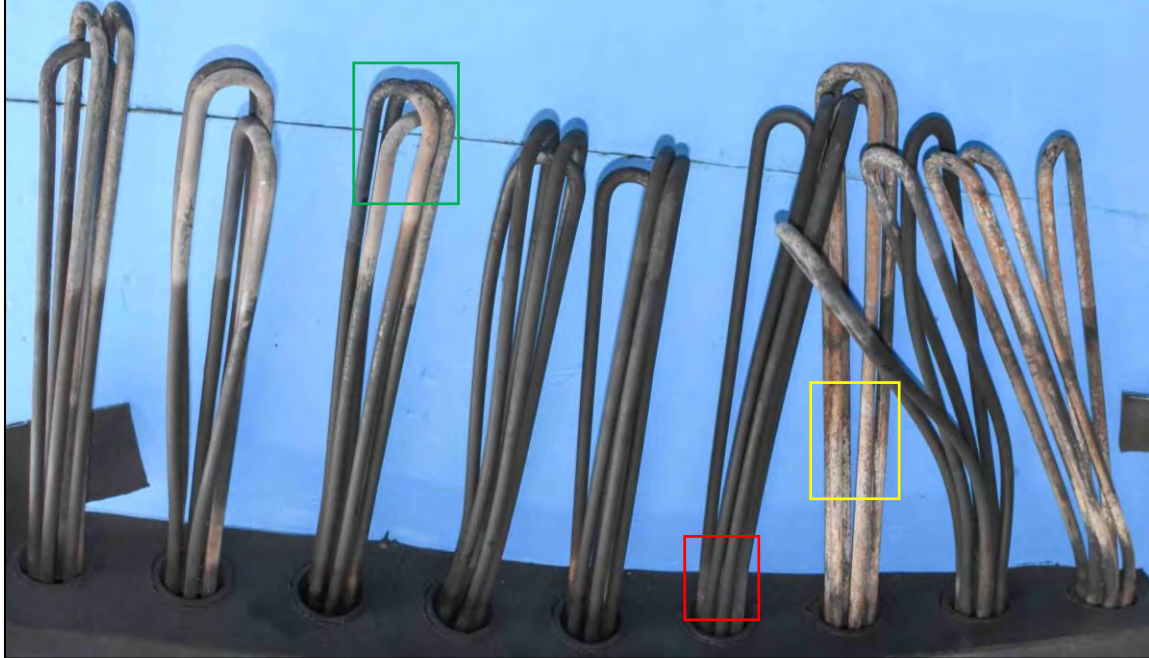
**Figure 85:** The heaters are sheathed-type heating elements (also known as Calrod™ heaters). The metal tubes of every heater sustained various degrees of deformation, which heaters #1 and #2 being most severe.

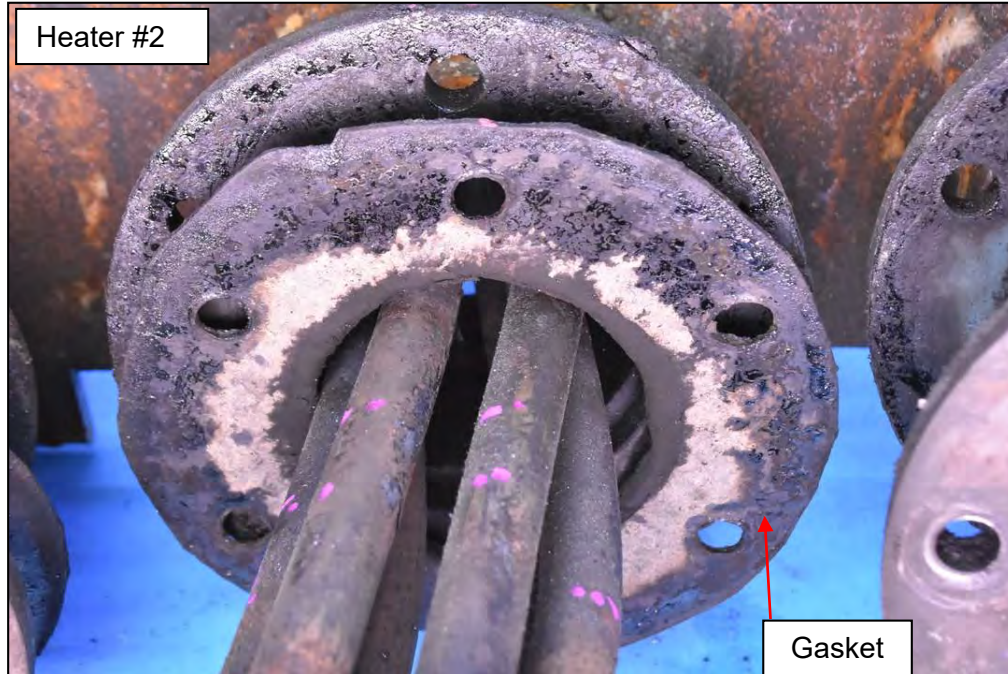
**Figure 87:** Due to the severe deformation, heaters #1, #2 and #3 cannot be removed without cutting the metal tubes. The gaskets were generally brittle with some parts still adhering to the flanges' surface.

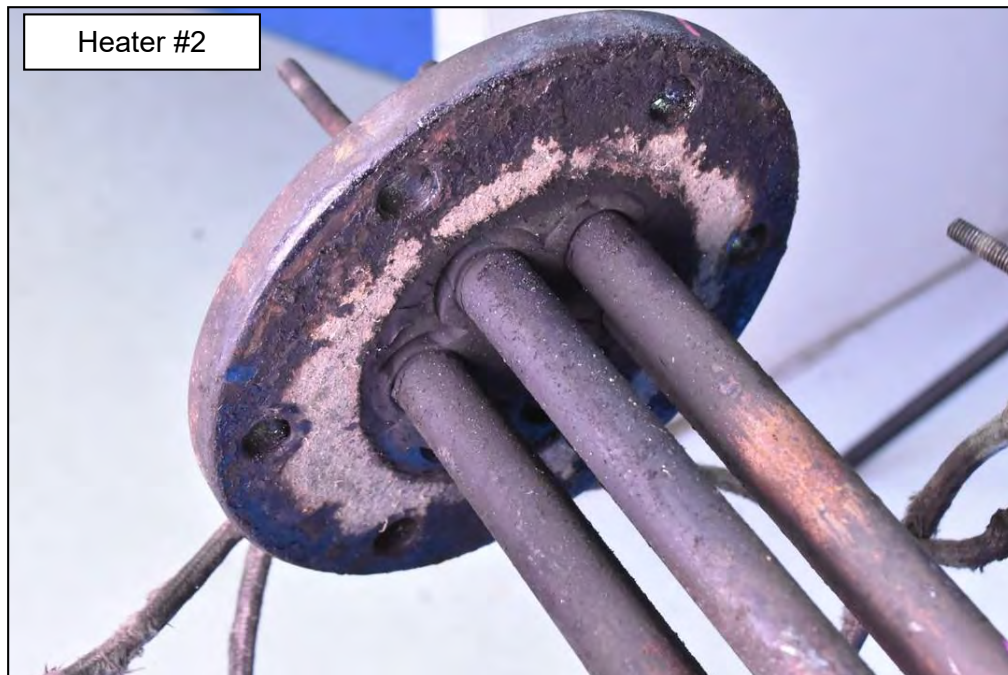
**Figure 88:** Heater flange condition from the side adhering to the gasket.

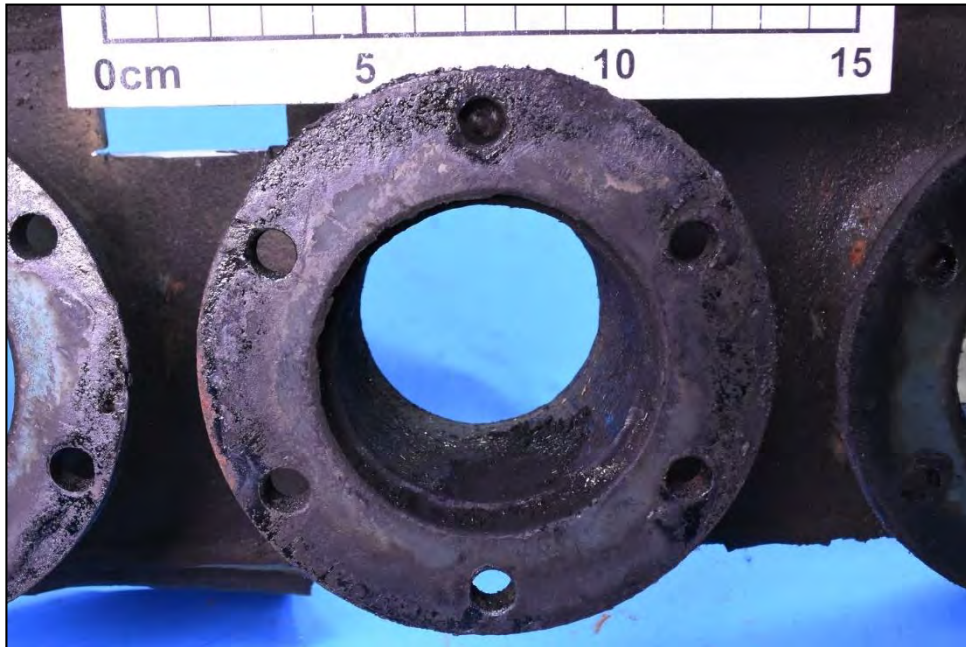
**Figure 89:** The rest of the heaters were removed, revealing generally similar flange condition. Oil residue were present inside.

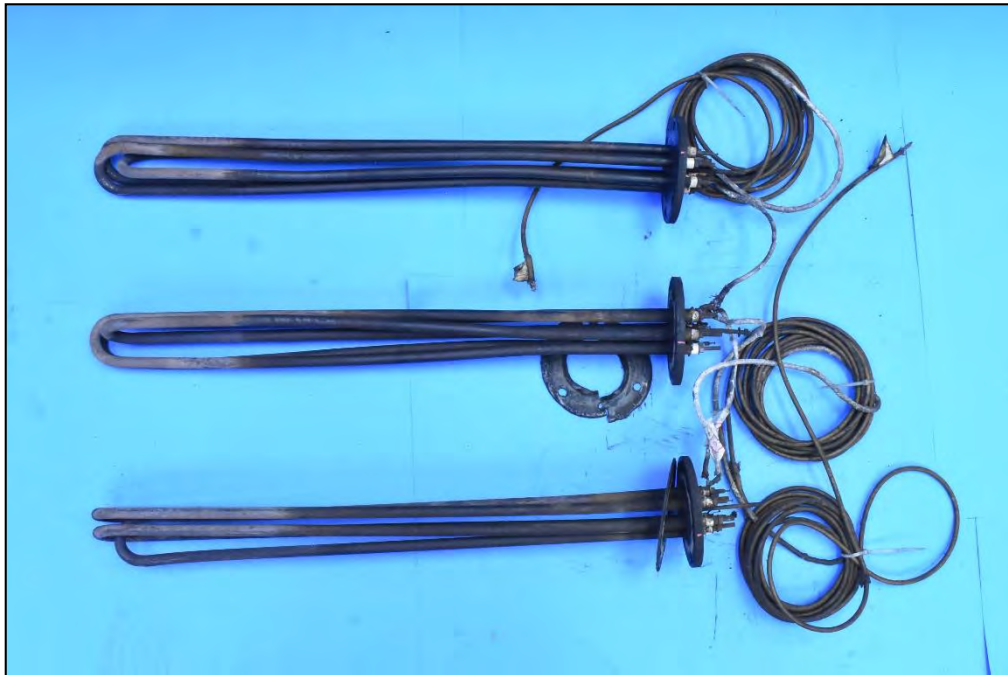
- 14 ➤ Signs of corrosion and peeling of coating were observed at various parts of the metal tubes (Figure 86).
- 16 ➤ All the gaskets had degraded and were generally brittle to the point where they broke with slight pressure (Figure 87 and Figure 90).

**Figure 90:** All the gaskets had degraded and were generally brittle to the point where they broke with slight pressure. Some broke during the removal of heaters.

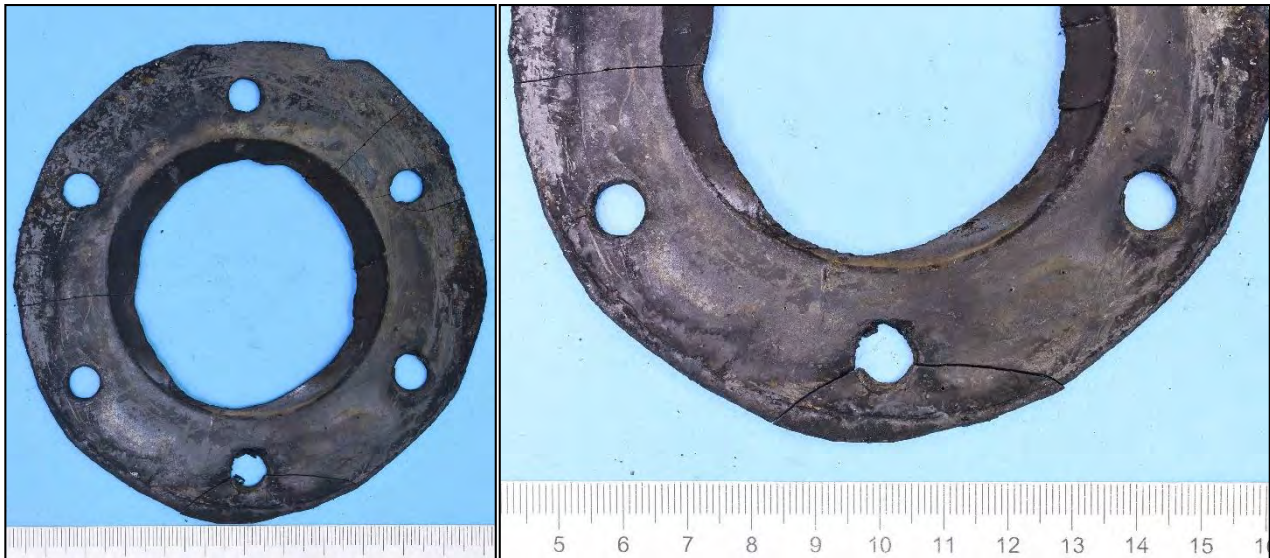
**Figure 91:** General view of gasket for heater #2. Some parts were broken during the shore hardness testing.

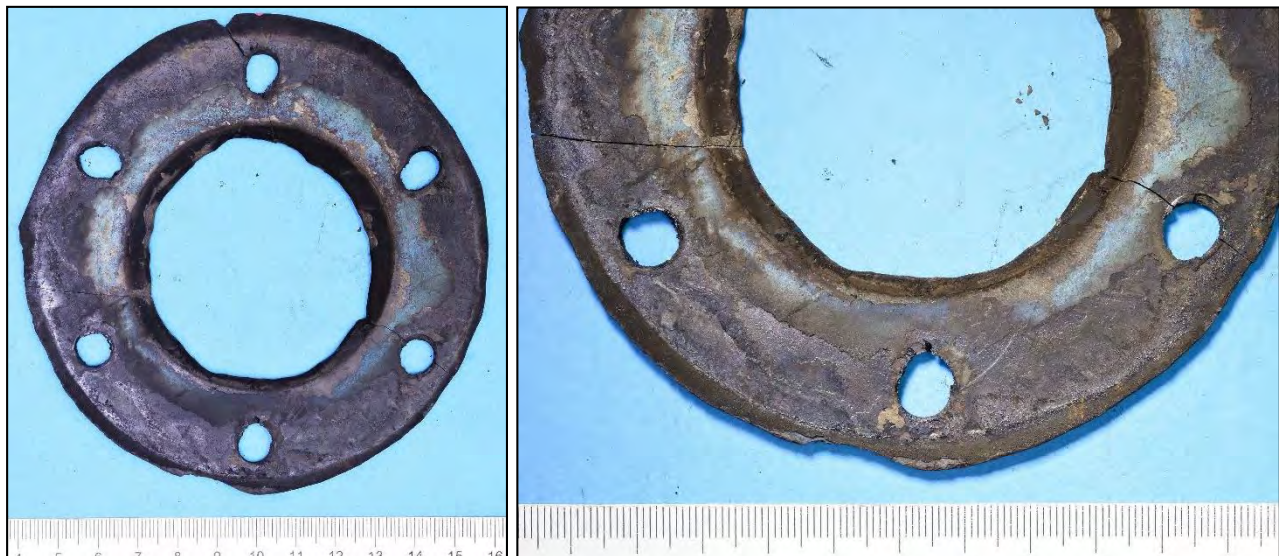
**Figure 92:** For comparison, gasket for heater #9 which was located furthest from the main rupture zone and heater #2, was selected to undergo shore hardness testing. Similarly, parts of it were broken during the testing.

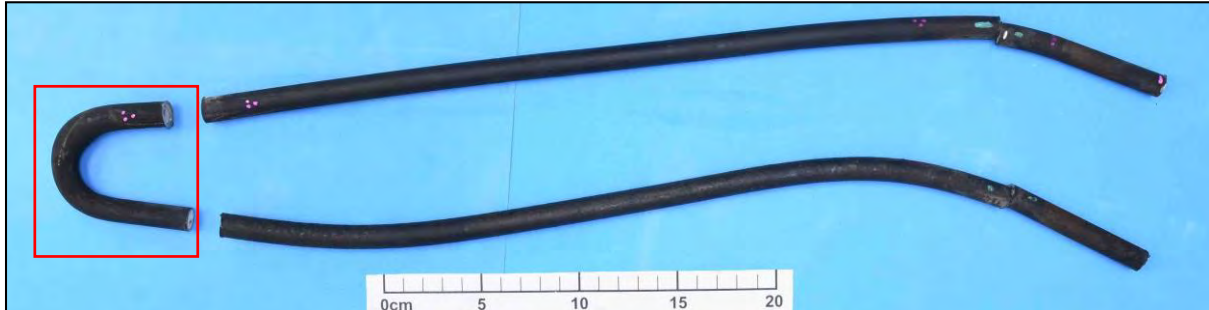
**Figure 93:** The LEW reported that heater #2 had unusual high resistance among the coils. With that reporting, the metal tubes were examined and the tube between terminals #3 and #6 were found to have a bulged area.

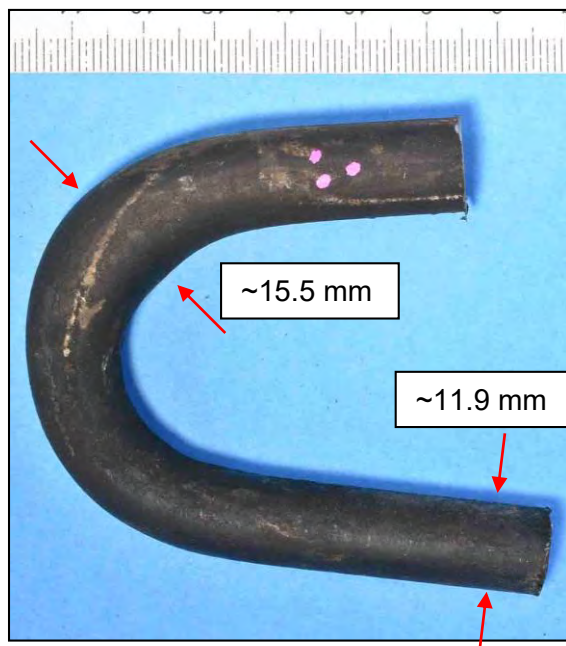
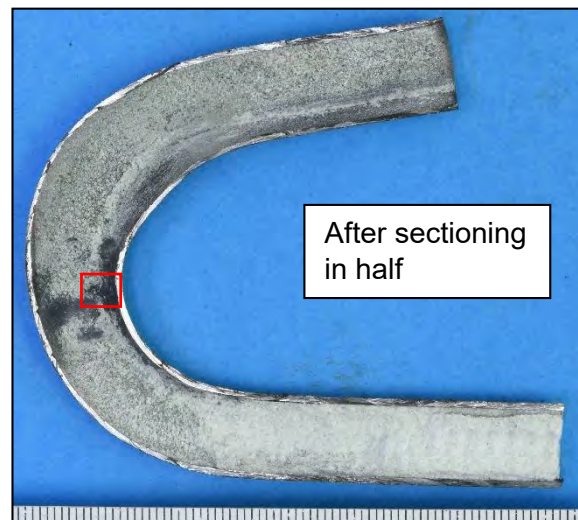
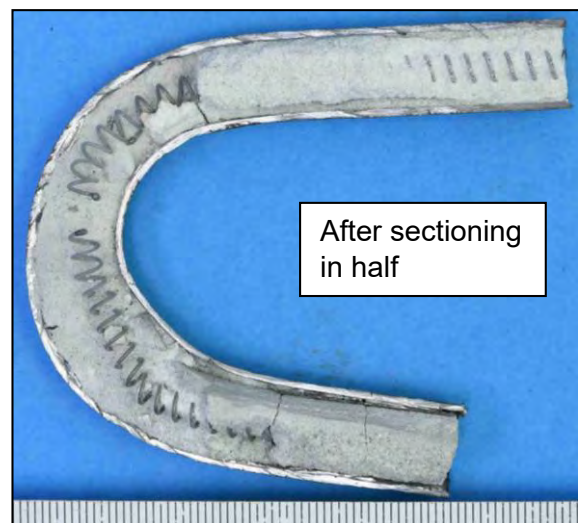
- 18 ➤ The LEW reported that heater #2 had an unusually high resistance among the coils.<sup>5</sup> Examination revealed that the metal tube between terminals #3 and #6 had a bulging area of about 15.5 mm diameter (the normal diameter of the metal tube is 11.9 mm) (Figure 93 and Figure 94).

**Figure 94:** The normal outer diameter was approximately 11.9 mm while the bulged area had a maximum outer diameter of about 15.5 mm. The area was sectioned in half to reveal the internal condition. The resistance wire inside had separated and the surrounding insulation powder were very loose.

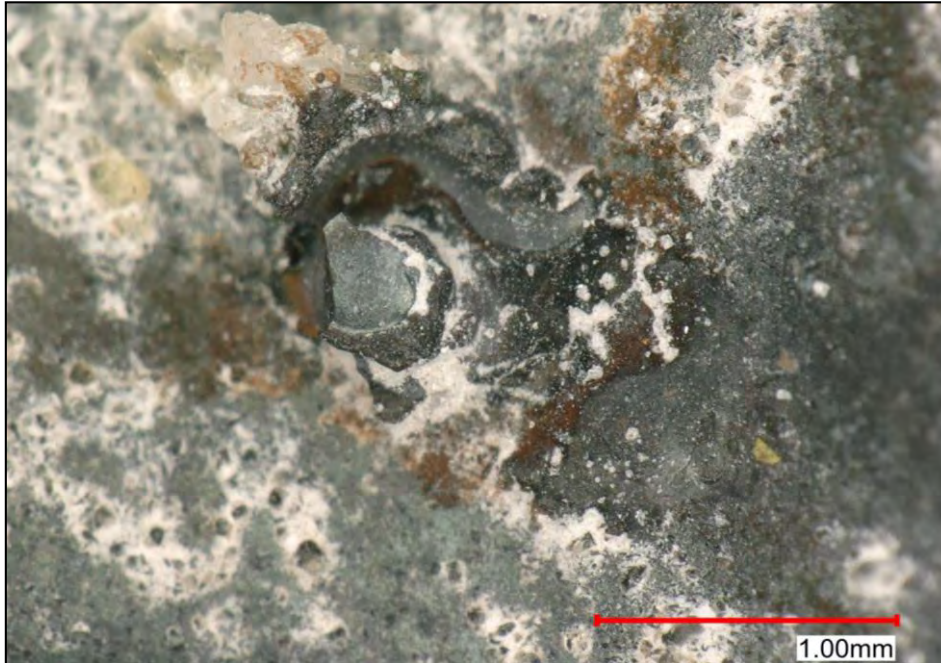
**Figure 95:** At the metal tube inner diameter wall corresponding to the location of the separated wire, a small melted bulb was observed adhering to the wall. .

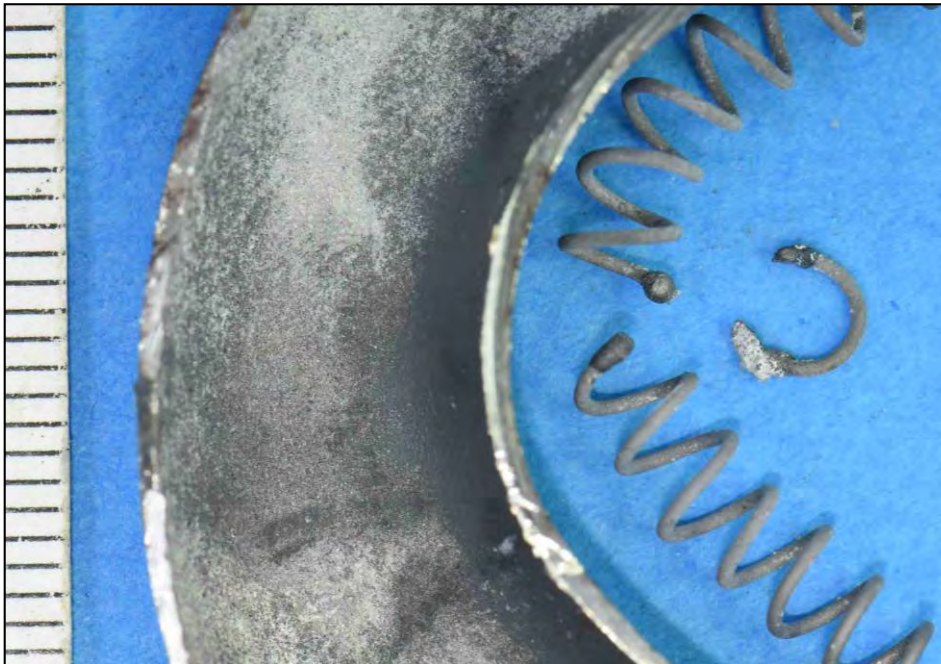
- 20 ➤ The resistance wire inside the metal tube between terminals #3 and #6 had separated by melting and the surrounding insulation powder was very loose (Figure 96). There was a small melted bulb adhering to the inner wall of the metal tube at this location (Figure 95). This suggested that the unusually high resistance in heater #2 was caused by damaged resistance wire.

**Figure 96:** The tips of the wire had melted with some of the insulation powder fused onto the tip.

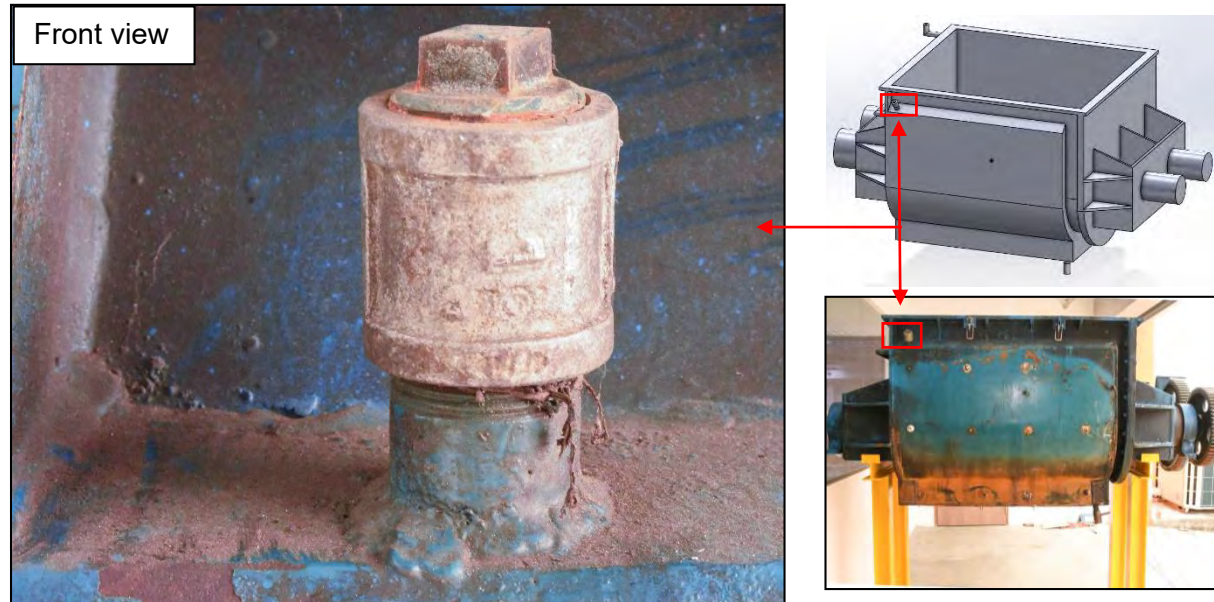
- 34 ➤ Both access and vent ports were plugged by square head plugs. Along with the closed drain port, all three of the oil jacket openings were closed (Figure 97 and Figure 98).
- 36 ➤ The oil funnel was not in use and was found at the ground floor of the Factory during the retrieval of the Mixer Machine onsite (Figure 99).
- 38

**Figure 97:** The access port had been plugged by a square head plug.

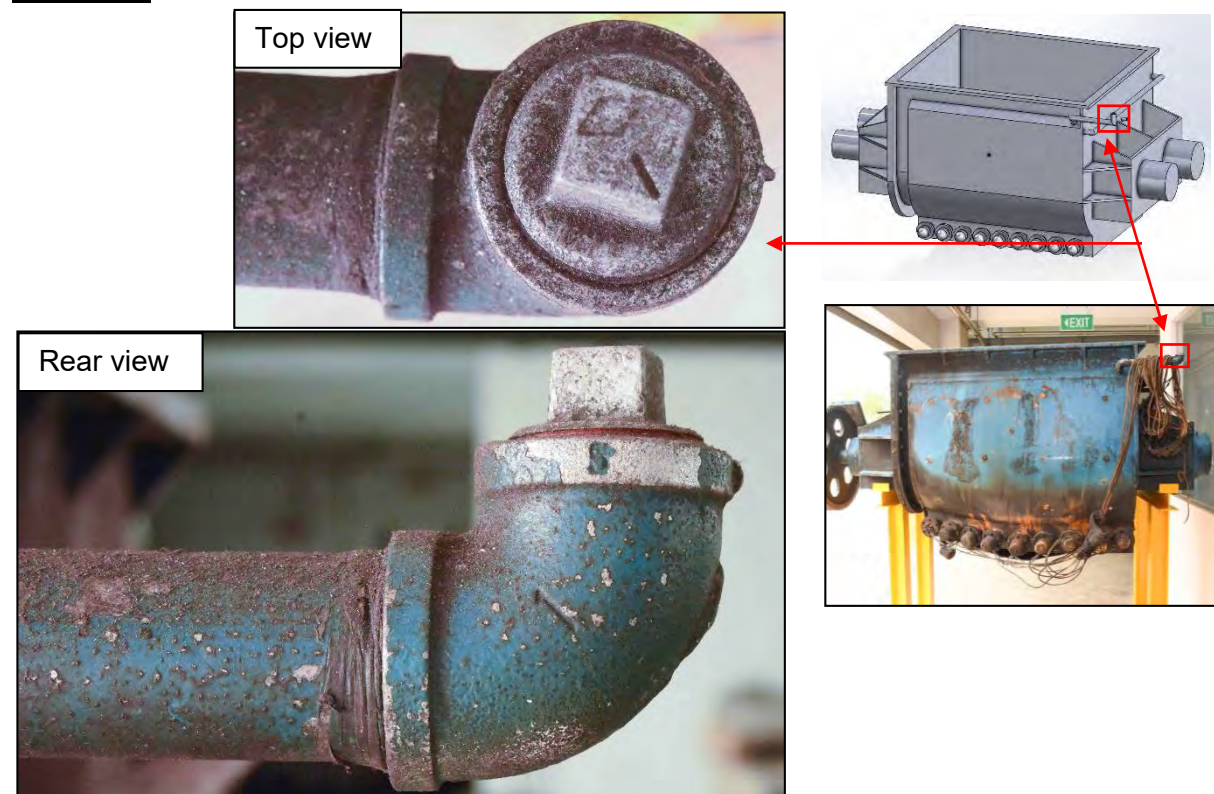
**Figure 98:** The vent port was also plugged by a square head plug.
