# **Report of the Inquiry Committee for the accident at Stars Engrg Pte Ltd on 24 February 2021**

**(PART II – ANNEXES)**

| Report No:<br><b>M21091</b> | Subject Group:<br><b>11219</b> | Date:<br><b>10<sup>th</sup> September 2021</b> |
| Title of Report:<br><b>Failure Analysis of a Failed Mixer Machine Retrieved from Unit 32E of Platinum @ Pioneer Building involved in a Fire Explosion Incident</b> | | Date of Last Revision/Revision No: |

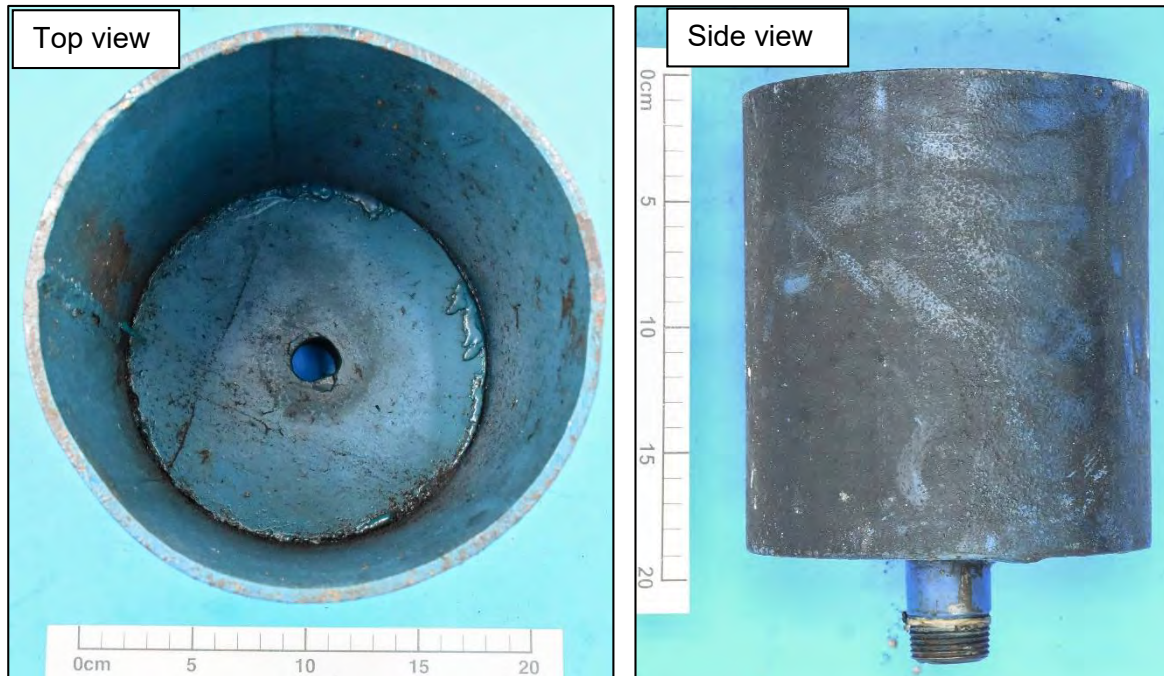
**Figure 99:** The oil funnel was not in use and was found at the ground floor of the Factory during the retrieval of the Mixer Machine onsite.

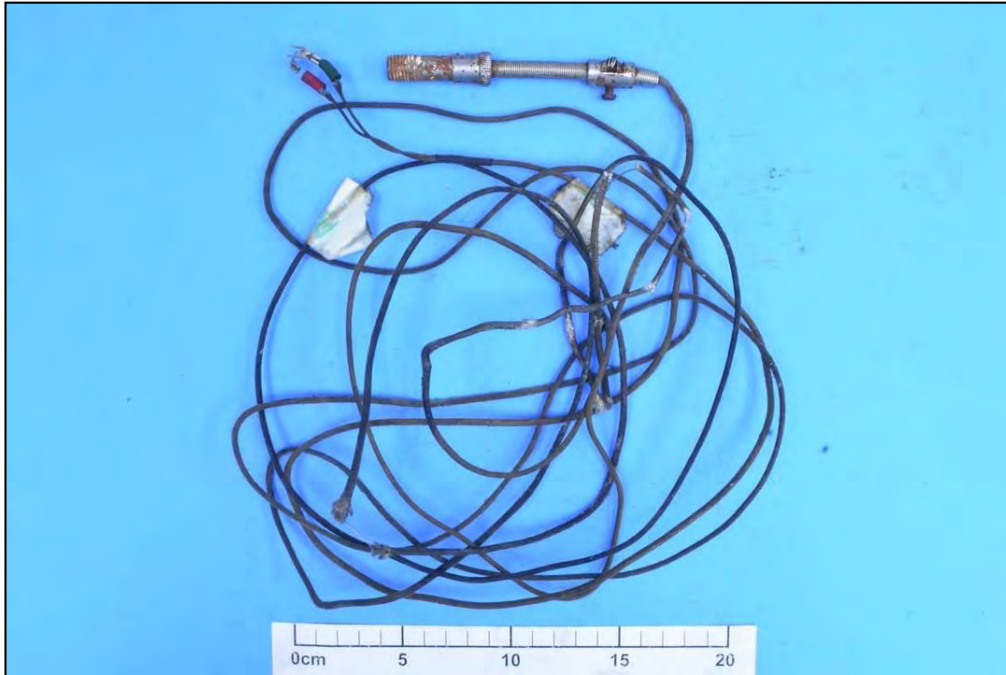
14 ➤ For RTD A, the sensor end was found inside the mixing chamber while the wire  
was still connected to the electrical panel (Figure 100 and Figure 101). RTD A  
16 was still intact, with the sensor in working condition.<sup>6</sup> The wire connectors (red  
and green) were still intact, which was originally connected to the “Jacket temp”  
thermostat (see Figure 107 and Figure 108).

**Figure 100:** RTD A retrieved onsite.

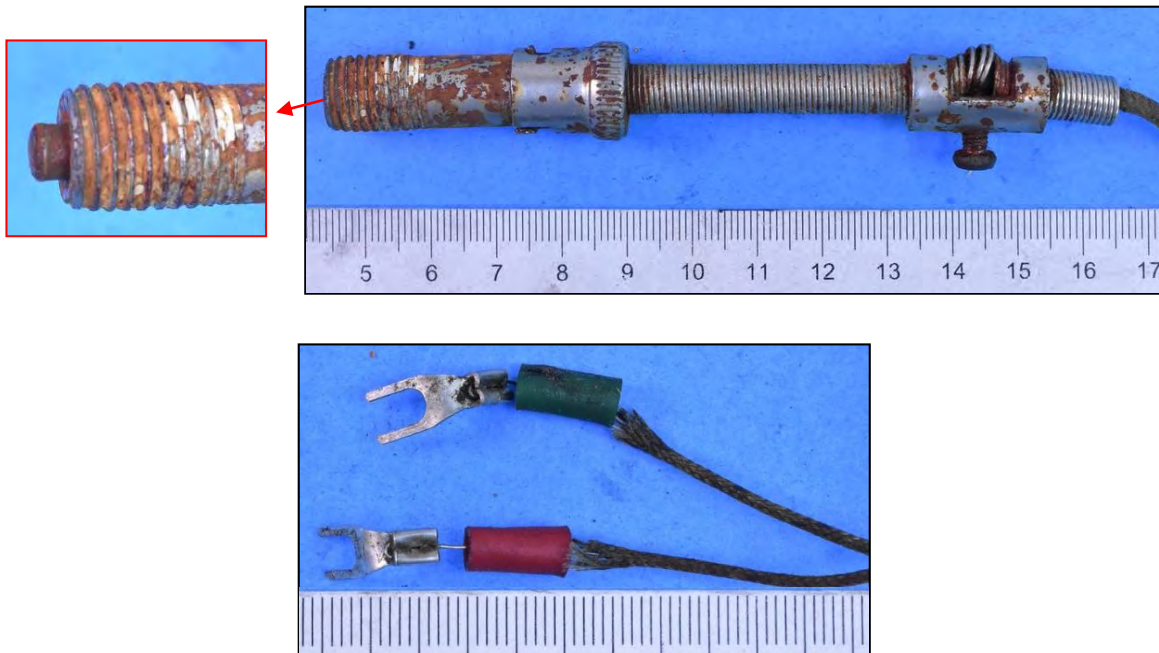
**Figure 101:** The RTD was still intact with the sensor. The wire connectors (red and green) were still intact, which was originally connected to the “Jacket temp” thermostat. See Figure 107.

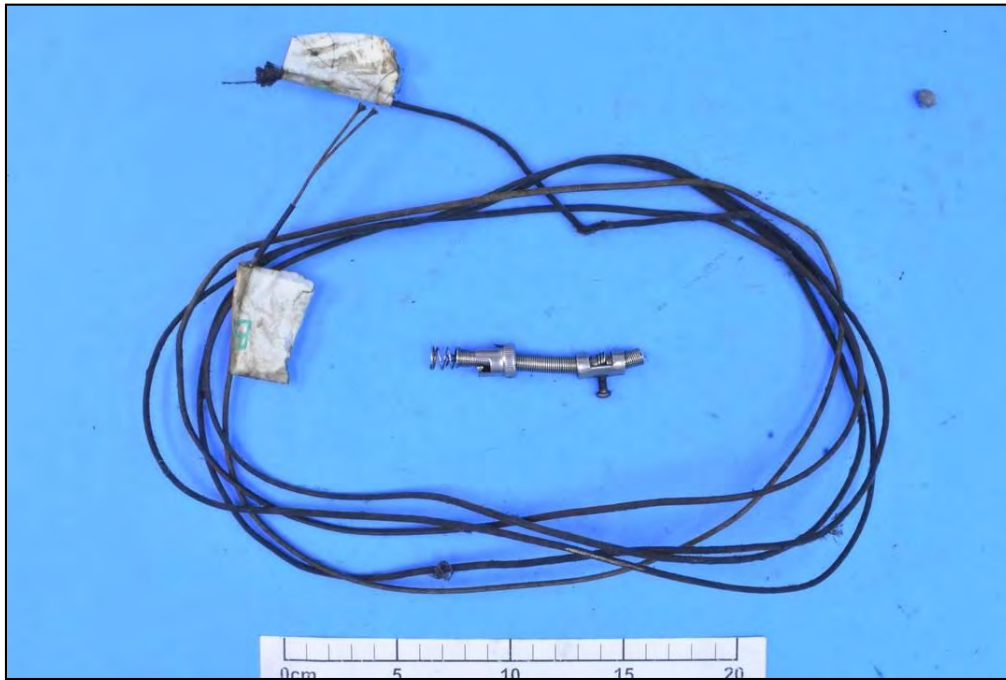
**Figure 102:** RTD B remnants retrieved onsite. Although this RTD was not attached to the electrical panel during the onsite inspection, the wires were originally connected to the “Material temp” thermostat as the connectors were still in place inside the panel. See Figure 107.

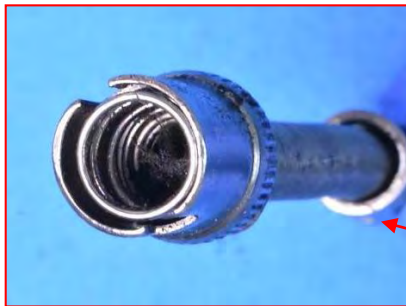
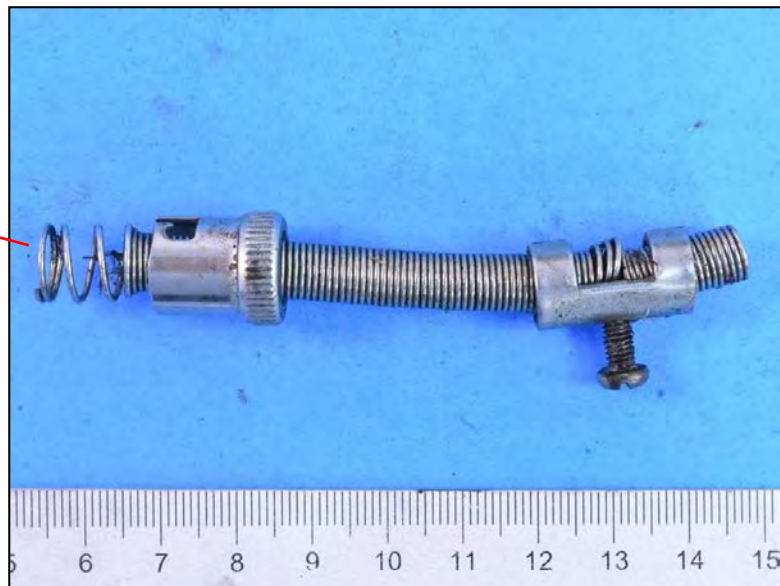
**Figure 103:** There was no sensor inside the holder.

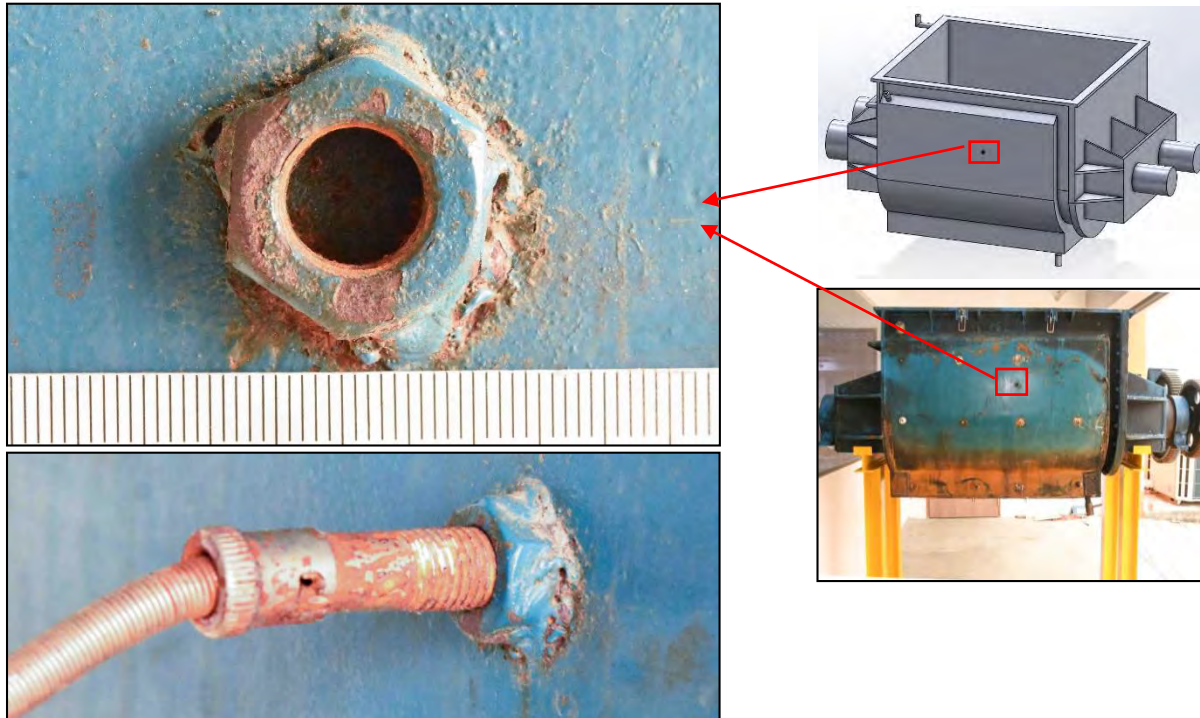
**Figure 104:** Close up view of the fixture intended for the RTD placement at the front side of the oil jacket. The fixture allows the sensor to reach the external surface of the oil jacket wall.

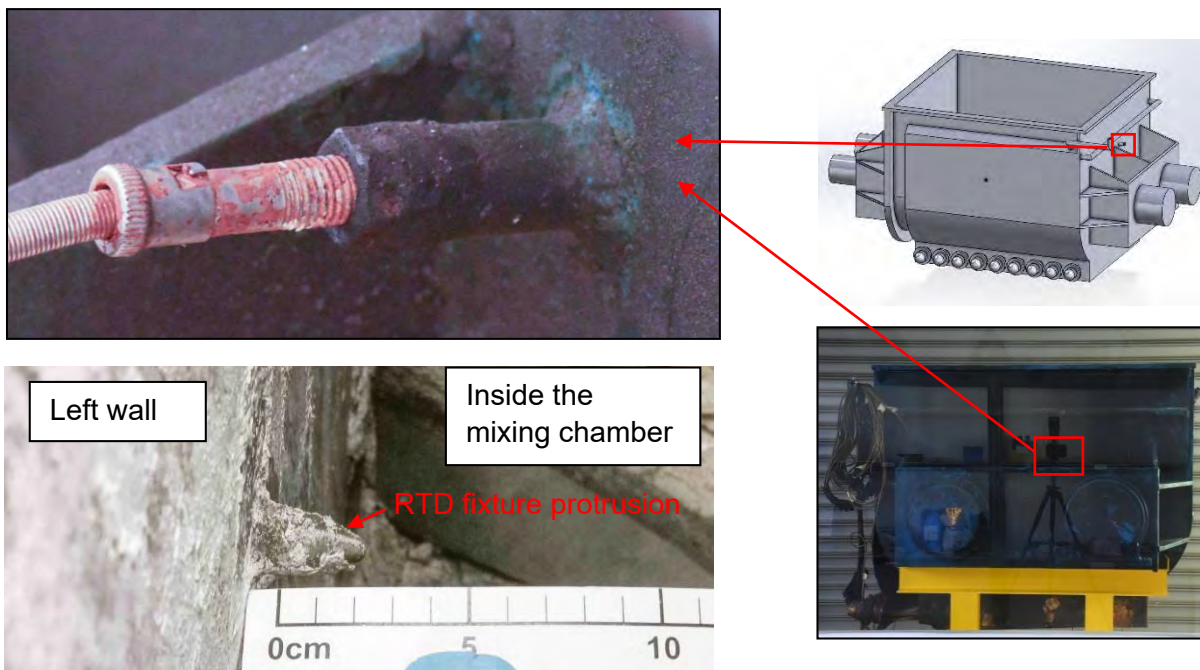
**Figure 105:** Close up view of the fixture intended for the RTD placement at the side of Mixer Machine nearest to the Platform stairs. This left wall is the wall containing the mixing material. The fixture slightly protruded into the wall thickness.

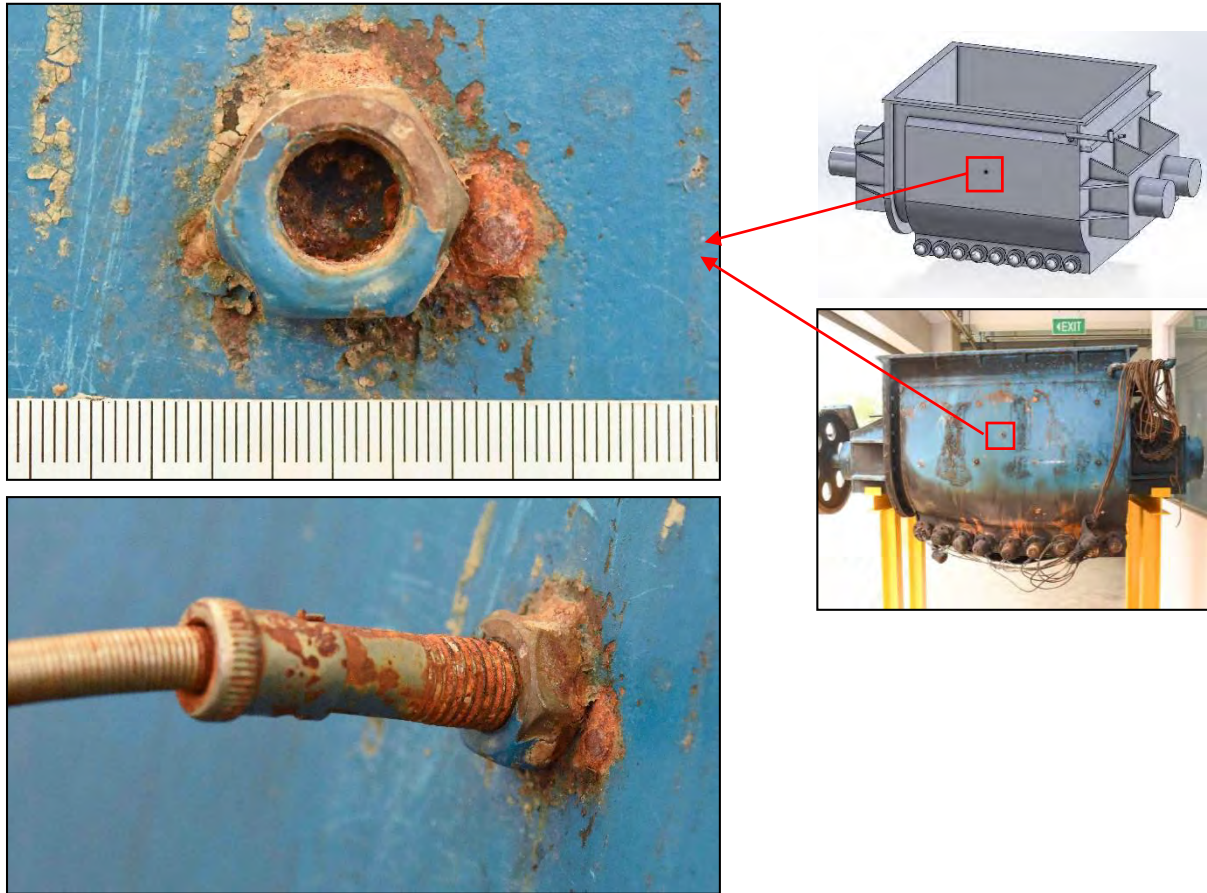
**Figure 106:** Close up view of the fixture intended for the RTD placement at the rear side of the oil jacket. The fixture allows the sensor to reach the external surface of the oil jacket wall.

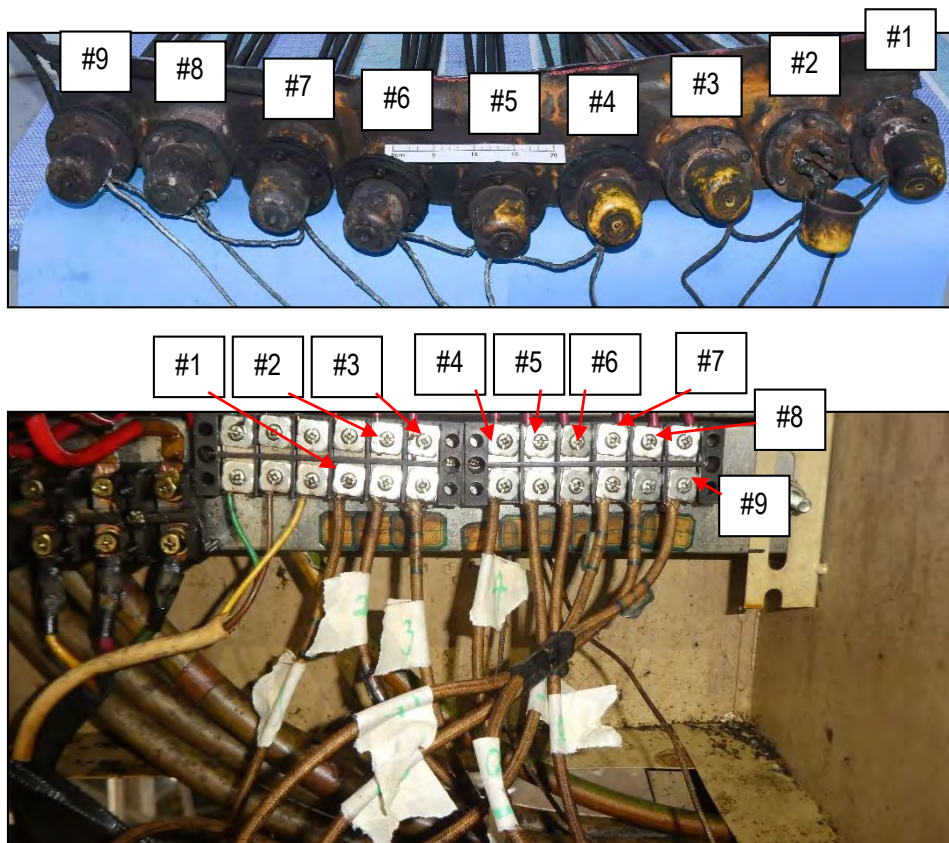
40 ➤ The wires inside the electrical panel were generally intact before the removal  
of the Mixer Machine to Matcor's laboratory (Figure 110).

**Figure 110:** □ The wires inside the electrical panel were generally intact before the removal of the Mixer Machine to Matcor's laboratory.

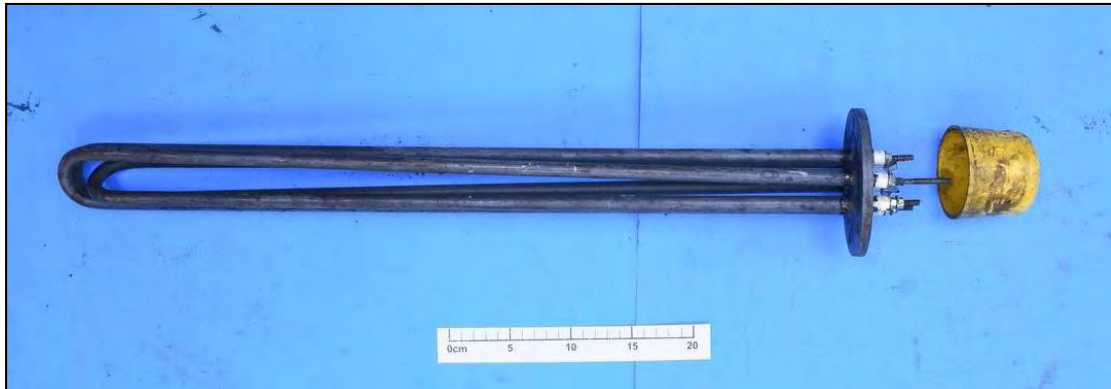
44 ➤ The heater found on the Platform beside the Mixer Machine had no significant  
damage or sign of usage observed, therefore the heater was most likely a new  
46 heater (Figure 111).

**Figure 111:** Heater found on the Platform beside the Mixer Machine. No significant damage was observed.

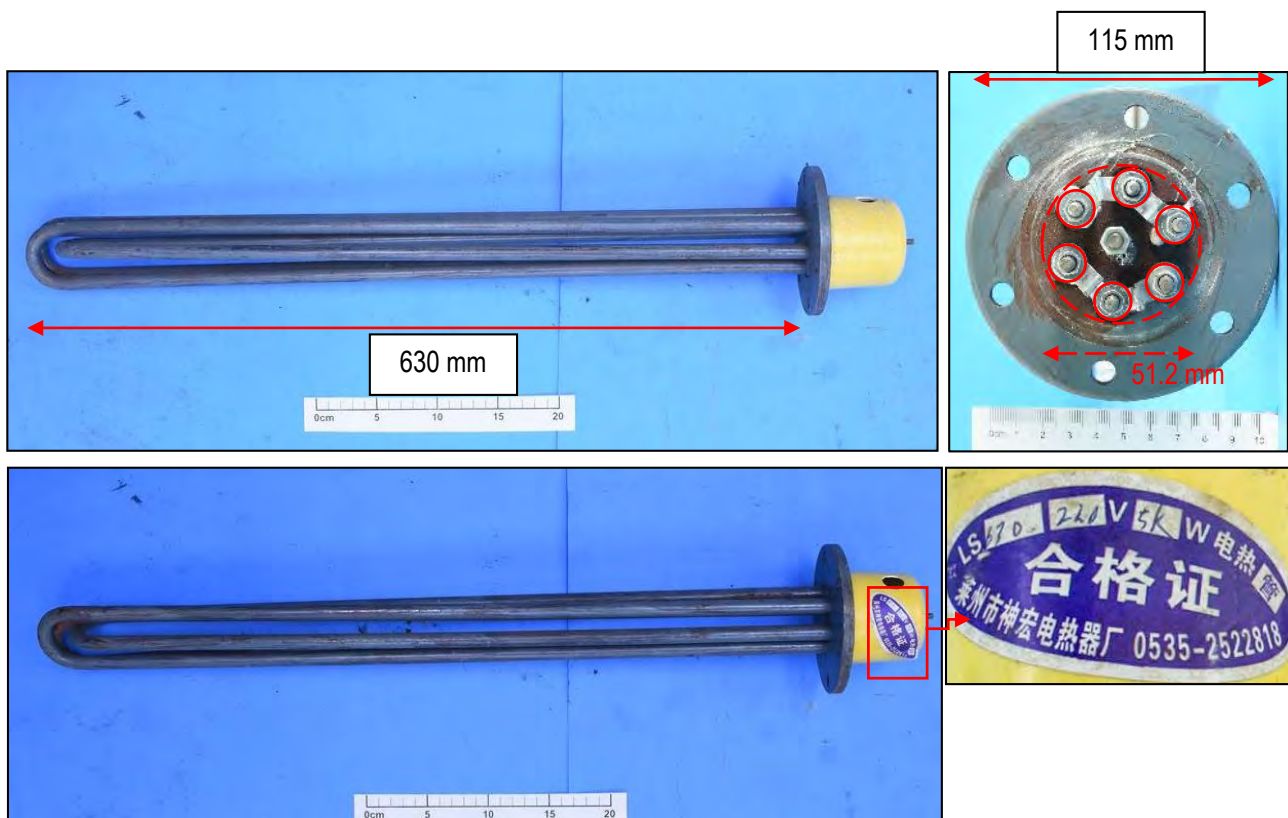
4 ➤ Two new heaters retrieved from storeroom on the second level of 32E Tuas  
6 Avenue 11 were used as reference. These two new heaters had labels on their  
terminal covers, indicating that the heaters were designed with specifications  
of 220V and 5kW (Figure 112).

8 ➤ The measured length of the heater coils was about 630 mm, the outer perimeter  
10 (circular) of the coils was about 51.2 mm and the flange's outer diameter was  
about 115 mm (Figure 112).

**Figure 112:** Two new heaters retrieved from storeroom on the second level of 32E Tuas Avenue 11 were used as reference. The measured length of the heater coils was about 630 mm, the outer perimeter (circular) of the coils was about 51.2 mm and the flange's outer diameter was about 115 mm. The label indicated that the heaters were designed with specifications of 220V and 5kW.

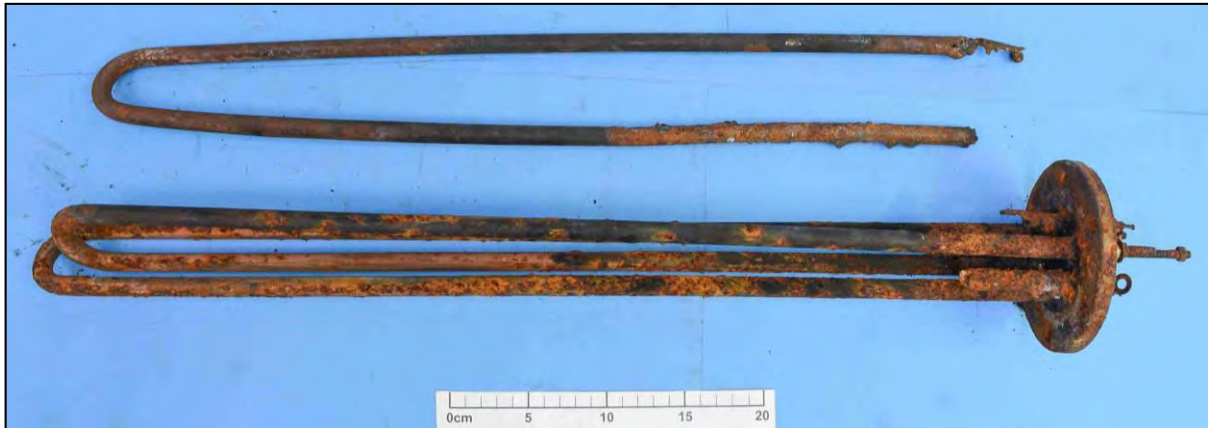
12 ➤ The used/failed heater received for analysis on 28th May 2021 was reportedly  
replaced in August 2020 after failing (Figure 113). One of the coils had broken  
14 off. The metal tube had deformed and melted off around the breakage location  
as evidenced by the bulbous and droplet-like shape of the metal (Figure 114).  
16 This was an indication of high temperature experienced by the metal tube,  
leading to localised melting of tube.

**Figure 113:** Used heater that were replaced after failure (received for analysis on 28th May 2021). This heater was reportedly replaced in August 2020 after it failed.

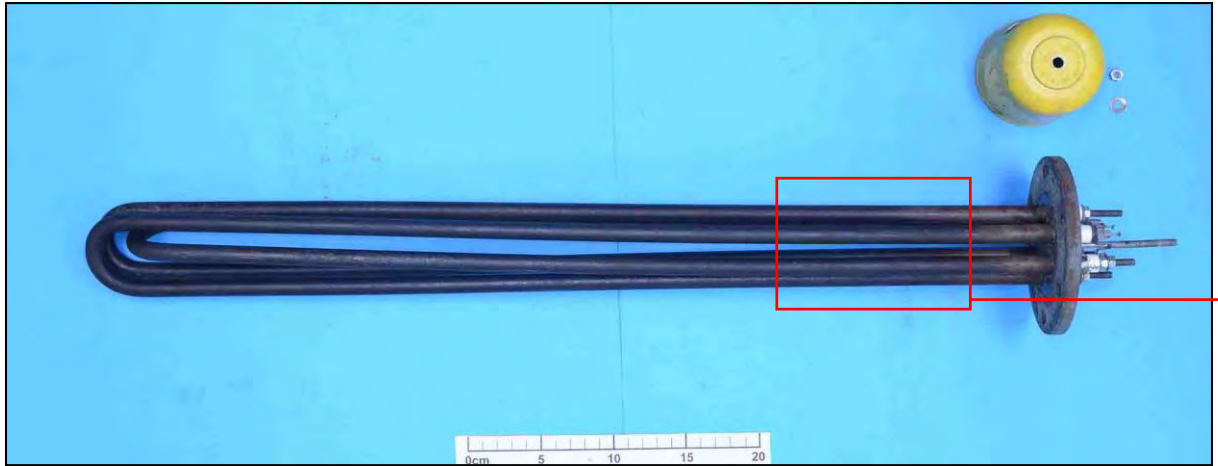
18 ➤ The other heater was received for analysis on 1st June 2021 (Figure 115 and  
Figure 116). The metal tubes had black appearance similar to the heaters inside  
the Mixer Machine. Several blisters of up to about 5 mm were also observed on  
20 the metal tubes. These observations suggested that this heater had been used  
before (see also Chapter 4.5.3 for metallographic examination findings). There  
22 was no information provided on when and why this heater was replaced.

**Figure 115:** A heater that was used and replaced (received for analysis on 1st June 2021). Not much information was provided about this heater.

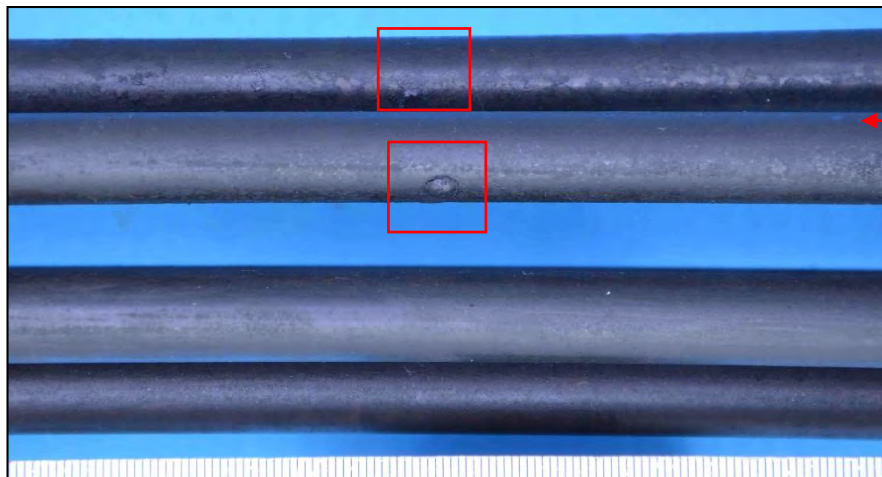
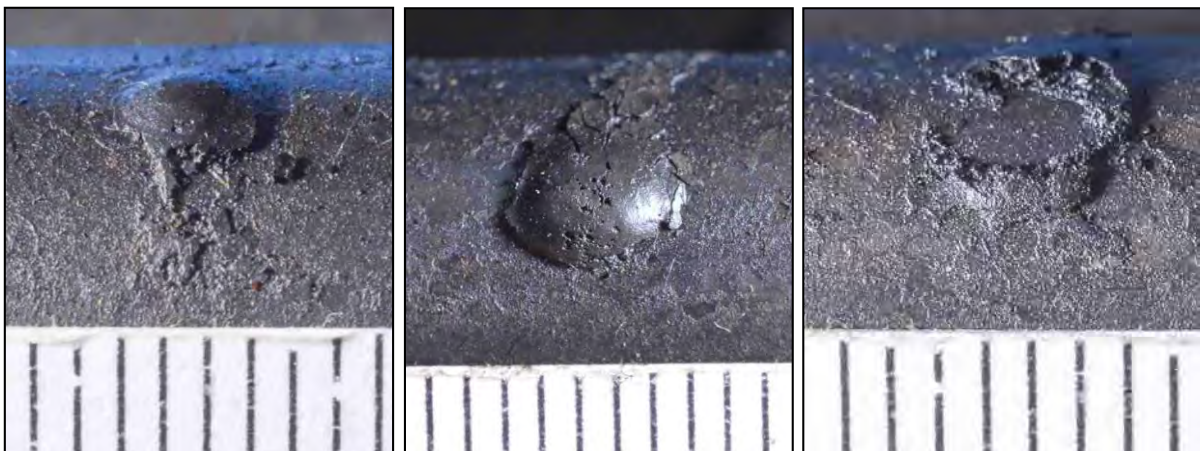
**Figure 116:** Several blisters of up to about 5 mm were observed on the metal tubes.

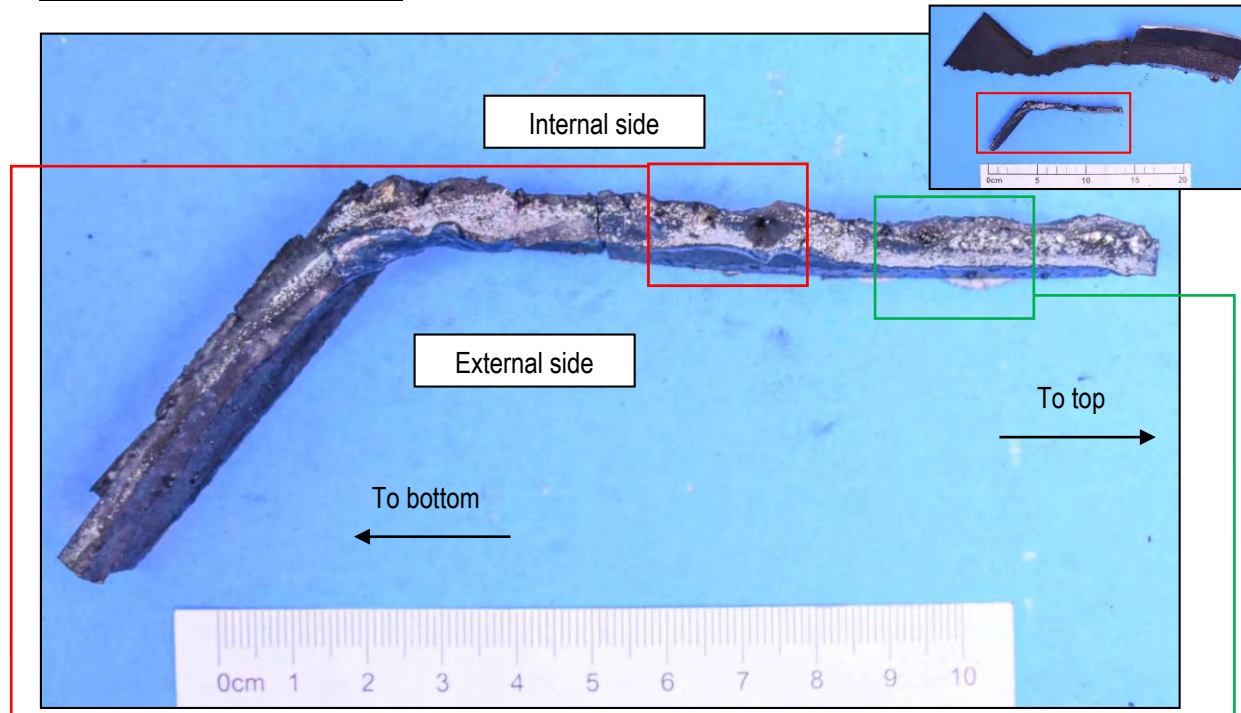
**Figure 119:** Fracture surface after cleaning in an ultrasonic bath of Alconox solution and subjected to SEM examination.

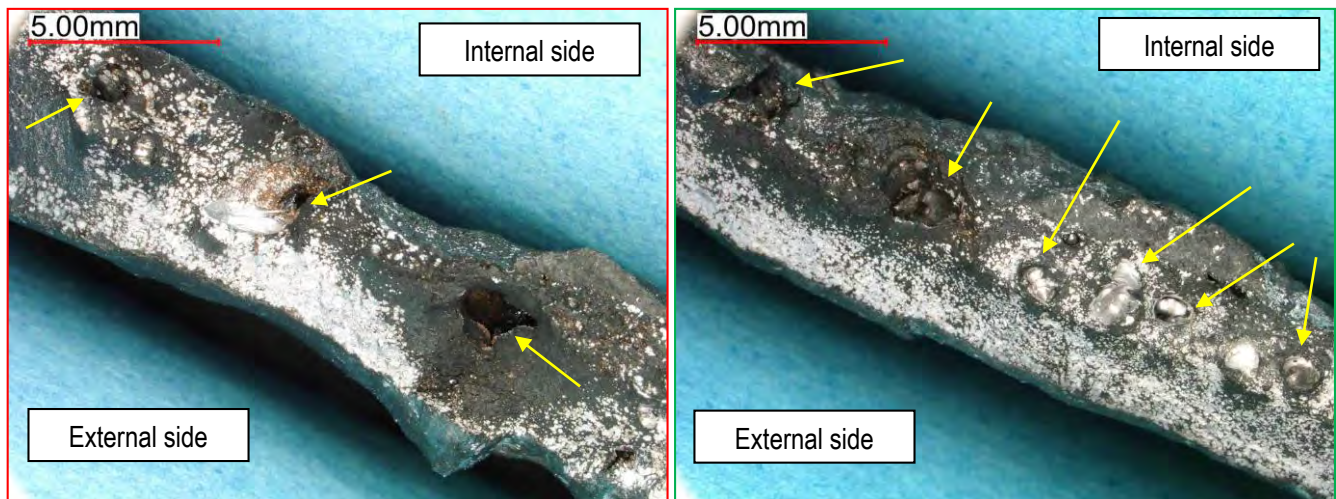
34 ➤ Macroscopic view of fracture surface revealed weld porosities throughout the  
fracture surface (which was the weld metal), predominantly at about the  
36 mid-depth from the external surface (Figure 120).

**Figure 120:** Macroscopic view of fracture surface. Weld porosities were observed throughout the fracture surface (which is the weld metal), predominantly at about the mid-depth from the external surface (indicated with yellow arrows).

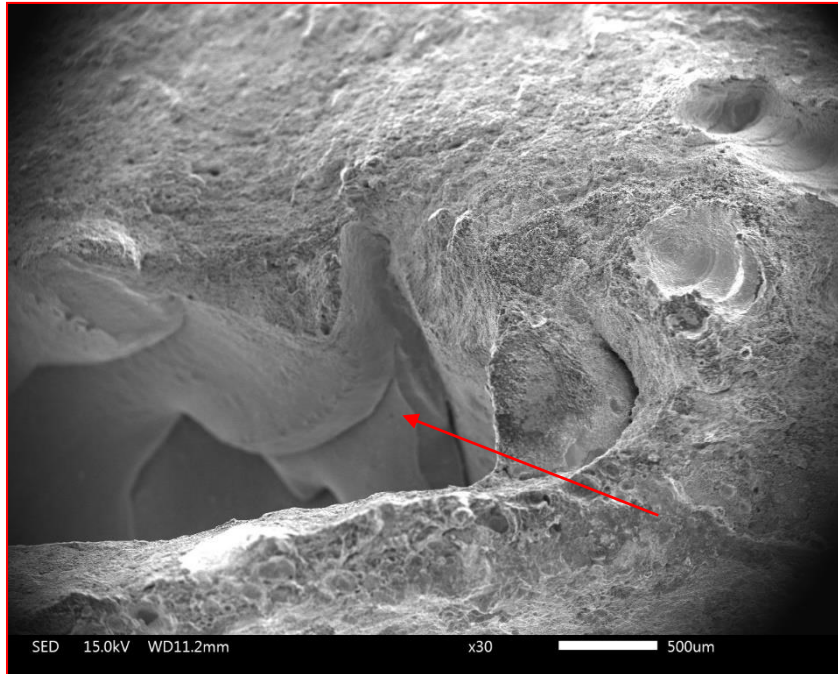
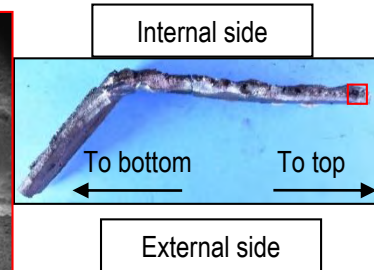
➤ Voids were confirmed under the SEM (Figure 121 and Figure 122).

**Figure 121:** Voids were observed scattered on the fracture surface, consistent with weld porosities.

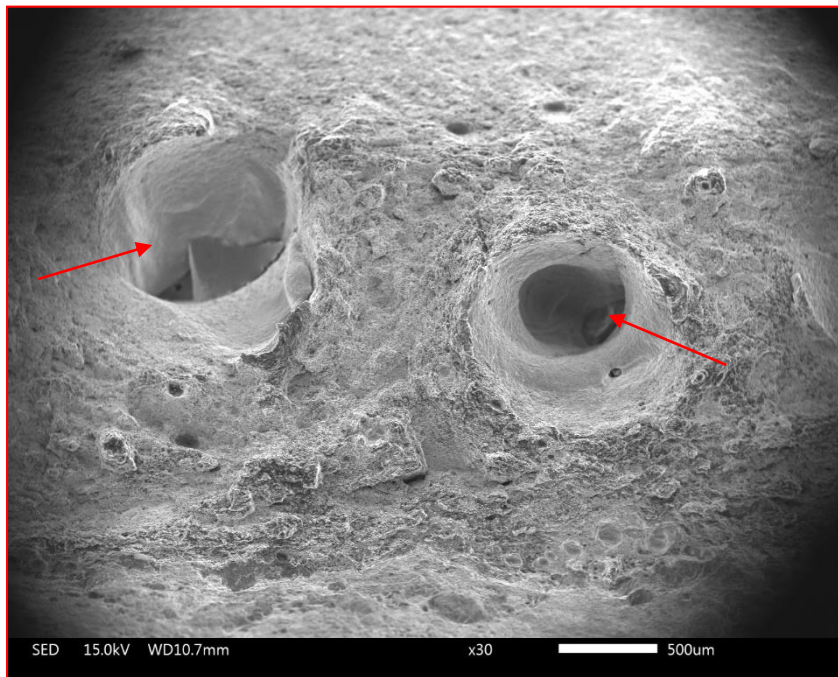
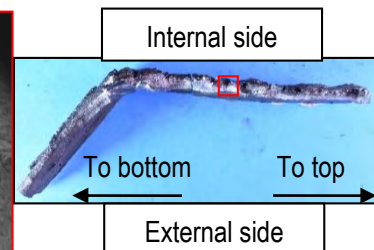
**Figure 122:** Voids were observed scattered on the fracture surface, consistent with weld porosities.

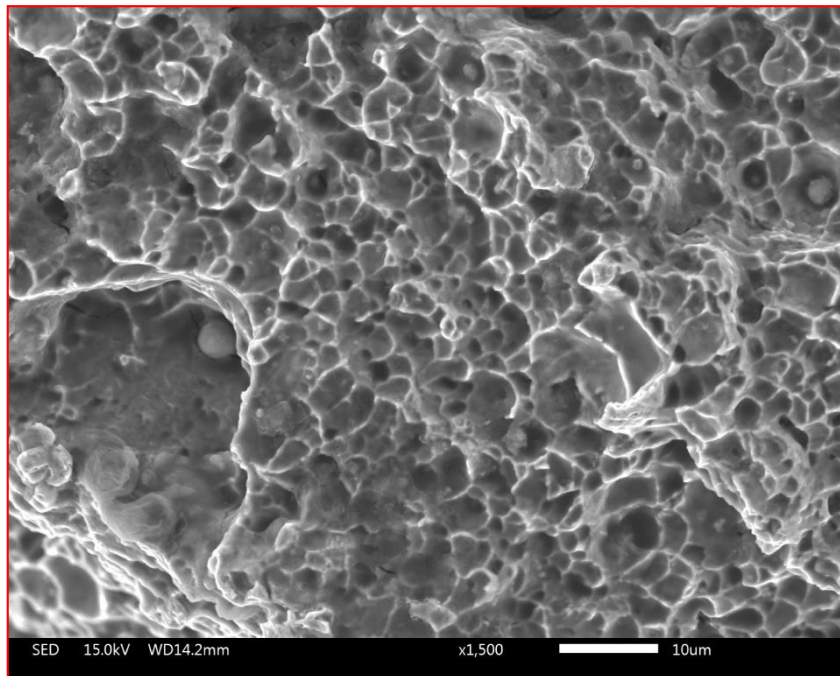
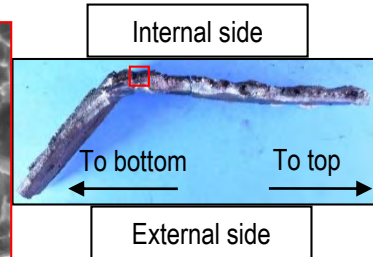
38 ➤ Relatively equiaxed dimples were generally observed throughout the fracture  
surface at regions adjacent to the internal side (Figure 123).

**Figure 123:** Relatively equiaxed dimples were generally observed throughout the fracture surface at regions adjacent to the internal side.

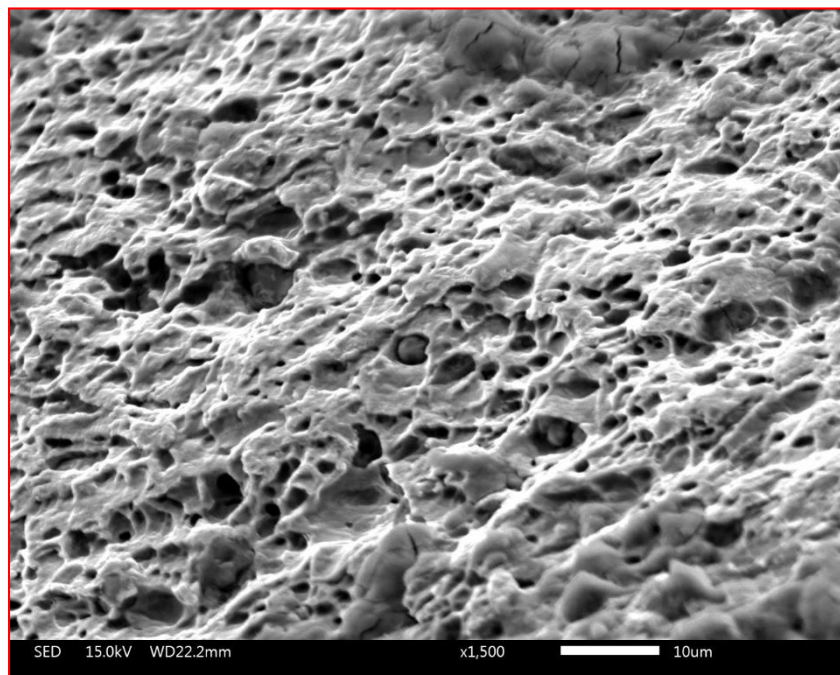
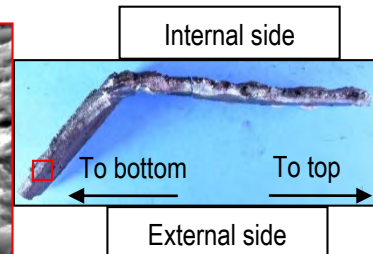
40 ➤ Elongated dimples were observed at regions adjacent to the external side  
(Figure 124).

**Figure 124:** Elongated dimples were generally observed throughout the fracture surface at regions adjacent to the external side.

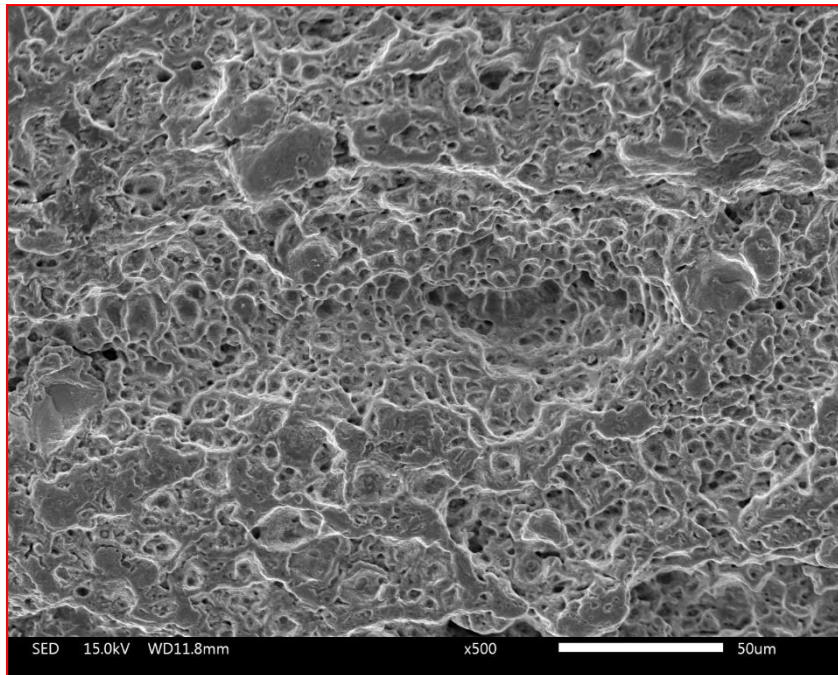
**Figure 127:** Equiaxed dimples were generally observed throughout the fracture surface at regions adjacent to the internal side.

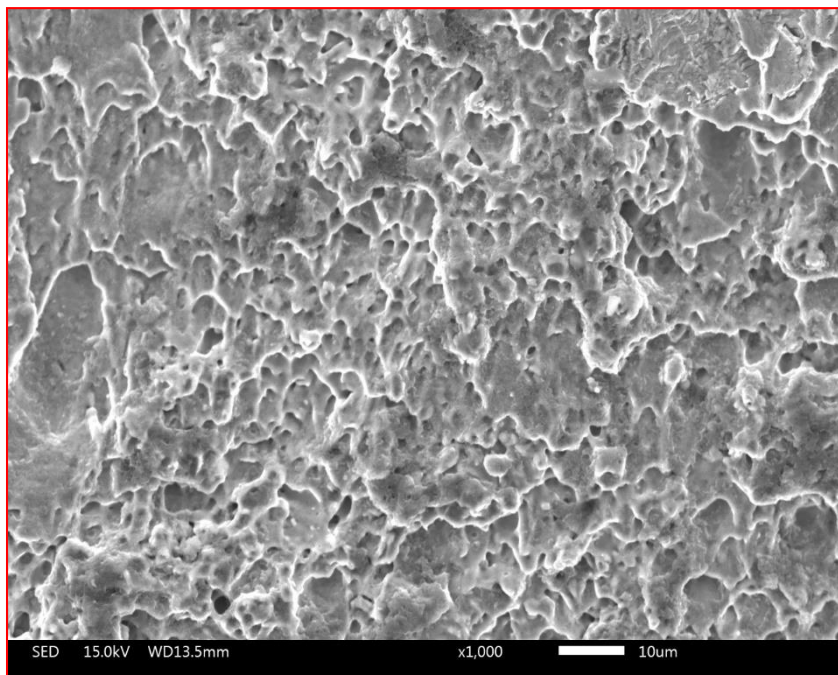
**Figure 128:** Elongated dimples were generally observed throughout the fracture surface at regions adjacent to the external side.

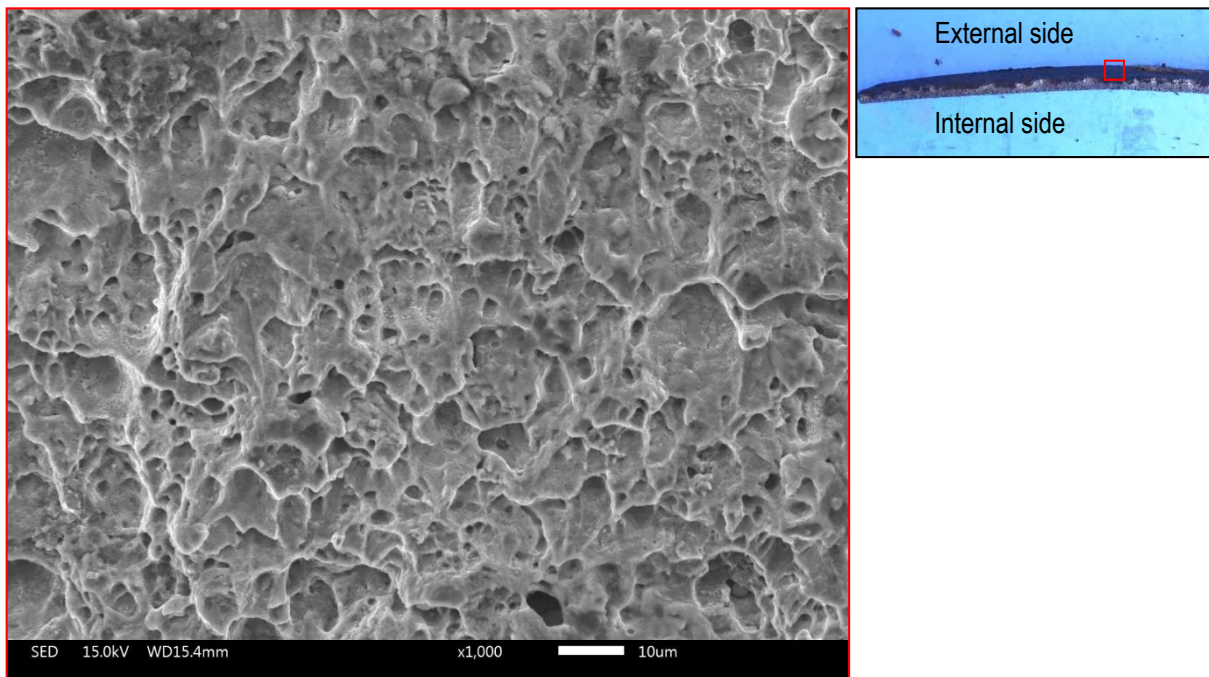
- Similarly, dimples were observed throughout the fracture surface of both examined samples. Equiaxed dimples were observed on the fracture surface at the regions adjacent to the internal side while elongated dimples were observed at the regions adjacent to the external side (Figure 129 and Figure 130).

**Figure 130:** Elongated dimples were generally observed throughout the fracture surface at regions adjacent to the external side.

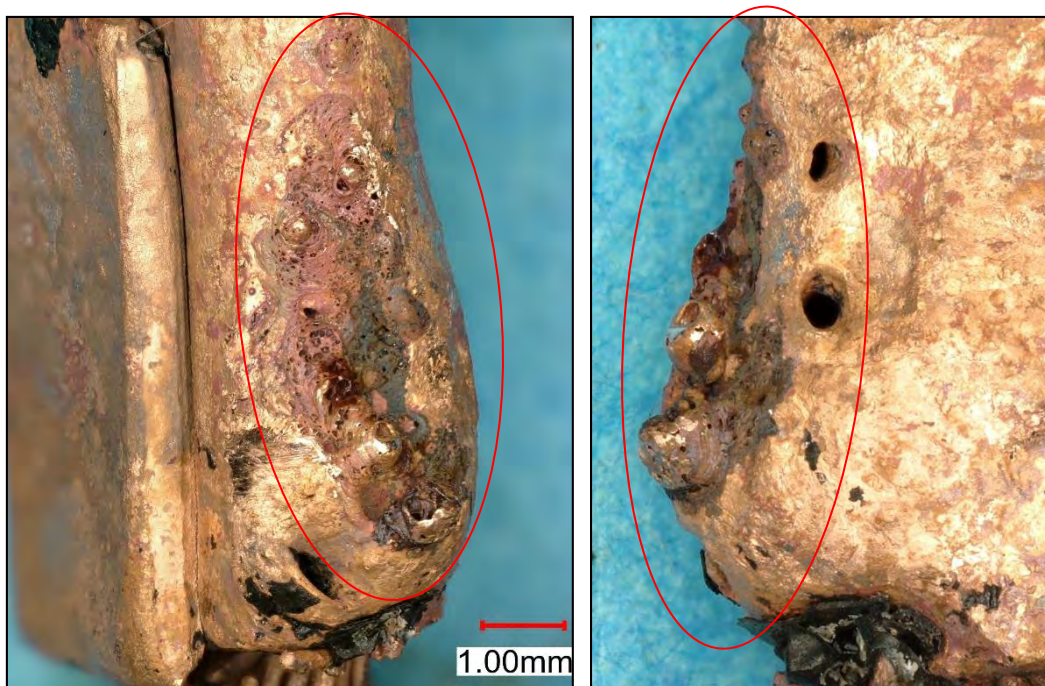
- Resolidification waves and great extent of porosity, characteristics of arcing damage, were observed at the bottom edge of the lug from terminal 3 (Figure 133 and Figure 134). SEM examination confirmed the arcing characteristic with large percentage of voids and concentric rings observed to be emanating from the centre of the arcing<sup>7</sup> damage (Figure 135 and Figure 136).
- Similarly, for the lug from terminal 4, resolidification waves were observed at the lug and washer that had fused them together (Figure 137 and Figure 138). SEM examination confirmed the arcing characteristic with concentric rings observed to be emanating from the centre of the arcing damage (Figure 139 and Figure 140).

**Figure 134:** Condition of lug after cleaning in an ultrasonic bath of Alconox solution. Resolidification waves and high porosity, characteristics of arcing damage, were observed at the bottom edge of the lug.

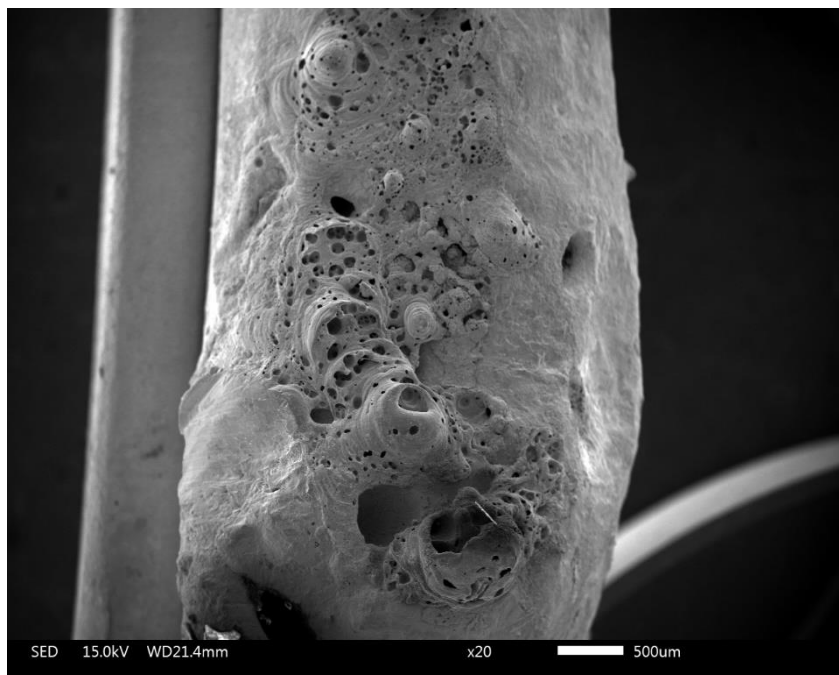
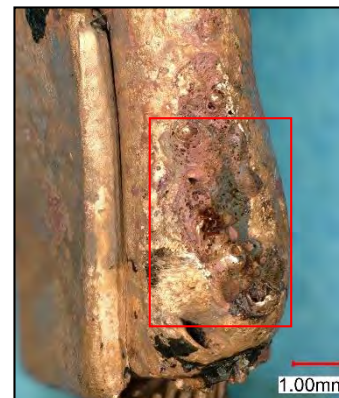
**Figure 135:** SEM confirms the arcing characteristic with large percentage of voids.

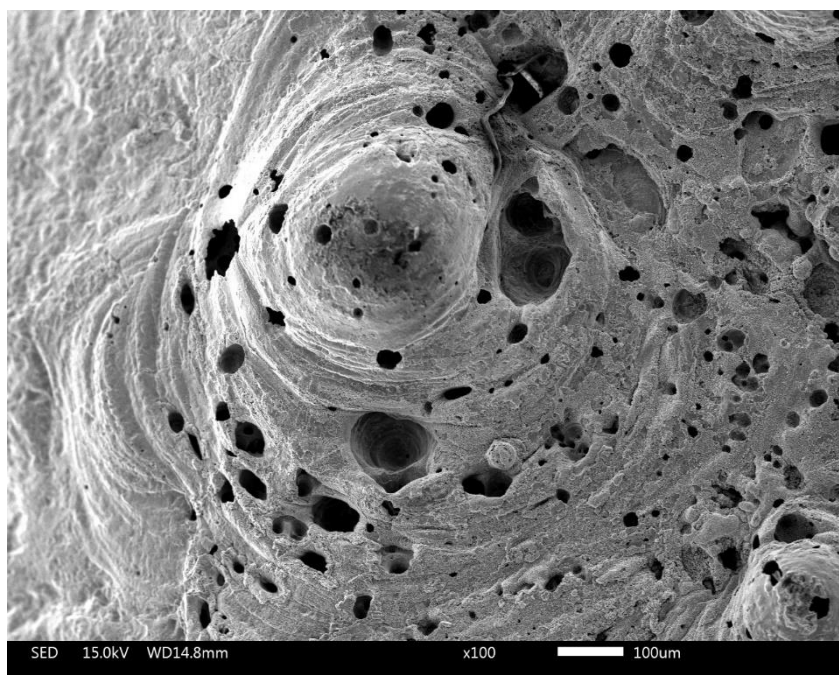
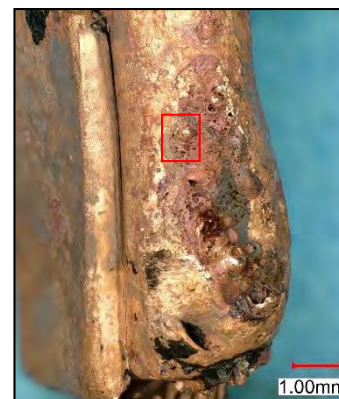
**Figure 136:** SEM confirms the arcing characteristic with large percentage of voids and concentric rings observed to be emanating from the centre of the arcing damage.

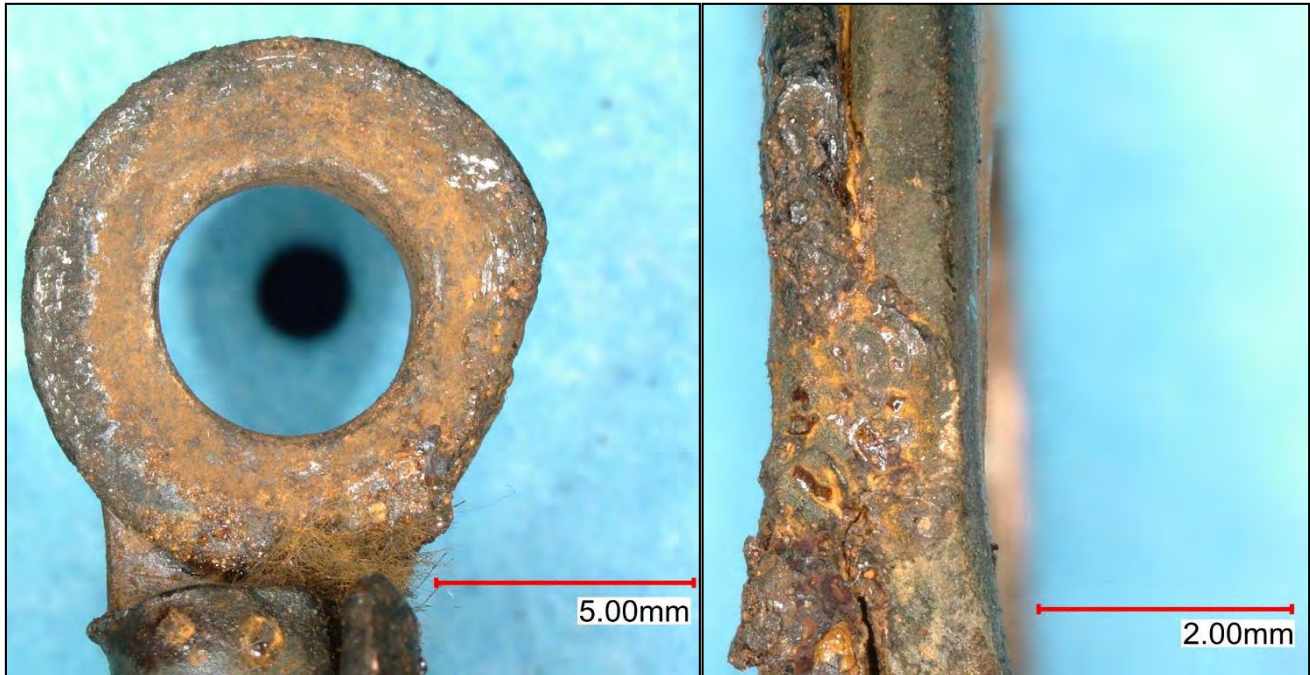
**Lug from terminal 4**

**Figure 137:** Condition before cleaning.

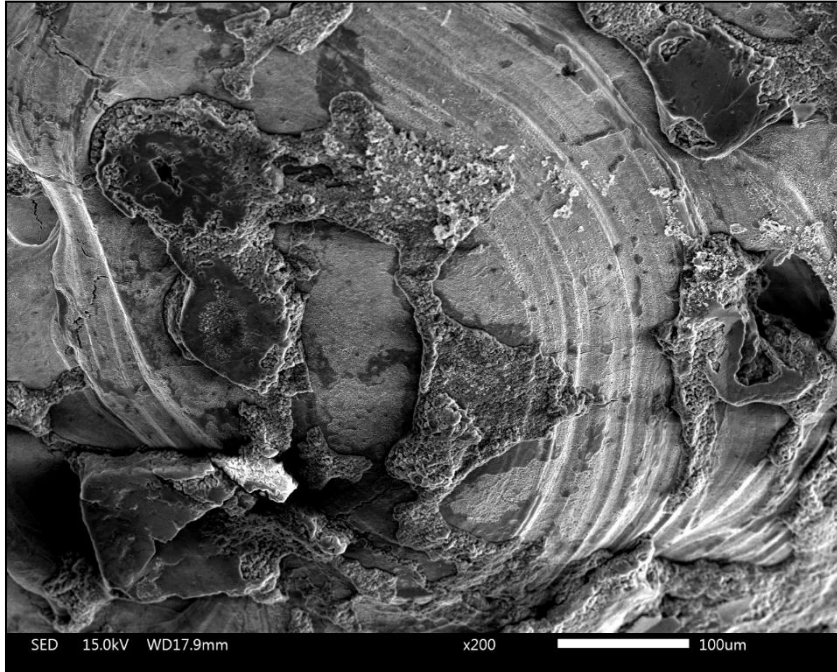
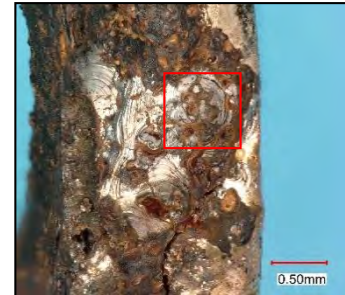
**Figure 139:** SEM confirms the arcing characteristic with concentric rings observed to be emanating from the centre of the arcing damage.
