# **Report of the Inquiry Committee for the accident at Stars Engrg Pte Ltd on 24 February 2021**

**(PART II – ANNEXES)**

| Report No:<br><b>M21091</b> | Subject Group:<br><b>11219</b> | Date:<br><b>10<sup>th</sup> September 2021</b> |
| Title of Report:<br><b>Failure Analysis of a Failed Mixer Machine Retrieved from Unit 32E of Platinum @ Pioneer Building involved in a Fire Explosion Incident</b> | | Date of Last Revision/Revision No: |

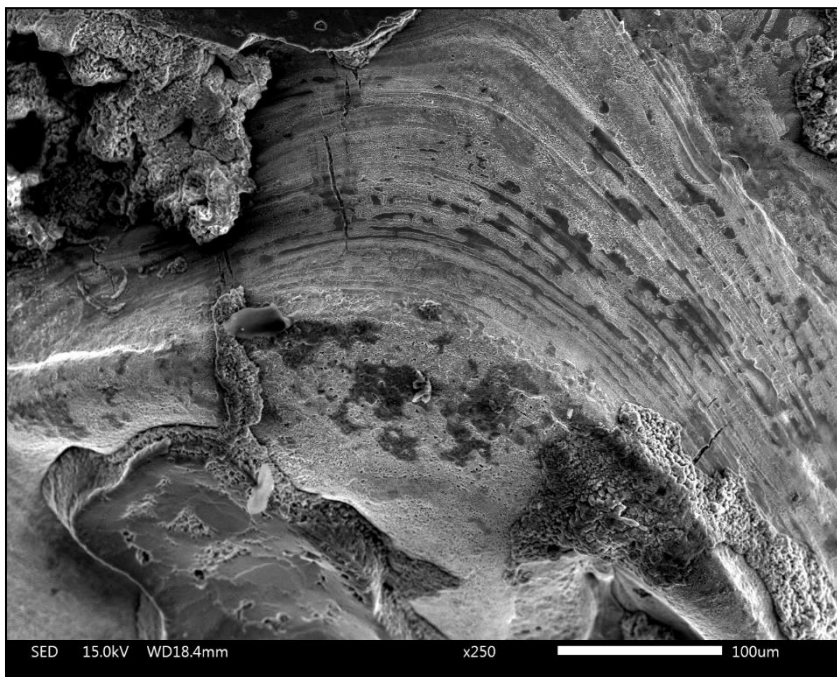
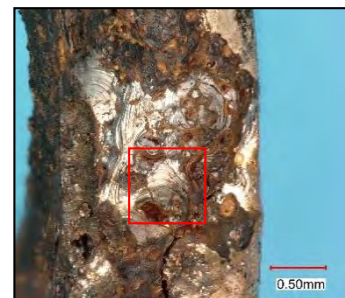
**Figure 140:** SEM confirms the arcing characteristic with concentric rings observed to be emanating from the centre of the arcing damage.

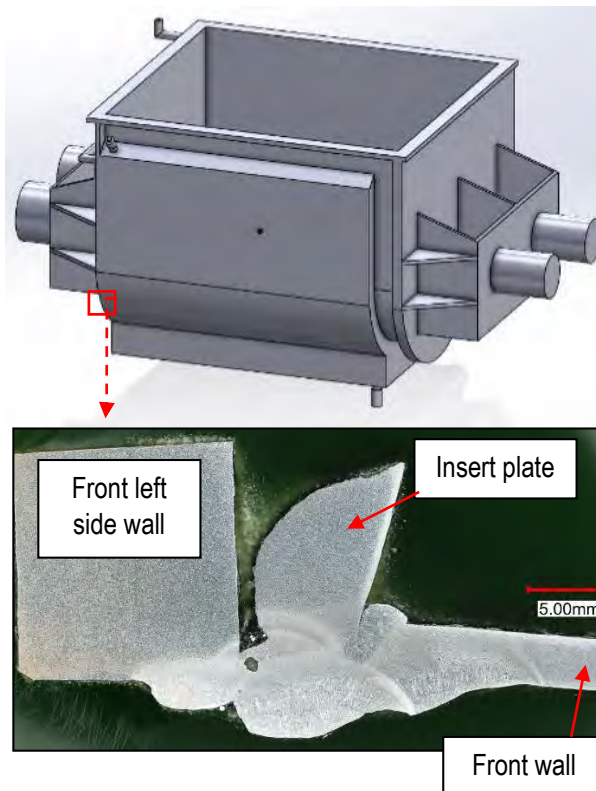
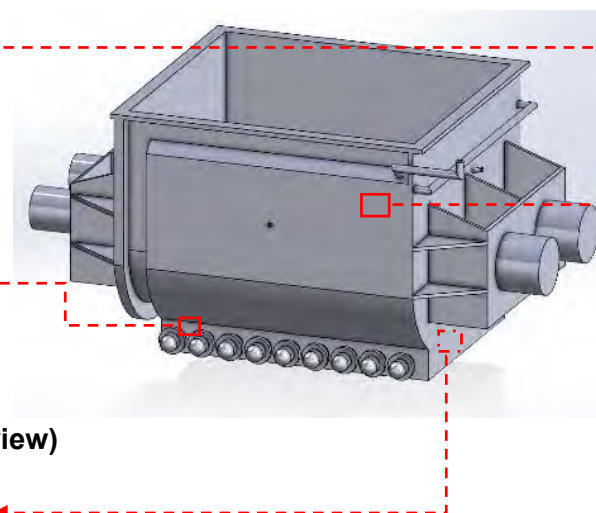
**Figure 141:** Chemical analysis conducted on the various oil jacket walls revealed elements typical of low carbon steel material.

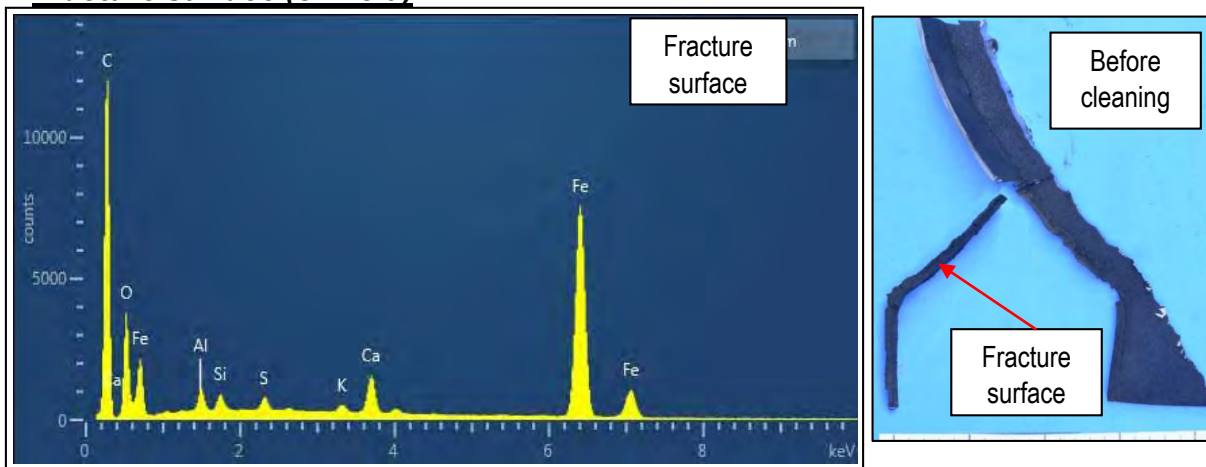
#### Fracture surface (of weld)

**Figure 142:** The major elements detected on the fracture surface were generally associated with the weld metal and constituents of the service medium.

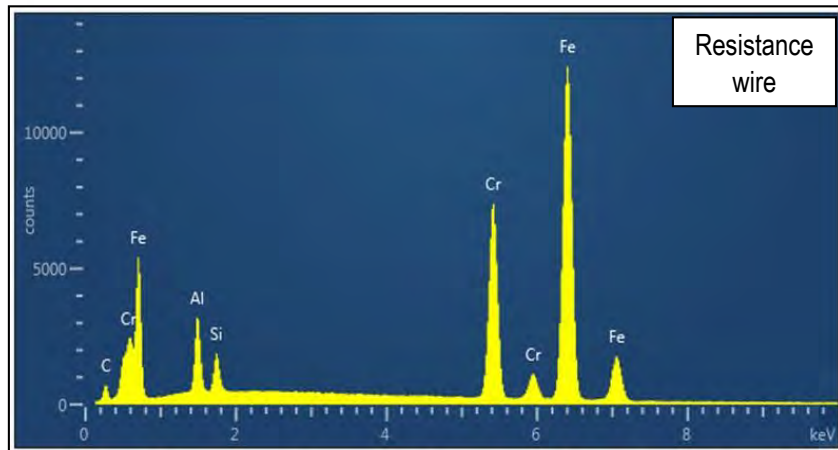
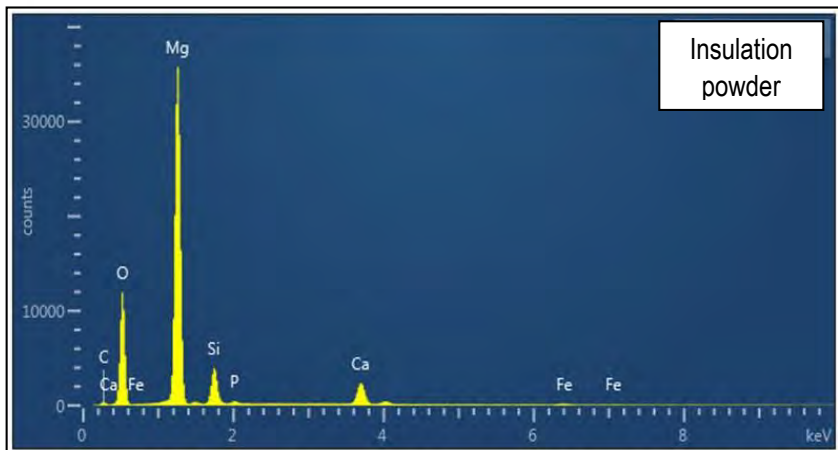
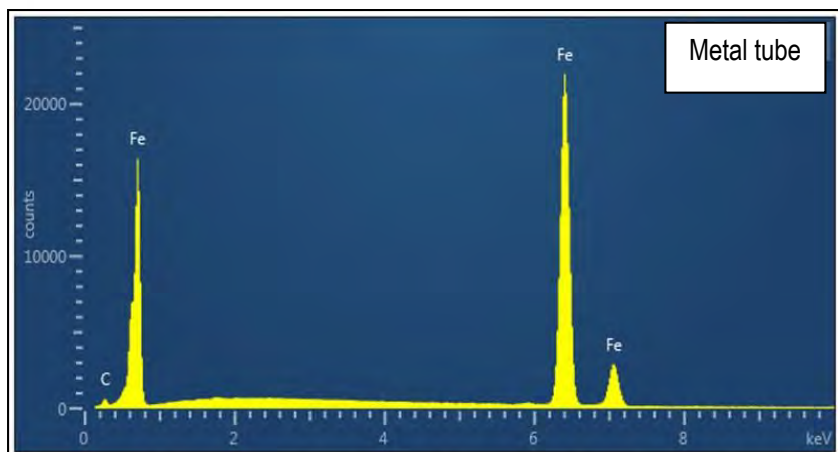
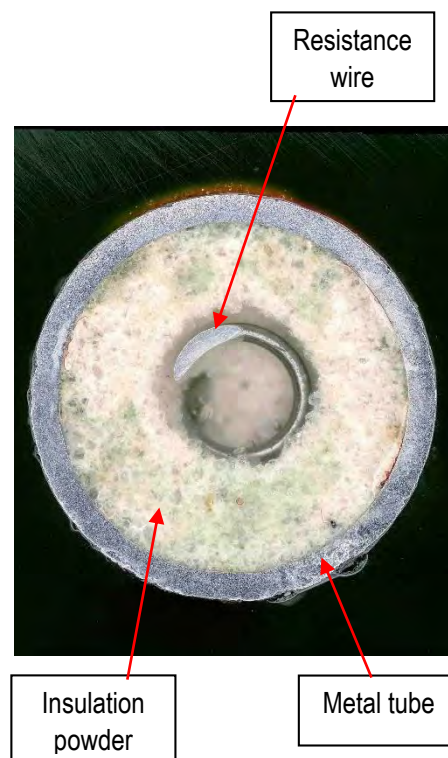
### Heater materials

**Figure 144:** Based on the major elements detected, the resistance wire is most likely constructed using Kanthal or Fe–Cr–Al material. The insulation powder is mainly magnesium oxide. The metal tube is constructed using carbon steel. All the material are typical of heating element construction.

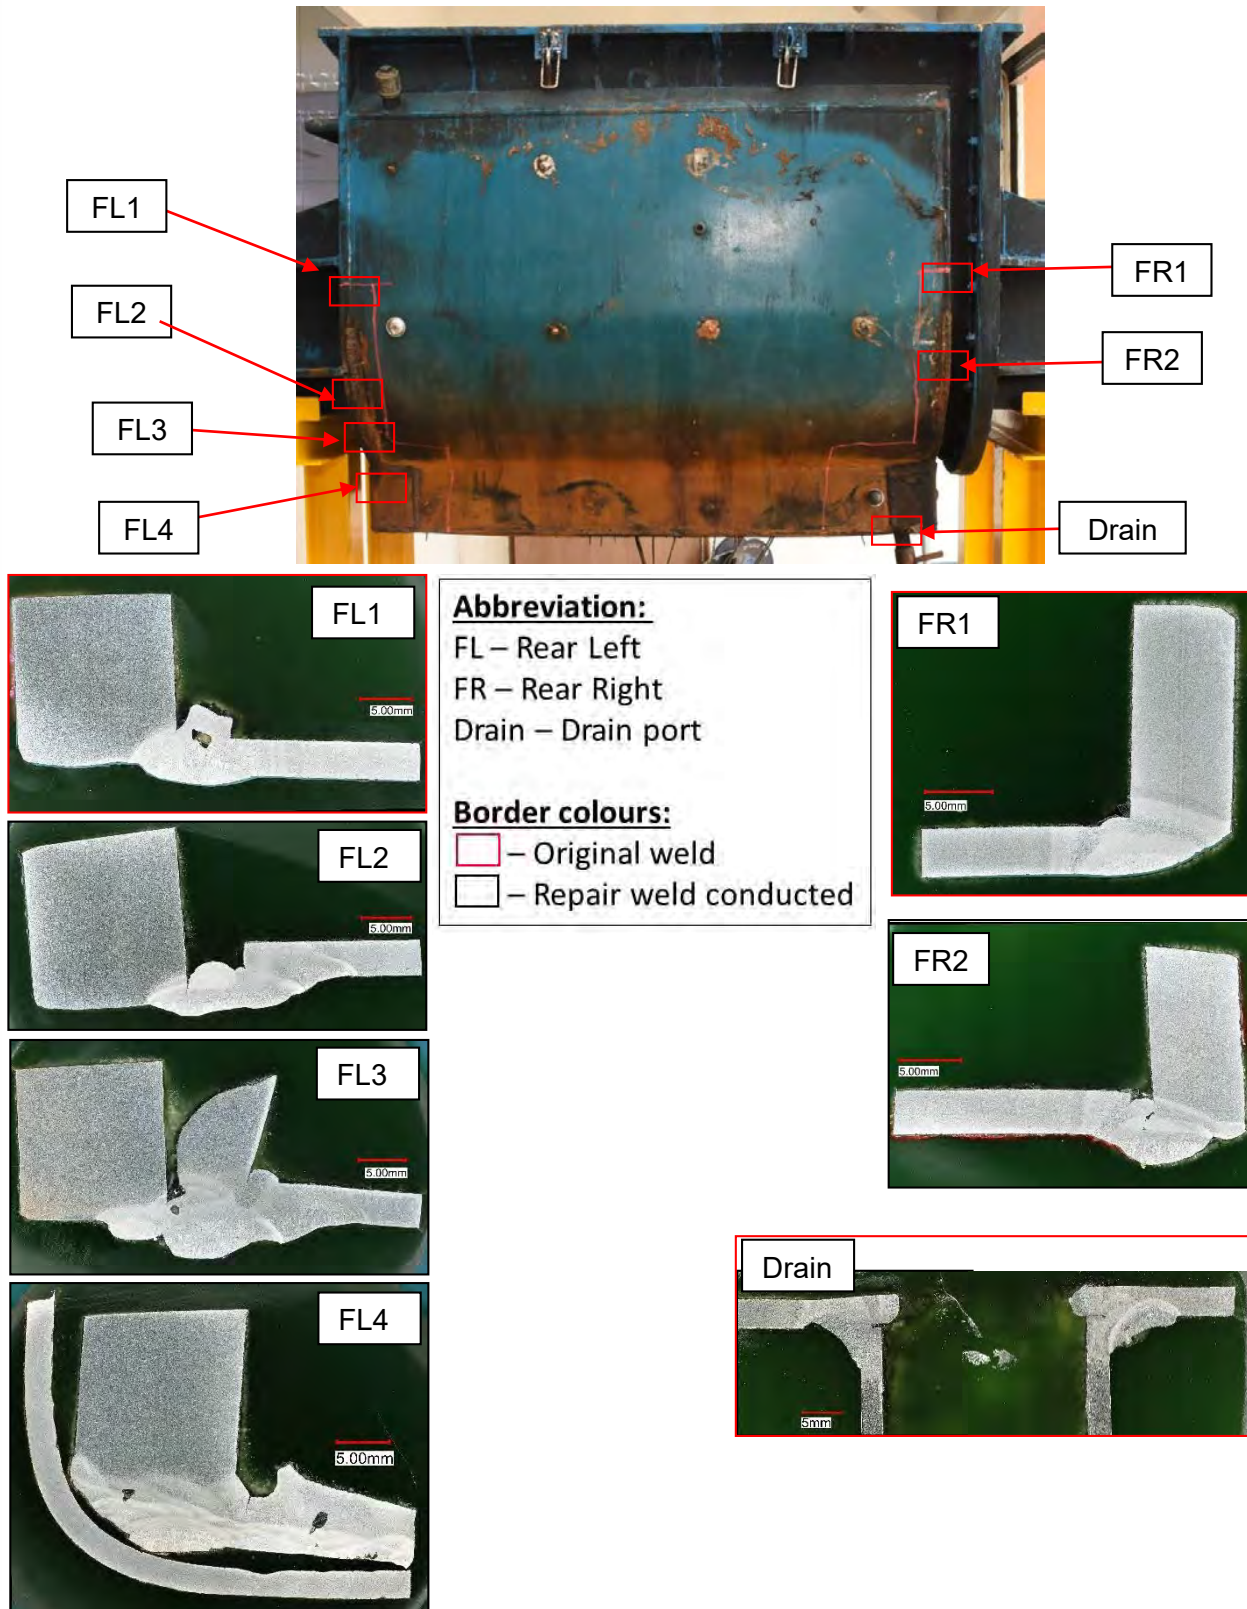
**Figure 145:** Samples for sectional metallographic examination.

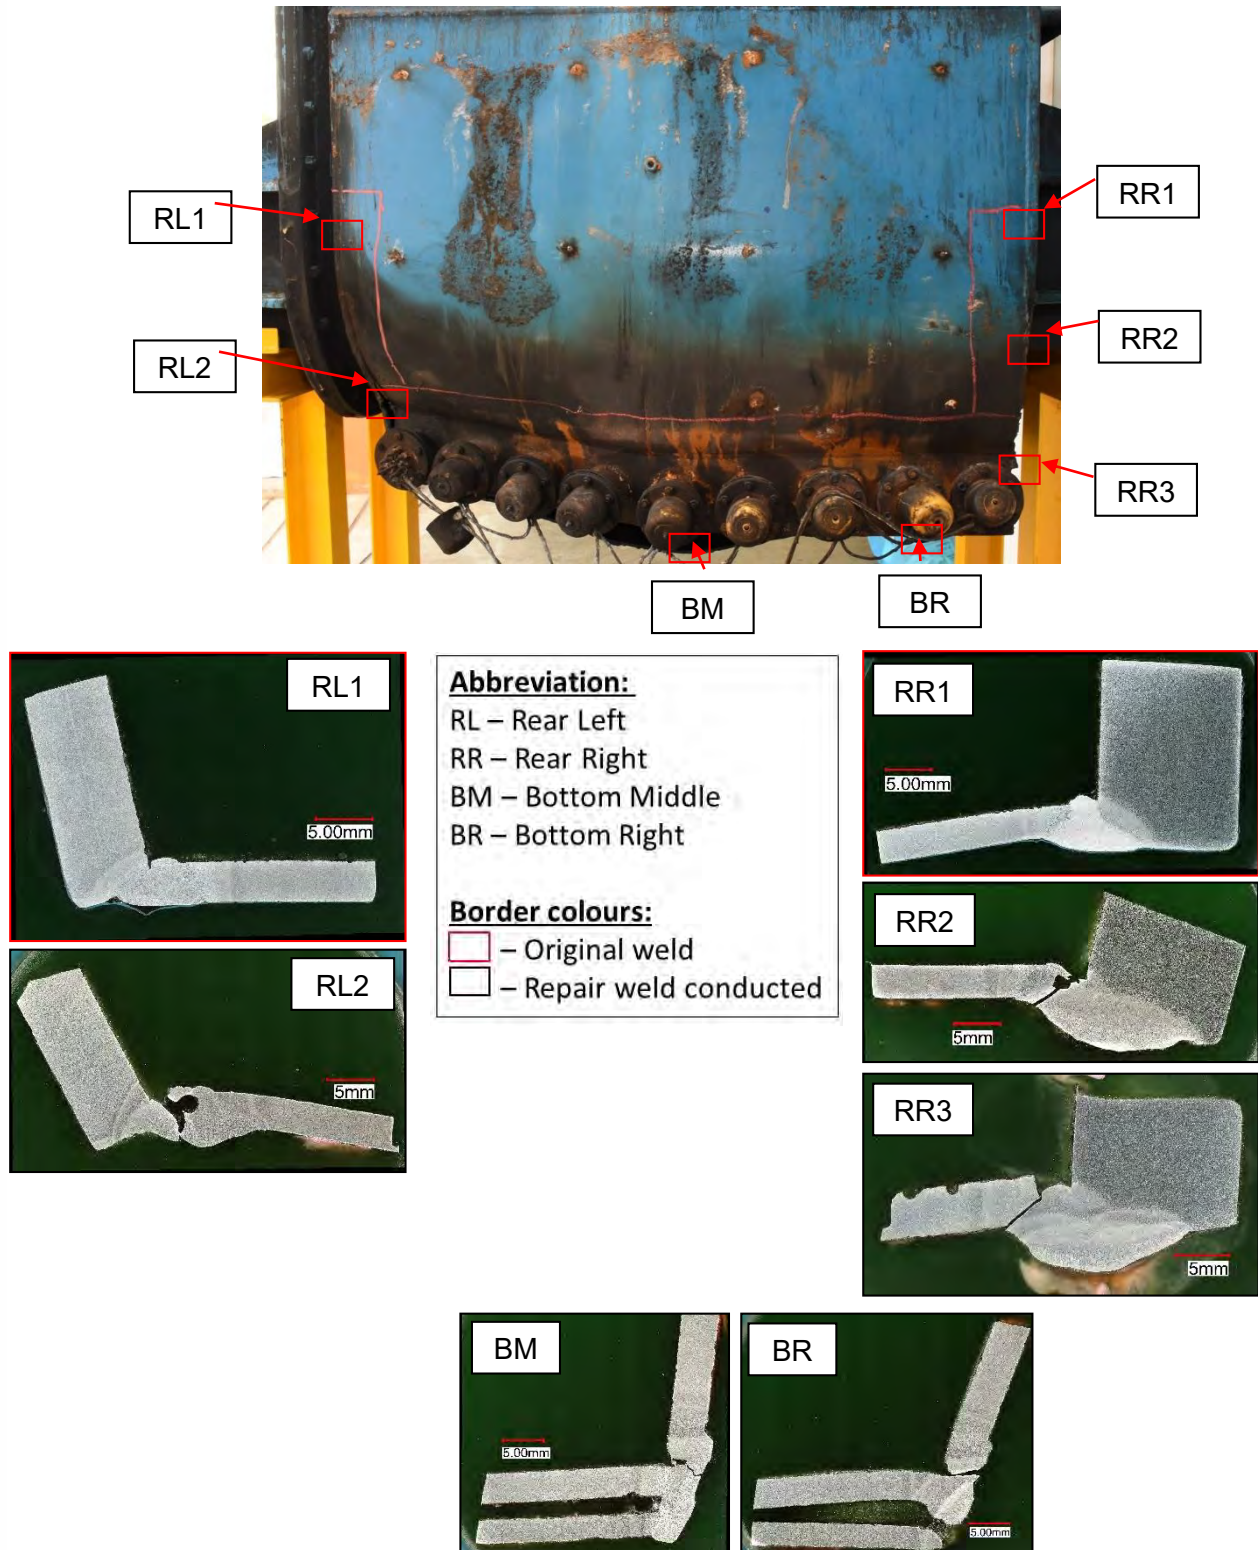
**Figure 146:** Samples for sectional metallographic examination.

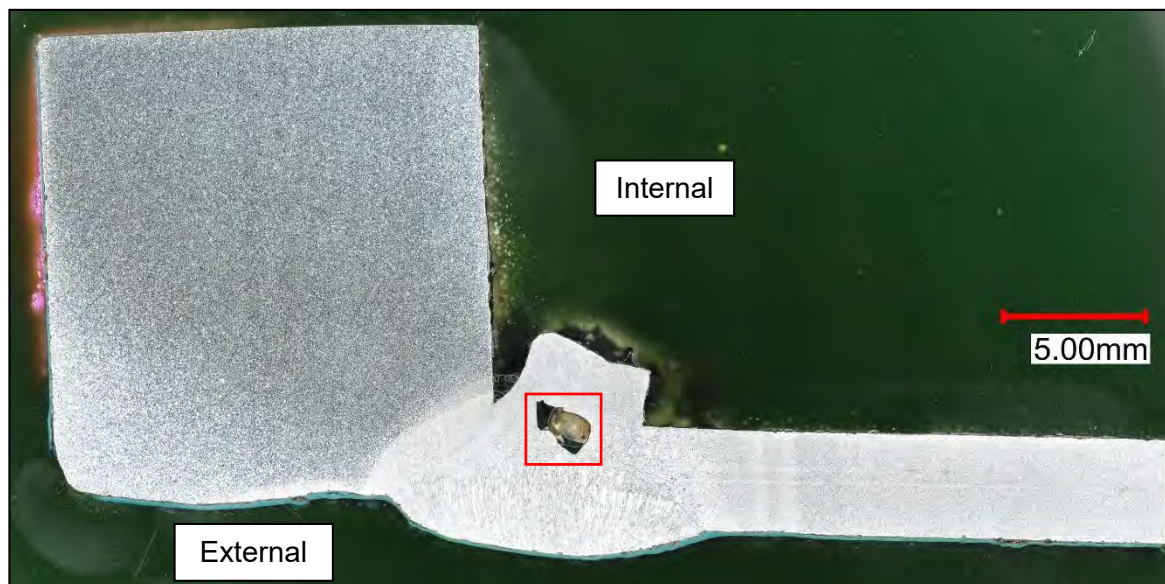
#### Front Left 1 (FL1)

- 20 ➤ Apart from location FL1, the weld joint examined at FR1 (Figure 157), RL1  
22 (Figure 163) and RR1 (Figure 167) were generally similar with no discontinuity  
found.
- 24 ➤ The weld at location FL1 had excessive root penetration with a void of about  
2 mm wide (Figure 147).
- 26 ➤ Incipient cracks were observed at location FL1 (Figure 148), RL1 (Figure 164)  
and RR1 (Figure 168).

**Figure 147:** Section metallographic examination was conducted across the original weld. Excessive root penetration was observed at this weld area. About 2 mm width void was observed in the middle of the weld root.

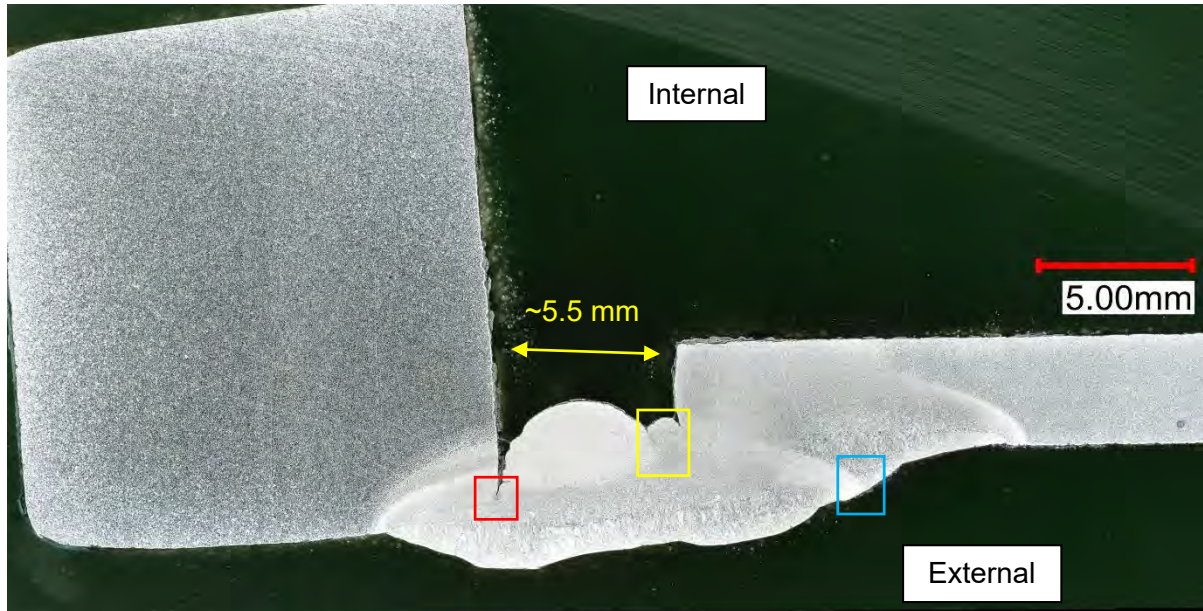
#### Front Left 2 (FL2)

- 30 ➤ All nine examined locations either had through-thickness cracks (RL2 [Figure  
32 165], RR2 [Figure 169], RR3 [Figure 171], BM [Figure 173] and BR [Figure  
34 175]) or incipient cracks (FL2 [Figure 149], FL3 [Figure 151], FL4 [Figure 155],  
FR2 [Figure 159]) that initiated from the weld root and propagated towards the  
external surface of the weld. Most of the incipient cracks were observed to be  
oxide filled.

10 ➤ Four out of nine locations had lack of root penetration with root openings of up  
12 to about 5.5 mm wide (FL2 [Figure 149], FL4 [Figure 155], FR2 [Figure 159]  
and RR3 [Figure 171]).

26 ➤ The weld at the repair weld locations had an obtuse joint angle (i.e. Figure 169)  
or large root opening (i.e. Figure 149) compared to the original weld locations  
28 that had relatively right angle joint. This suggested that severe deformation and  
opening of the weld seams had occurred before repairs were conducted.

26 The lack of root penetration with wide root opening (up to about 5.5 mm wide) at the  
repair welds of the oil jacket edges strongly suggested that the original welds at had  
ruptured open before repair weld and reinforcement plates were added (Figure 149,  
Figure 155, Figure 159, Figure 171). Such large root gaps are evidence of severe  
deformation in the oil jacket walls, typical of overpressure failure. The deformation of  
the walls prevented a close fit for repair welding, leading to lack of root penetration.  
When the rupture was repaired, the macro and micro features of earlier cracks were  
removed/destroyed.

**Figure 149:** Sectional metallographic examination was conducted across the repair weld. Lack of root penetration was observed with a root opening of about 5.5 mm. Closer examination was made in the following colour bordered figures.

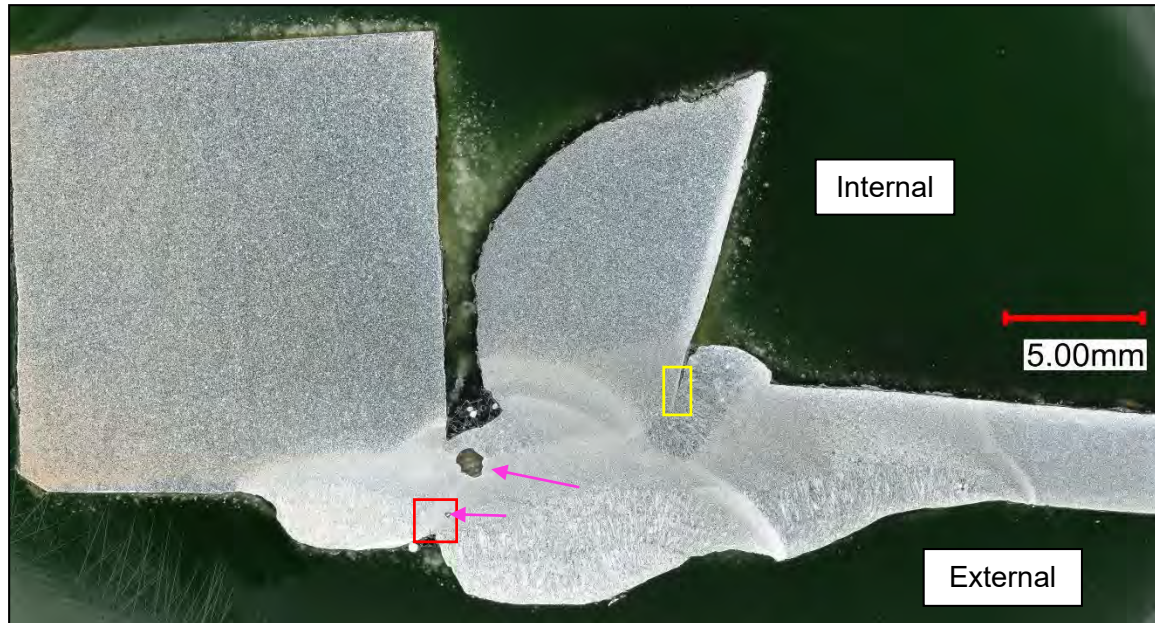
#### Front Left 3 (FL3)

4 ➤ Seven out of nine examined locations had voids scattered within the weld metal  
6 (FL3 [Figure 151], FL4 [Figure 155], FR2 [Figure 159], RL2 [Figure 165], RR2  
[Figure 169], BM [Figure 173] and BR [Figure 175]). The voids were up to  
2.5 mm wide in size.

**Figure 151:** Sectional metallographic examination was conducted across the repair weld with a visible insert plate from the internal side (see Figure 47). Voids up to about 1.0 mm were observed (in pink).

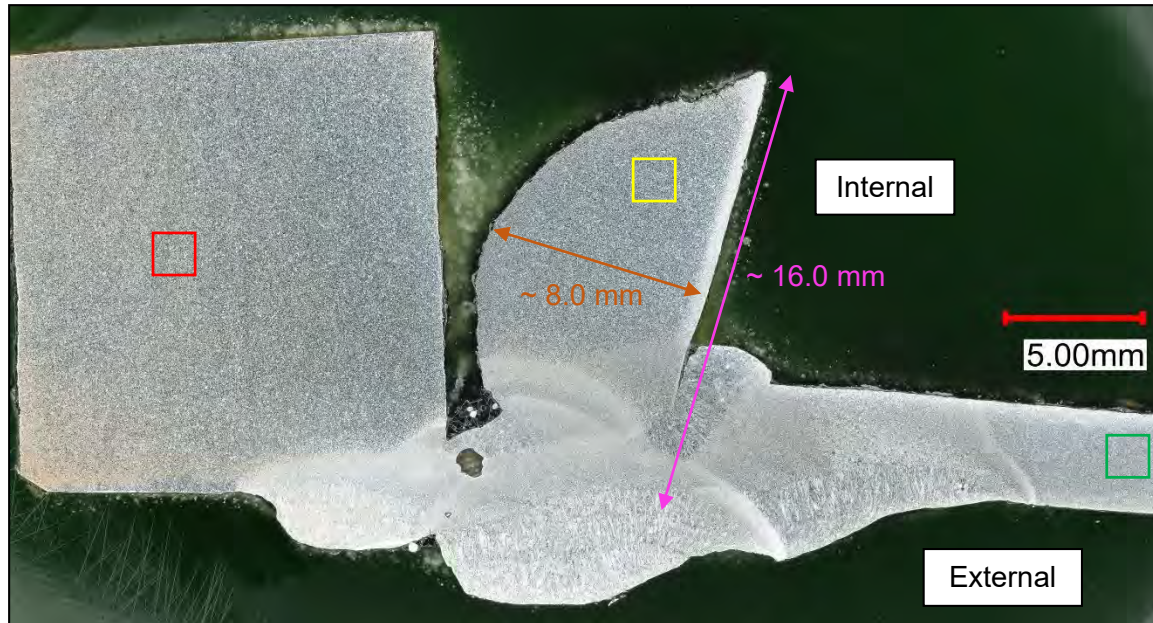
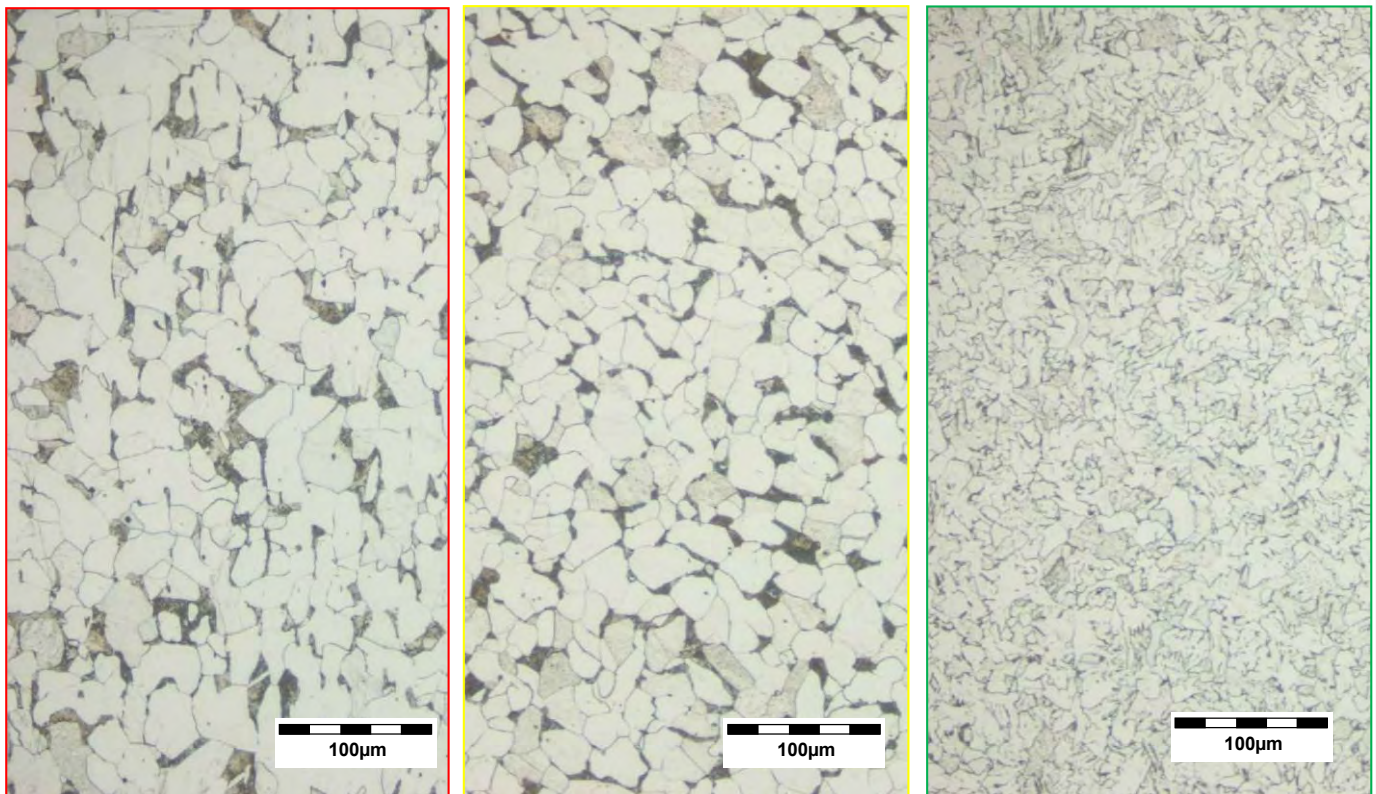
#### Front Left 3 (FL3)

14 ➤ At location FL3 (Figure 153 and Figure 154), the insert plate between the weld  
16 joint was confirmed to be a separate (and different) metal piece that was welded  
18 in between the front left side and front walls. Although their microstructures  
consisted of ferrite with pearlite, their microstructures differ such that the front  
left wall has flow lines from rolling process (manufacturing), the insert plate  
does not have flow lines and the front wall has finer grains.

20 ➤ The width and thickness of the insert plate were approximately 8.0 mm and  
16.0 mm respectively (the length was measured earlier at about 120.0 mm, see  
also Figure 47). At the time of reporting, the source of the insert plate and when  
it was welded into the oil jacket were unknown.

**Figure 153:** The insert plate is confirmed to be a separate metal piece welded between the front left side and front walls. The width and thickness of the insert plate were approximately 8.0 mm and 16.0 mm respectively (the length was measured earlier at about 120.0 mm).

**Figure 154:** Micrographs at 200x magnification. The base metals of the oil jacket walls (left and right) and the added metal piece (middle) consisted of ferrite pearlite microstructure. Their microstructures differ such that the front left wall has flow lines from rolling process (manufacturing), the insert plate does not have flow lines and the front wall has finer grains.

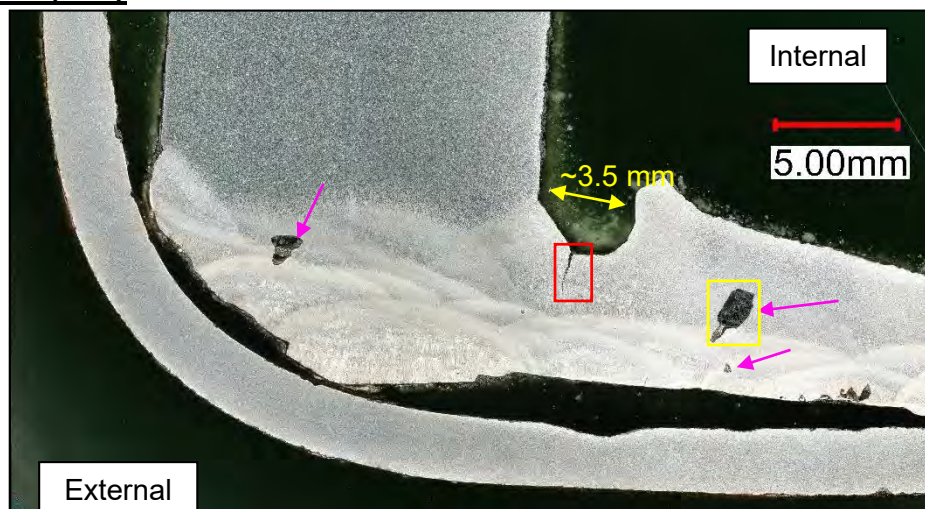
#### Front Left 4 (FL4)

**Figure 155:** Sectional metallographic examination was conducted across the repair weld and corner reinforcement plate. Lack of root penetration was observed with a root opening of about 3.5 mm wide. Voids of up to 2.5 mm wide were scattered in the weld metal (in pink).

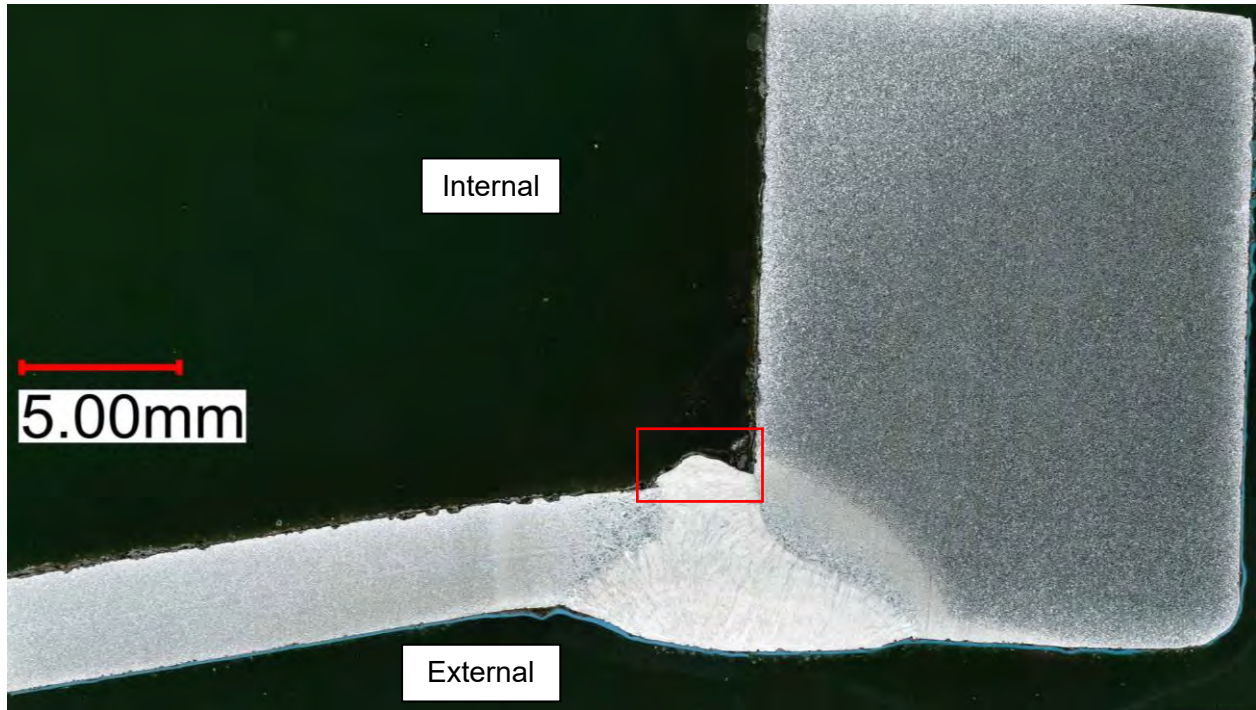
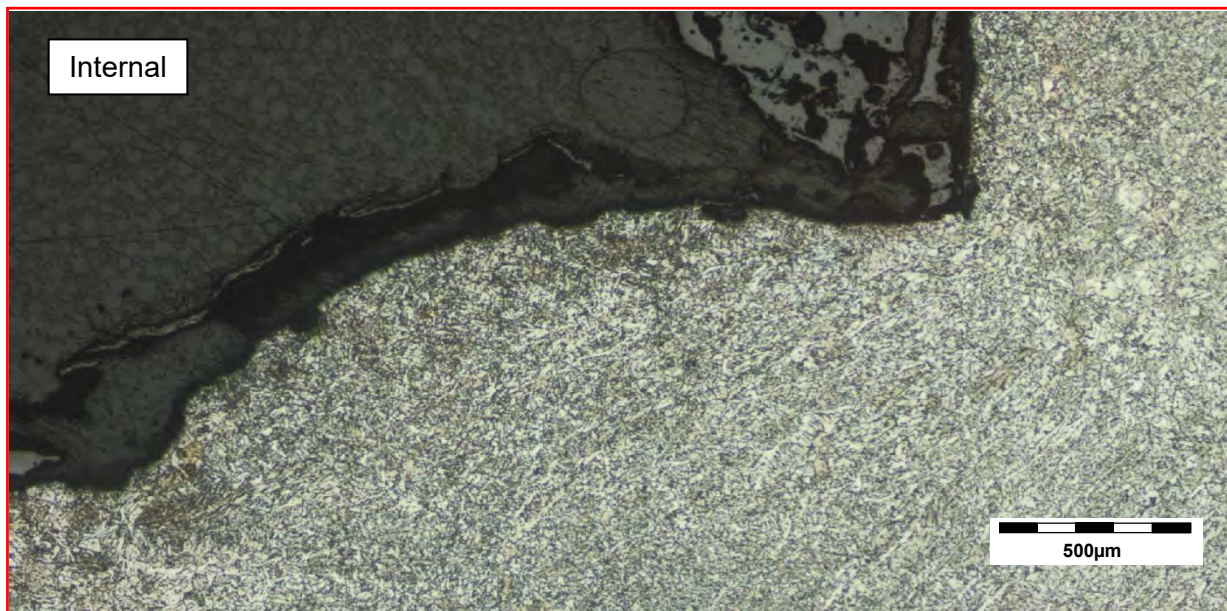
**Front Right 1 (FR1)**

**Figure 157:** Sectional metallographic examination was conducted across an original weld. No discontinuity found at this weld joint.

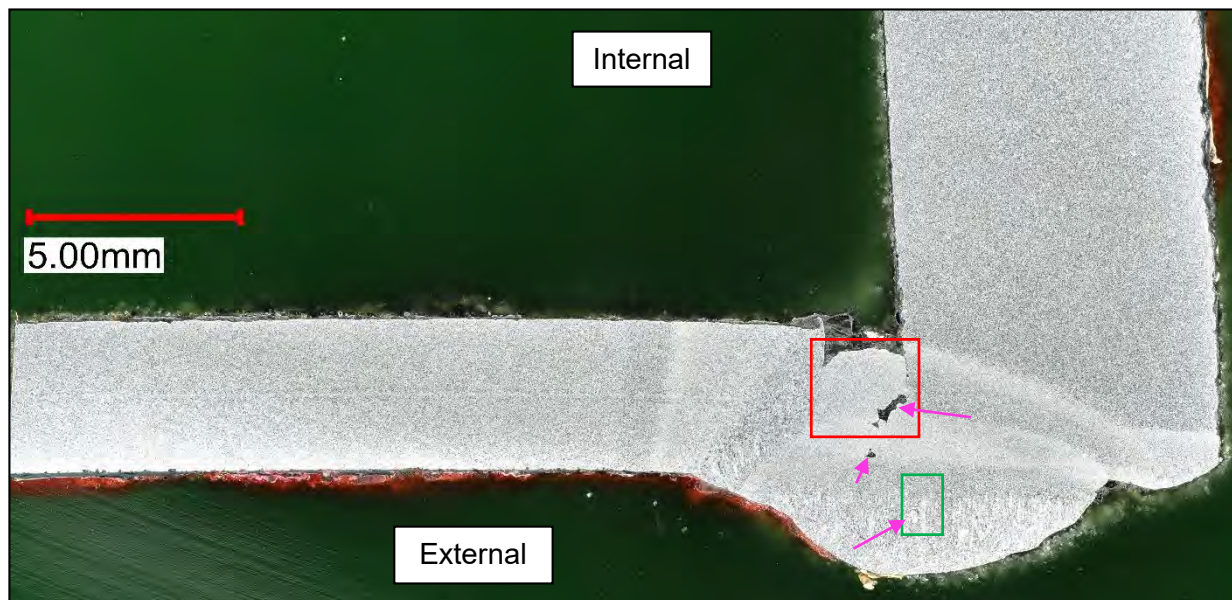
#### Front Right 2 (FR2)

**Figure 159:** Sectional metallographic examination was conducted across the repair weld. Lack of root penetration was observed with a root opening of about 1.6 mm wide. Voids up to about 1.0 mm were observed in the weld metal.

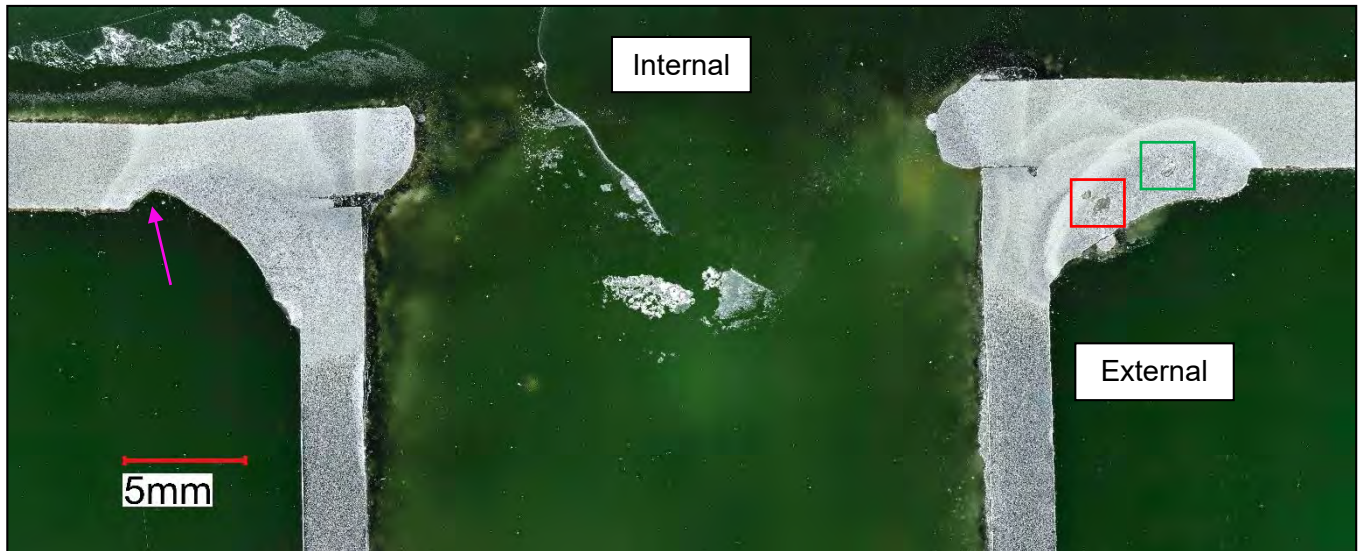
**Drain**

32 ➤ The weld had undercut at the weld toe (Figure 161). Voids of up to about  
1.0 mm wide were observed scattered in the weld metal. The weld metal had a  
non-uniform distribution of weld structure (Figure 162).

**Figure 161:** Sectional metallographic examination was conducted across the drain port. The weld had undercut at the weld toe (in pink arrow). Voids up to about 1.0 mm wide were observed scattered in the weld metal.

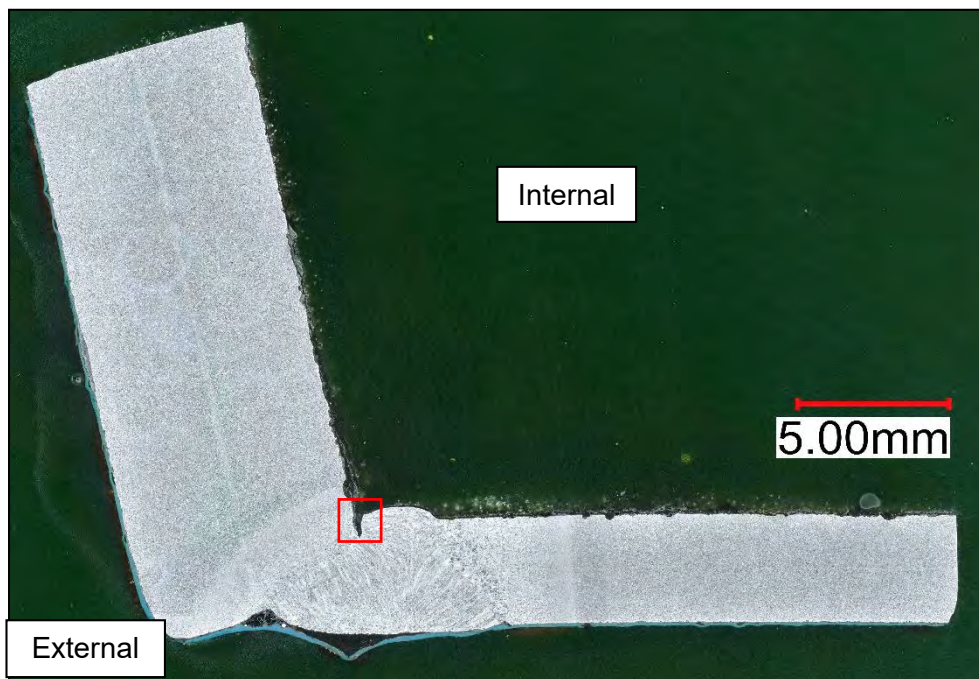
#### Rear Left 1 (RL1)

**Figure 163:** Sectional metallographic examination was conducted across the original weld. Incipient crack was observed at the weld root, propagated towards the weld face. Apart from that, no significant weld discontinuity was found.

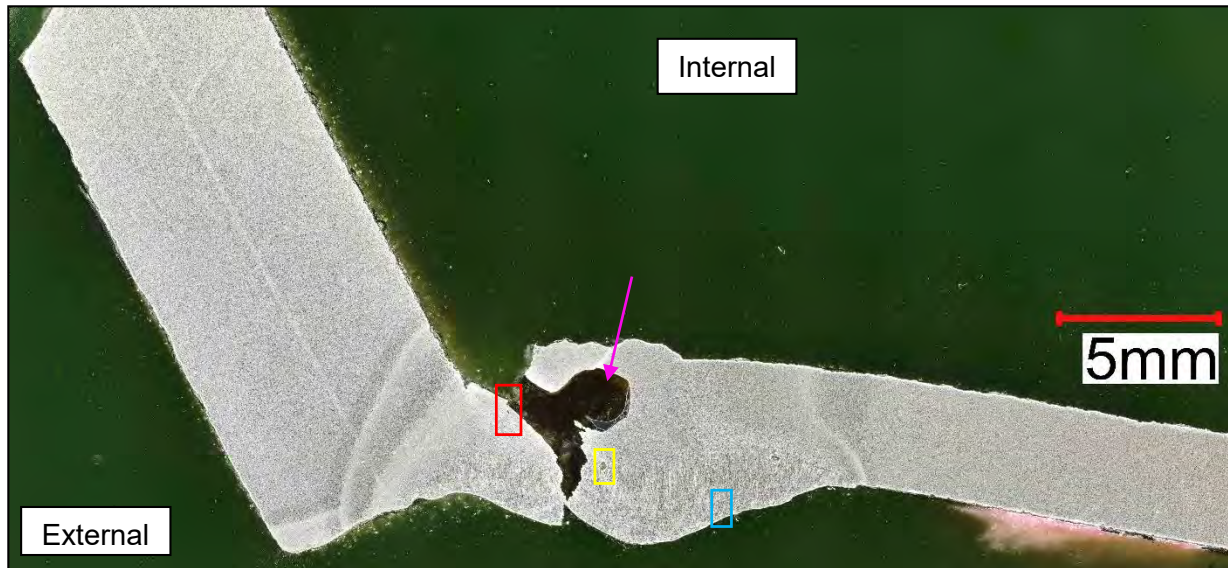
**Rear Left #2**

**Figure 165:** Sectional metallographic examination was conducted across the repair weld which had cracked through. Multiple voids were observed scattered in the weld metal with size up to about 1.7 mm wide.

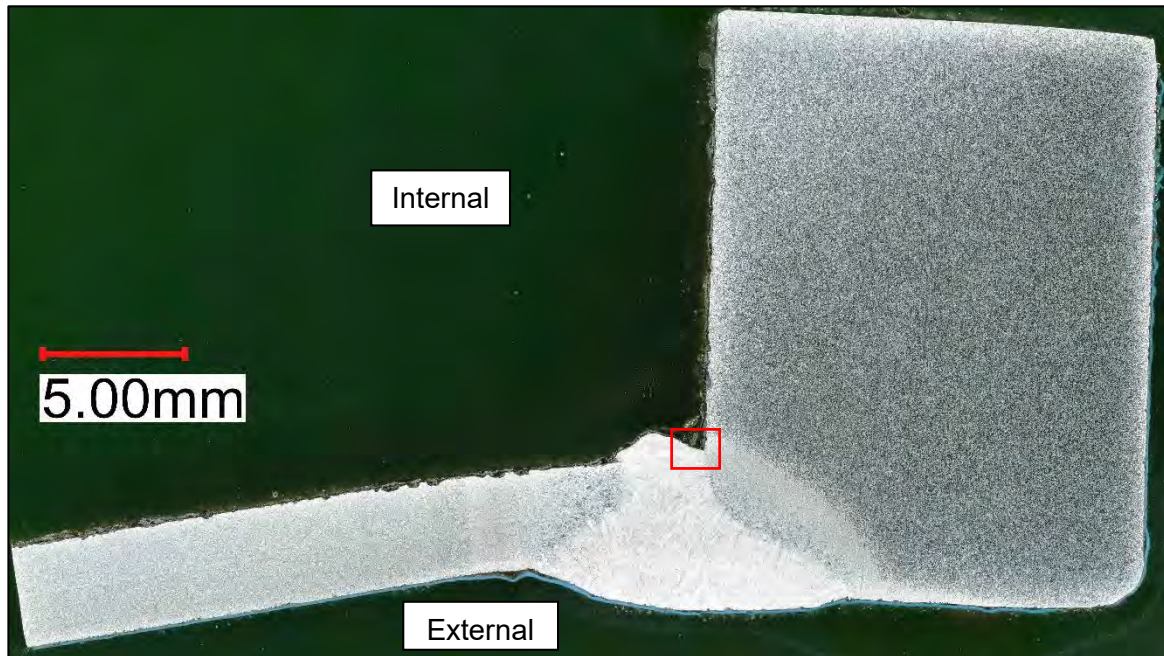
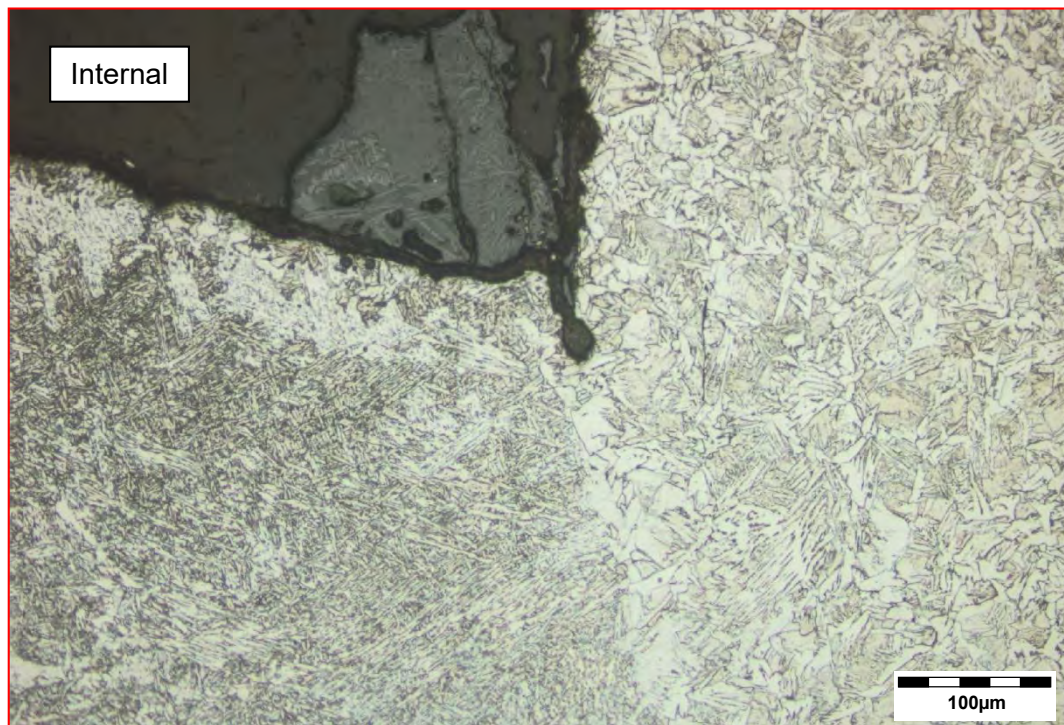
**Rear Right #1**

**Figure 167:** Sectional metallographic examination was conducted across the original weld. Apart from a small incipient crack initiated from the weld root, no weld discontinuity was found.

**Figure 168:** Micrograph at 200x magnification. A 60µm incipient crack (with some oxide scale) was observed at the weld root.

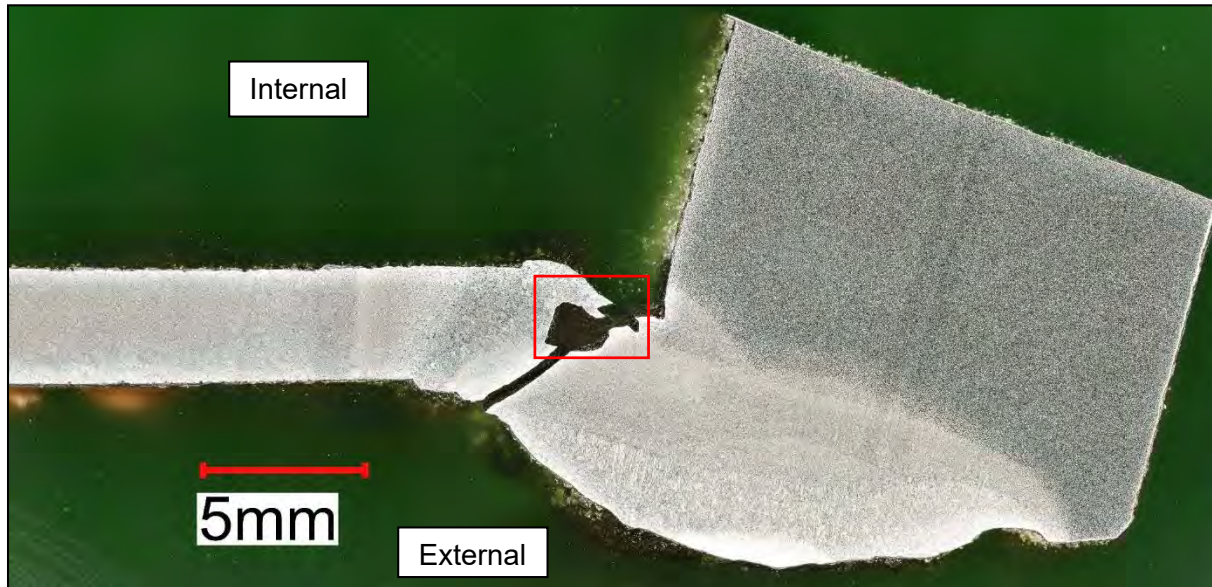
**Rear Right #2**

**Figure 169:** Sectional metallographic examination was conducted across the repair weld which had cracked through. Voids up to about 1.5 mm wide were in the weld metal (red box).

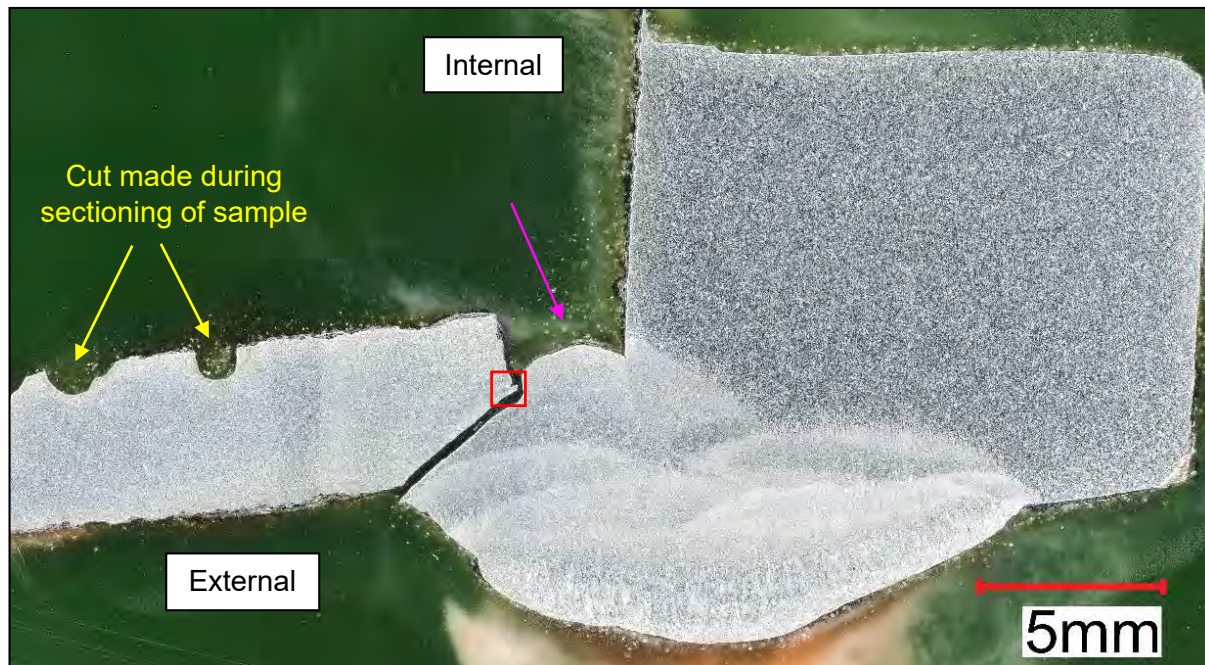
#### Rear Right #3

**Figure 171:** Sectional metallographic examination was conducted across the repair weld and through crack. The weld had lack of root penetration with root opening of about 3.0 mm wide (pink arrow).

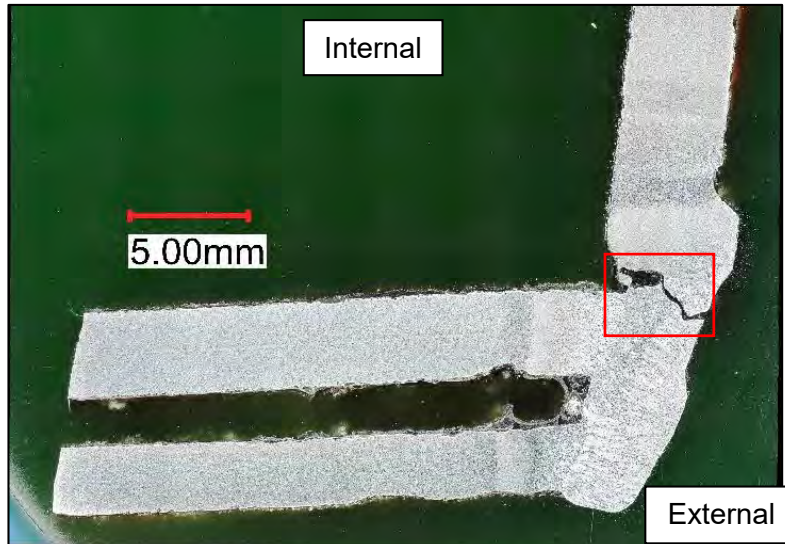
#### Bottom Middle

**Figure 173:** Sectional metallographic examination was conducted across the weld between bottom plate and reinforcement plate. A void of about 1.0 mm was observed (red box) along the through crack path.

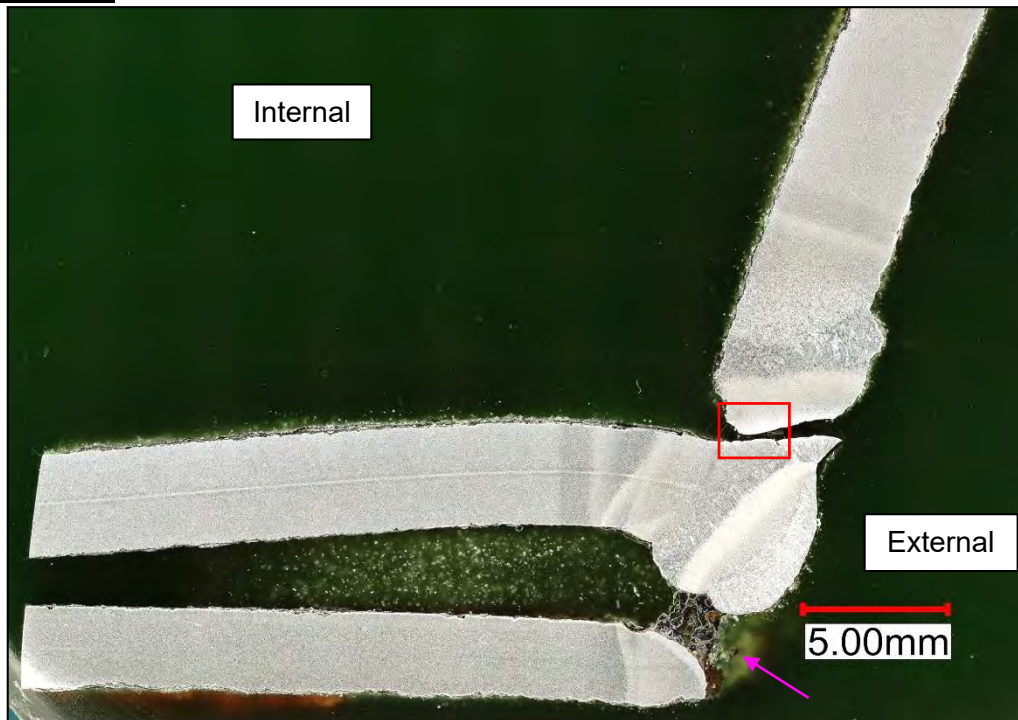
#### Bottom Right

**Figure 175:** Sectional metallographic examination was conducted across the weld between the bottom plate and reinforcement plate. A through-thickness void was observed at the weld joint of the reinforcement plate (pink arrow).
