# **Report of the Inquiry Committee for the accident at Stars Engrg Pte Ltd on 24 February 2021**

**(PART II – ANNEXES)**

| Report No:<br><b>M21091</b> | Subject Group:<br><b>11219</b> | Date:<br><b>10<sup>th</sup> September 2021</b> |
| Title of Report:<br><b>Failure Analysis of a Failed Mixer Machine Retrieved from Unit 32E of Platinum @ Pioneer Building involved in a Fire Explosion Incident</b> | | Date of Last Revision/Revision No: |

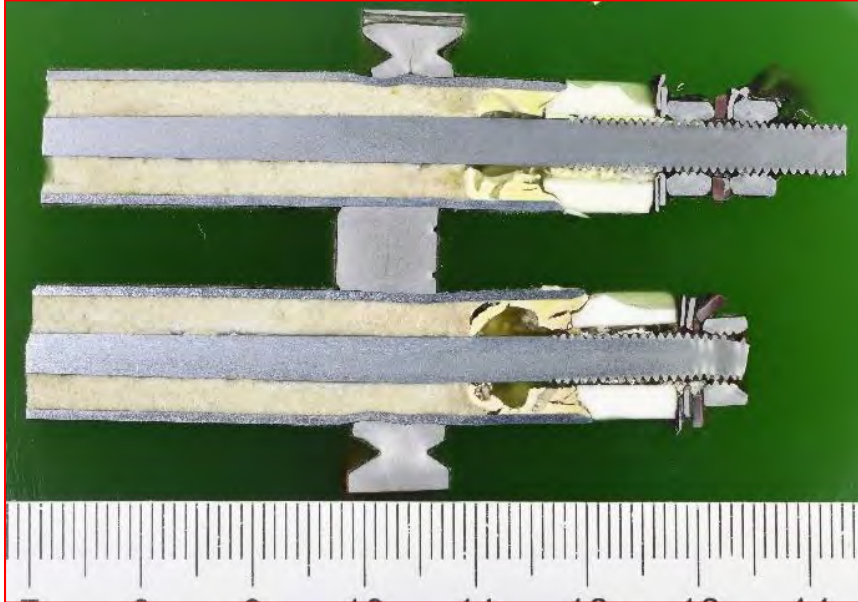
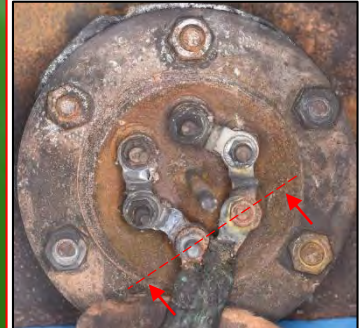
**Figure 177:** A section was made across the two lug-connected-terminals and flange of heater #2. The lug with arcing point was adjusted slightly to achieve the cross sectional view of it.

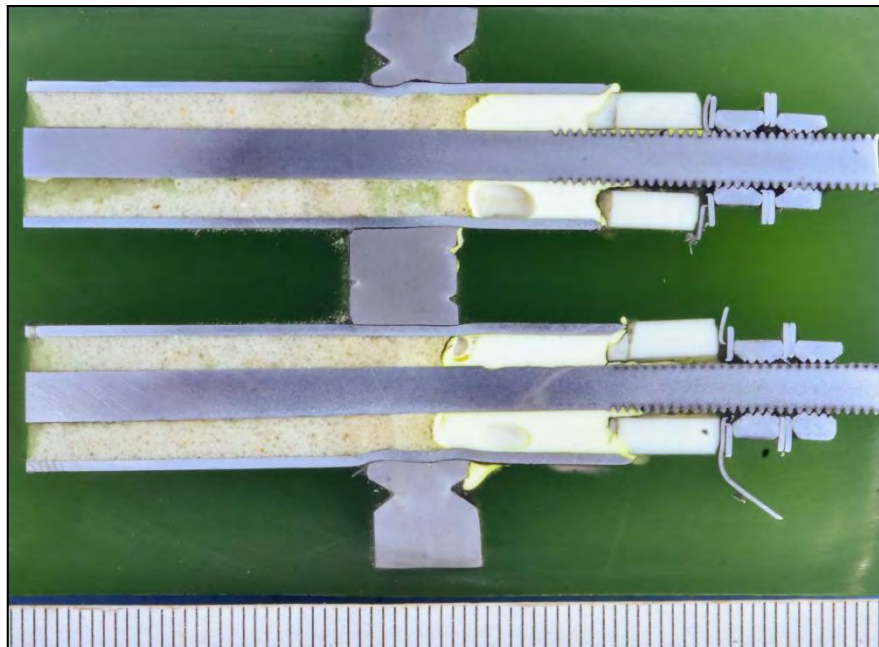
**Figure 178:** A section was made across two terminals and flange of a new heater as reference.

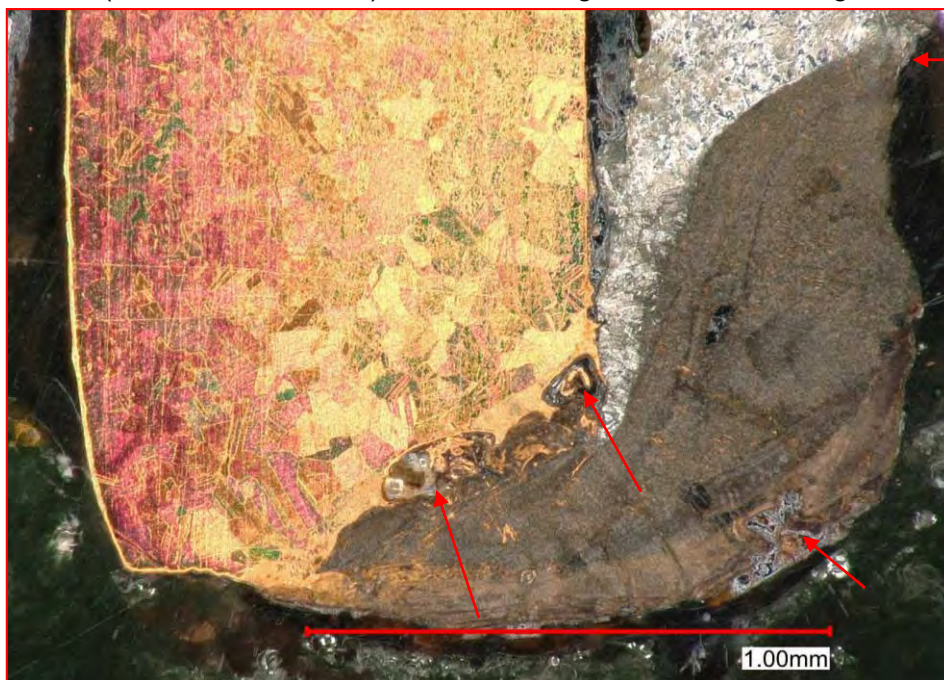
42 ➤ Close up view of the arcing location on the lug (see also Figure 122) revealed  
emanating pattern of metal melting and porosities which confirmed the  
occurrence of arcing (Figure 180).

**Figure 180:** Close up view of the arcing location of the lug (see also Figure 138). The emanating pattern of melting and porosity (red arrows) confirm the arcing at this location.

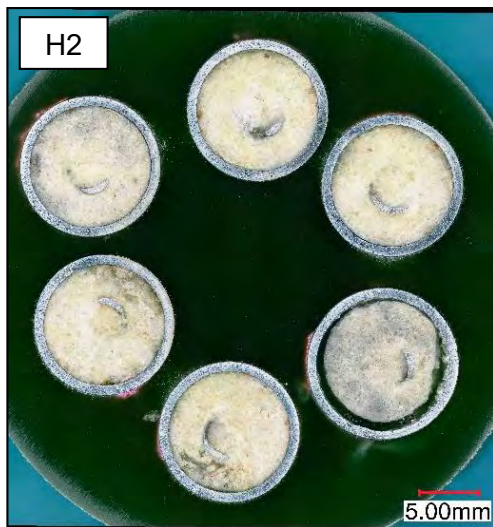
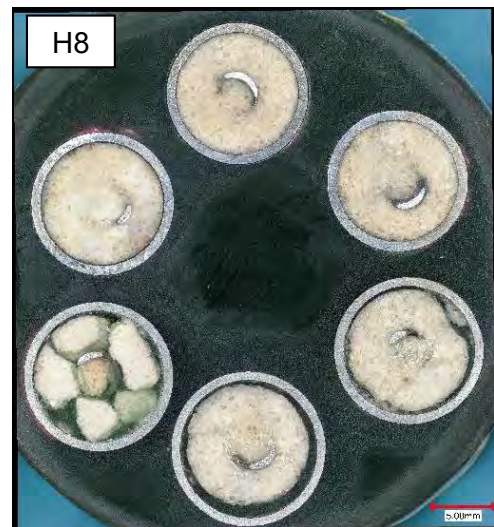
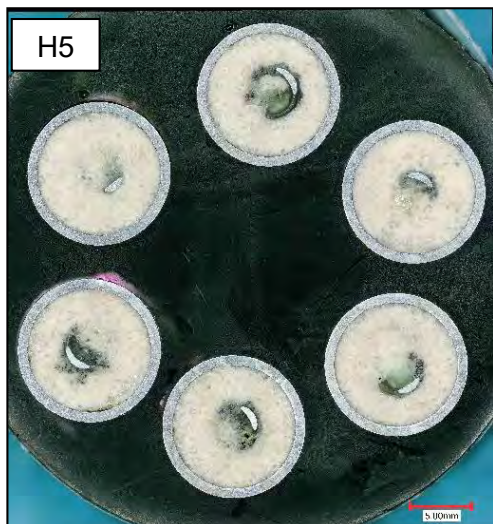
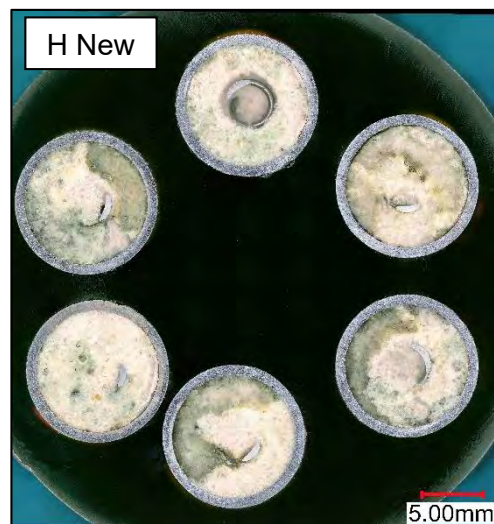
**Figure 181:** Heaters #2, #5 and #8 were sectioned 10 cm from the end of the heaters, across the metal tubes as shown in example above for metallographic examination. A new heater was sectioned the same way for comparison.

**Figure 182:** Cross sections for heater #2 (abbreviated as H2), heater #5 (abbreviated as H5), heater #8 (abbreviated as H8), new heater (abbreviated as H New).

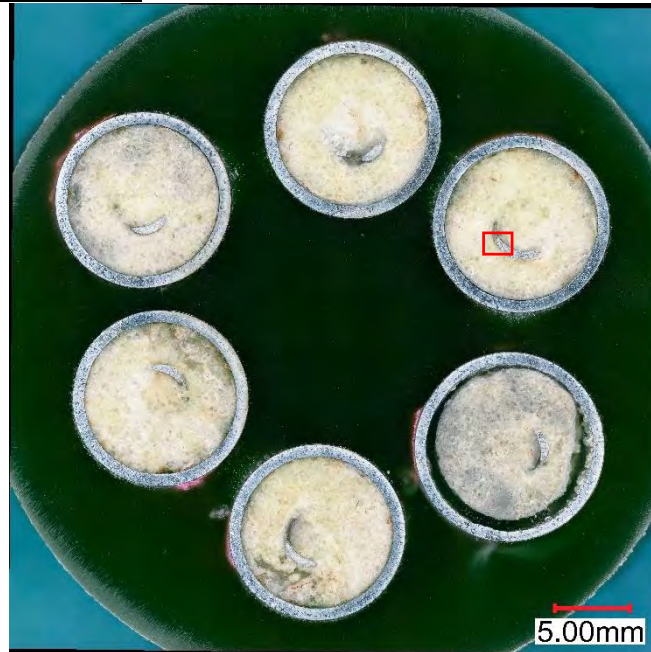
**Figure 183:** Sectional metallographic examination was conducted across metal tubes of heater #2.

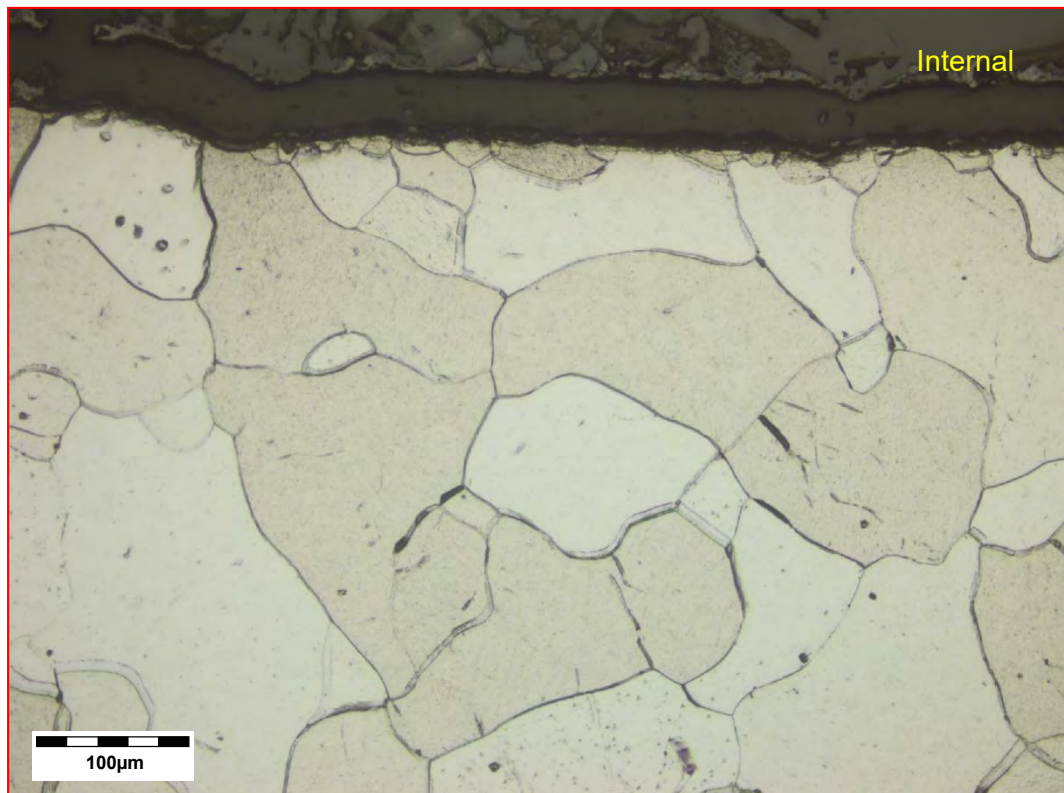
24 ➤ Heater #2 had an average grain size of about 222 µm or ASTM number range  
of 0 – 3 at metal tube corresponding to position of terminal #2 (upper half of  
26 metal tubes located above the centreline of the bore of the heater flange, Figure  
185 and Figure 186) and about 124 µm or ASTM number range of 3 – 4 at metal  
28 tube corresponding to orientation of terminal 4 (lower half of metal tubes located  
below centreline of the bore the heater flange, Figure 187 and Figure 188). The  
centreline of the bore of the heater flange was indicated in Figure 212.

**Figure 186:** Micrograph of the metal tube at 200X magnification (compared with H New, Figure 204).

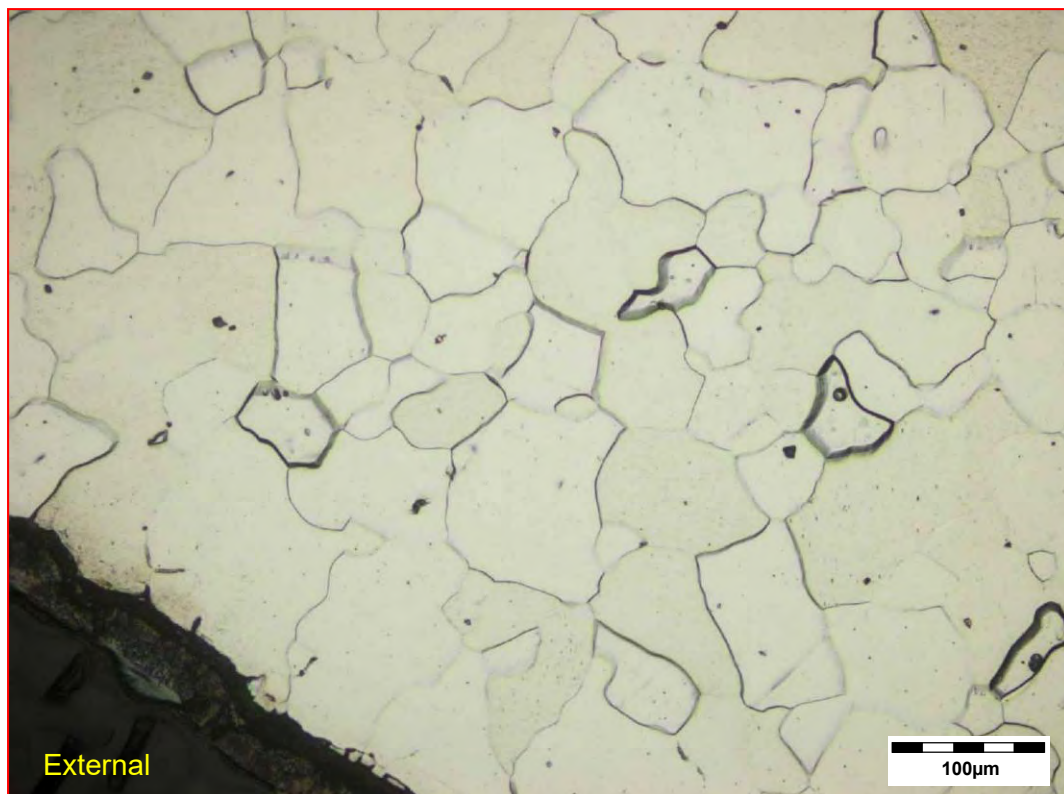
**Figure 188:** Micrograph of the metal tube at 200X magnification (compared with H New, Figure 204).

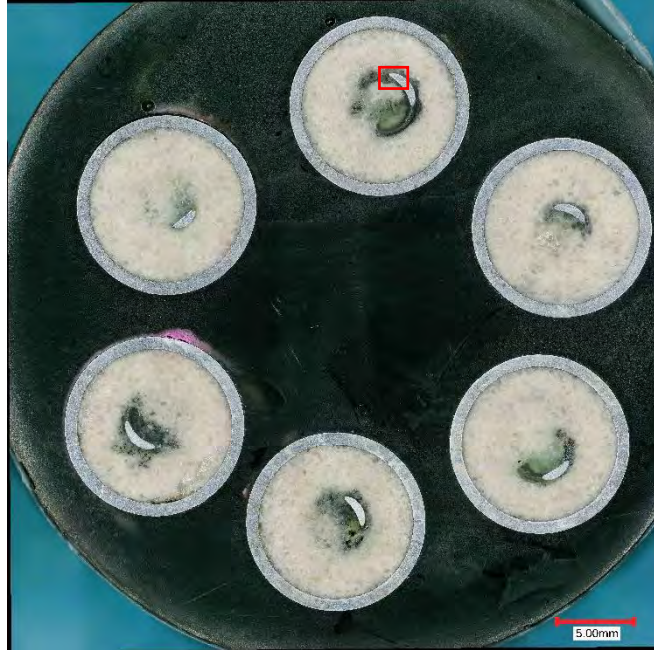
**Figure 189:** Sectional metallographic examination was conducted across metal tubes of heater #5.

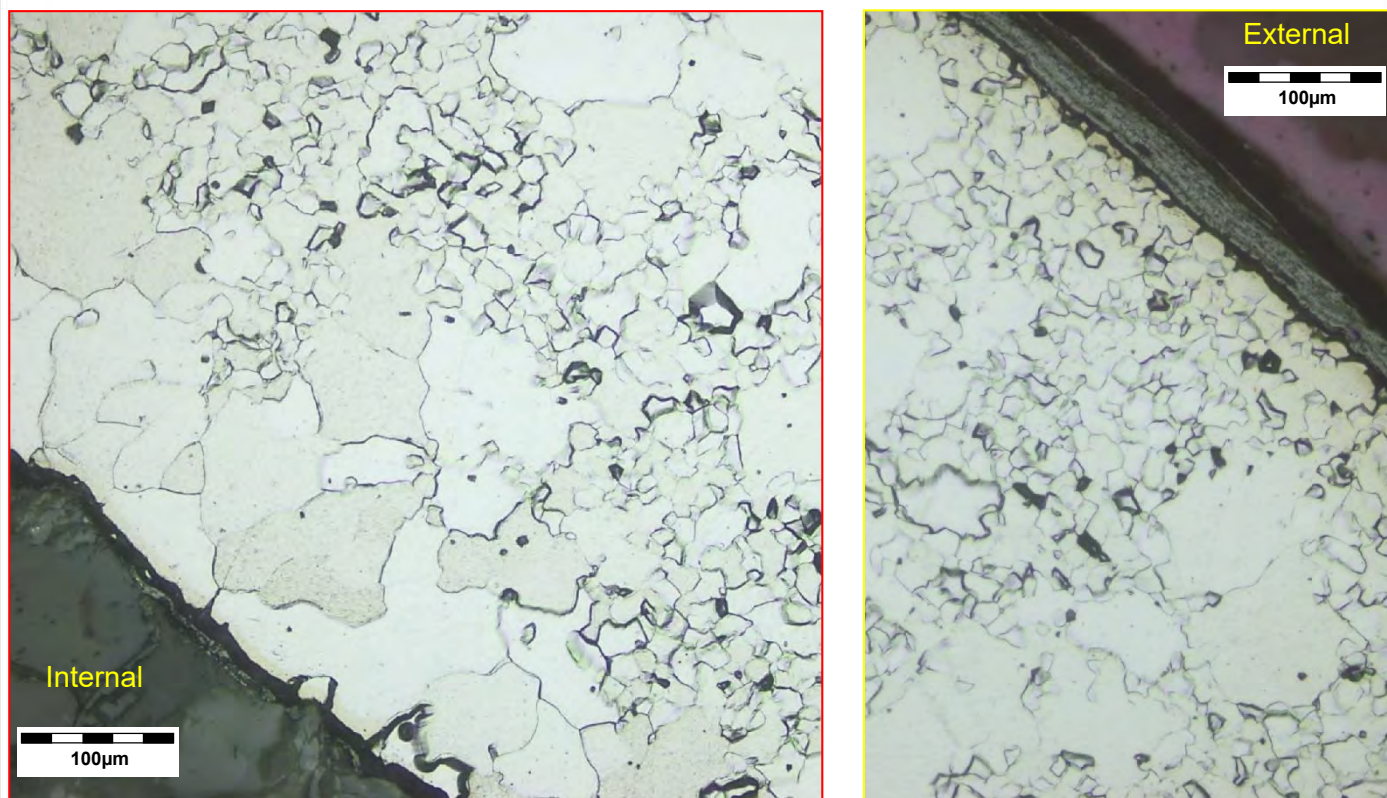
30 ➤ Heater #5 had a mixture of grain sizes where the upper half of the metal tubes  
32 had higher density of large grains compared to lower half of metal tubes. The  
tubes had an average grains size of about 63 µm at metal tube corresponding  
34 to position of terminal 1 (upper half of tubes, Figure 191 and Figure 192) and  
about 58 µm at metal tube corresponding to orientation of terminal 4 (lower half  
36 of tubes, Figure 193 and Figure 194). Both metal tubes’ had grains with a mix  
of sizes ranging between ASTM number 3 – 4 and 8 – 9.

**Figure 192:** Micrographs of the metal tube at 200X magnification (compared with H New, Figure 204).

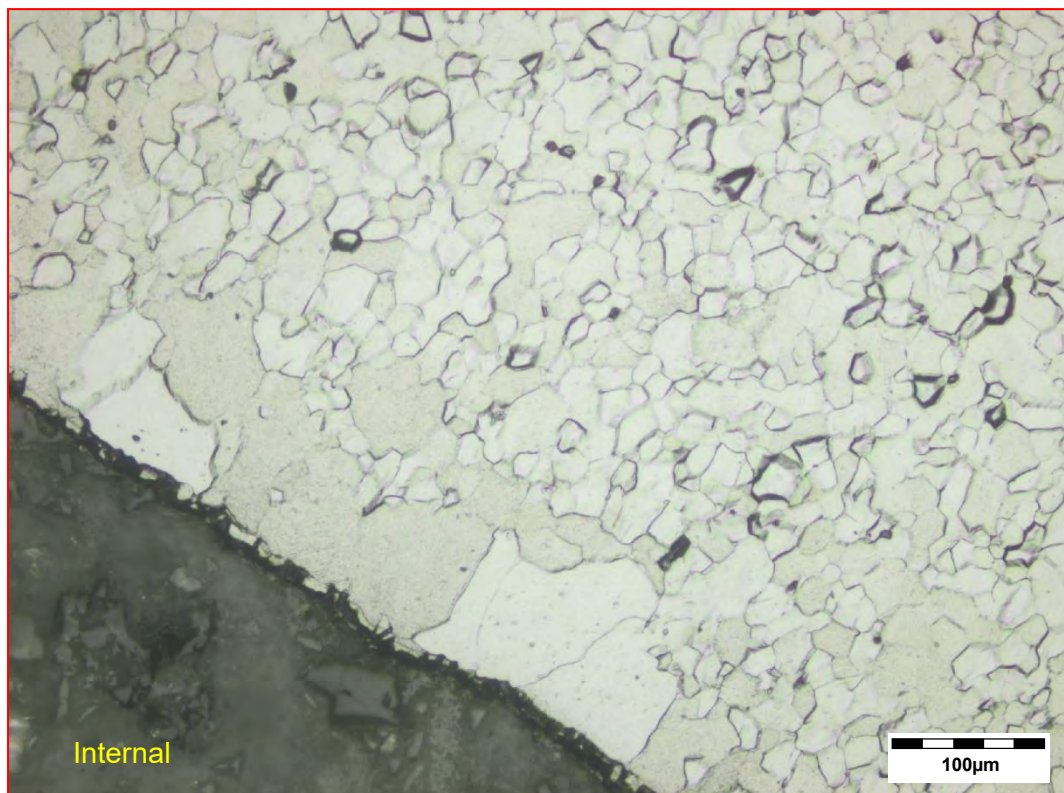
**Figure 194:** Micrograph of the metal tube at 200X magnification (compared with H New, Figure 204).

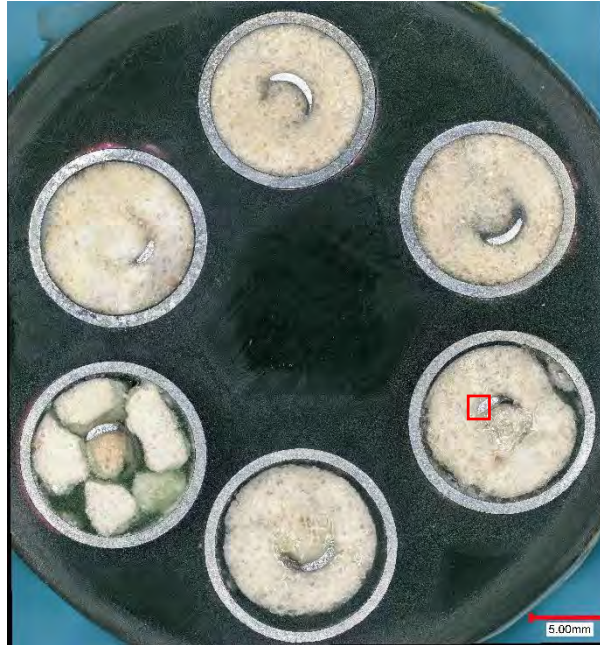
**Figure 195:** Sectional metallographic examination was conducted across metal tubes of heater #8.

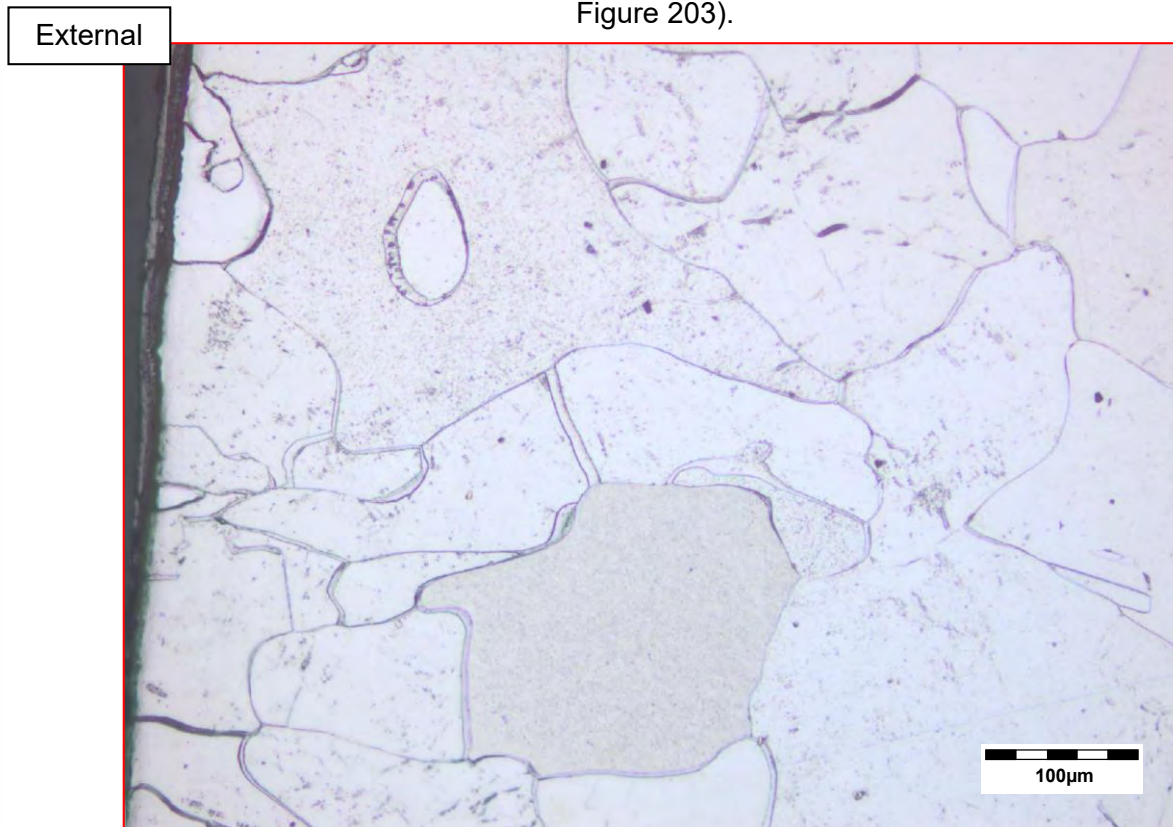
38 ➤ Heater #8 had an average grain size of about 188 µm or ASTM number range  
of 0 – 3 at metal tube corresponding to position of terminal 6 (upper half of  
40 tubes, Figure 197 and Figure 198) and about 110 µm or ASTM number range  
of 3 – 5 at metal tube corresponding to orientation of terminal 3 (lower half of  
tubes, Figure 199 and Figure 200).

**Figure 198:** Micrograph of the metal tube at 200X magnification (compared with H New, Figure 204).

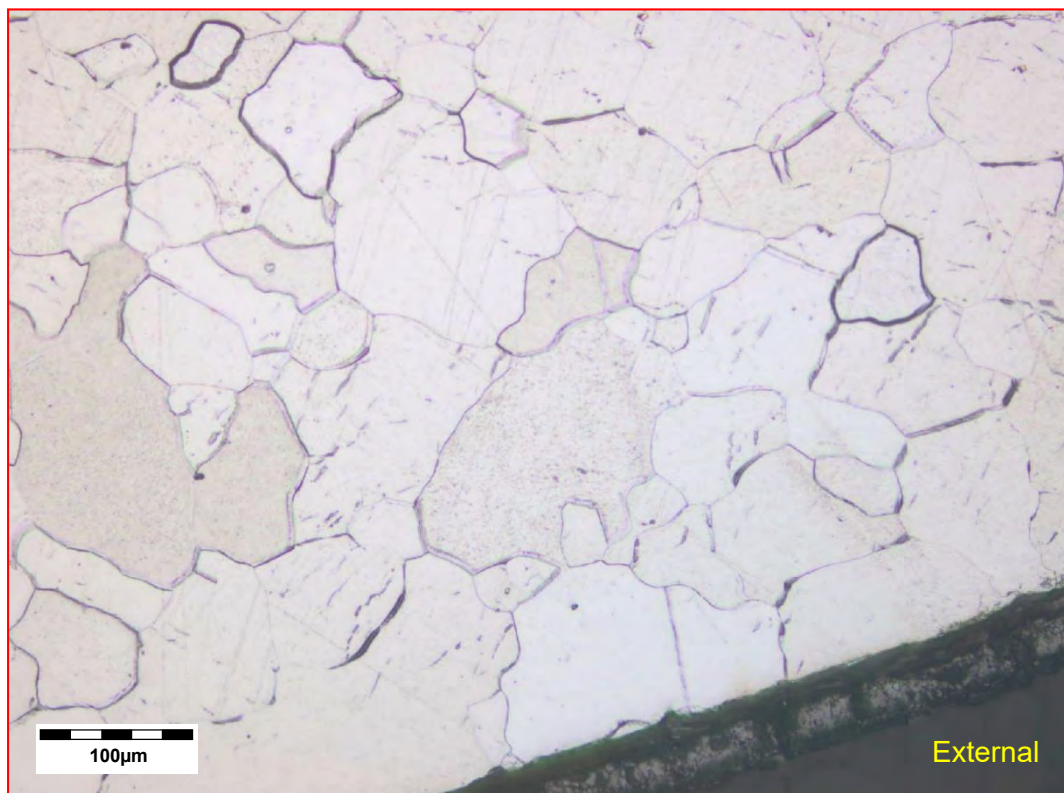
**Figure 200:** Micrograph of the metal tube at 200X magnification (compared with H New, Figure 204).

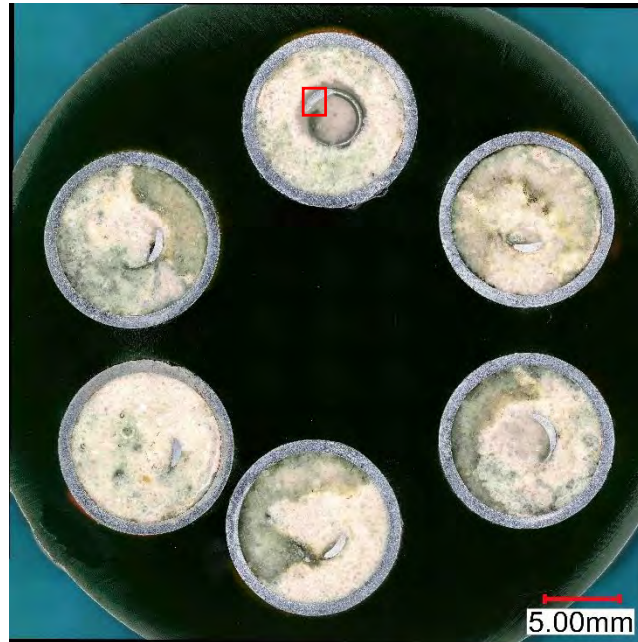
**Figure 201:** Sectional metallographic examination was conducted across metal tubes of new heater.

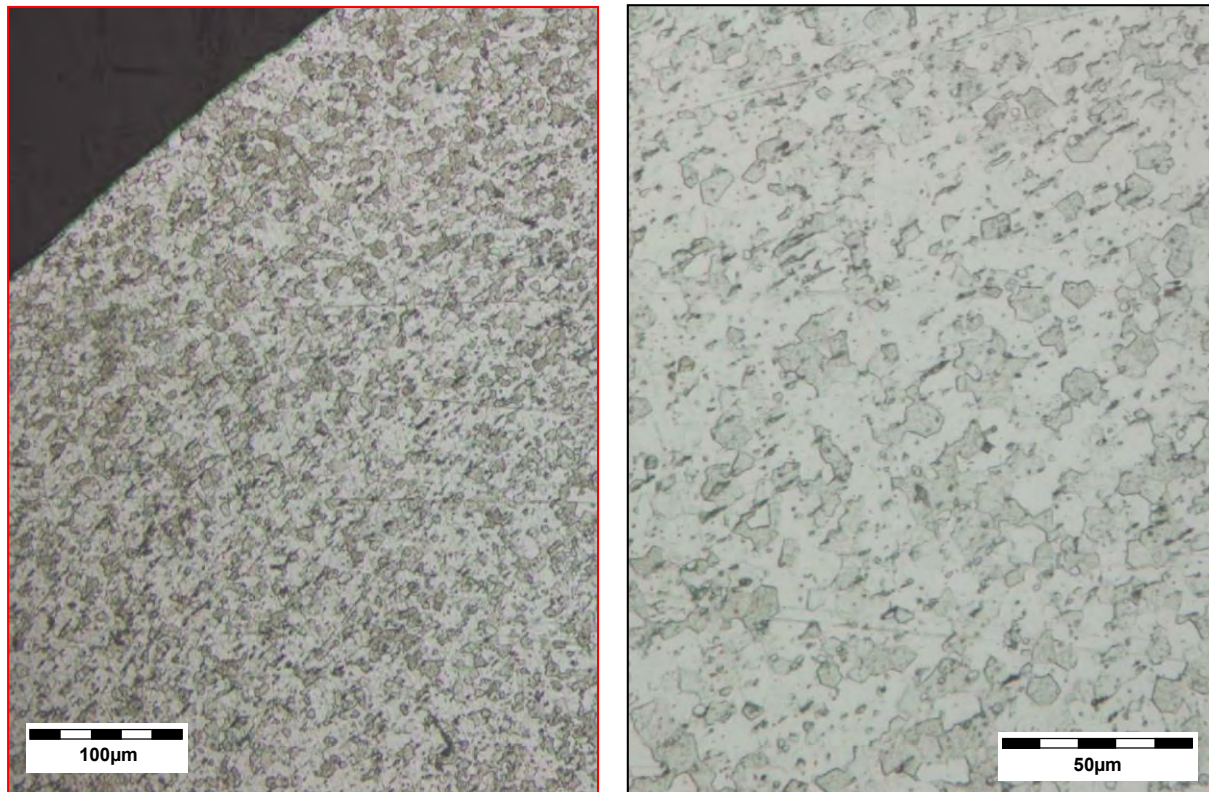
16 ➤ All the resistance wires within the metal tubes of heaters #2 (Figure 184), #5  
18 (Figure 190) and #8 (Figure 196) were generally similar in microstructure and  
had experienced grain growth to similar degree when compared to the  
resistance wire in the new and unused heaters (Figure 202).

**Figure 202:** Micrographs of the resistance wire at 200X (left) and 500X (right) magnifications. All the resistance wires were generally similar in microstructure and grain size. The grain size is significantly smaller compared with the other examined heaters.

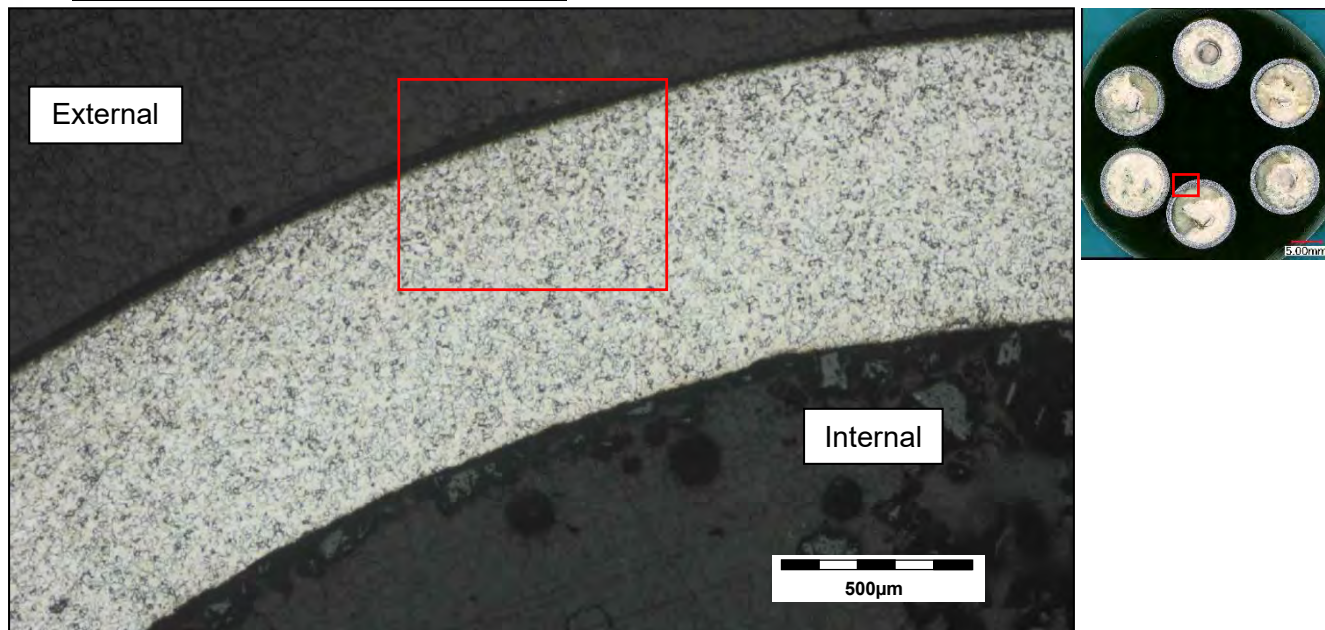
14 ➤ The new heater had an average grains size of about 9 µm or ASTM number  
range of 9 – 10 throughout all the metal tubes (Figure 203 and Figure 204).

**Figure 203:** Micrograph of the metal tube at 50X magnification. All the metal tubes were generally similar in microstructure. The grain size is significantly smaller compared with the other examined heaters.

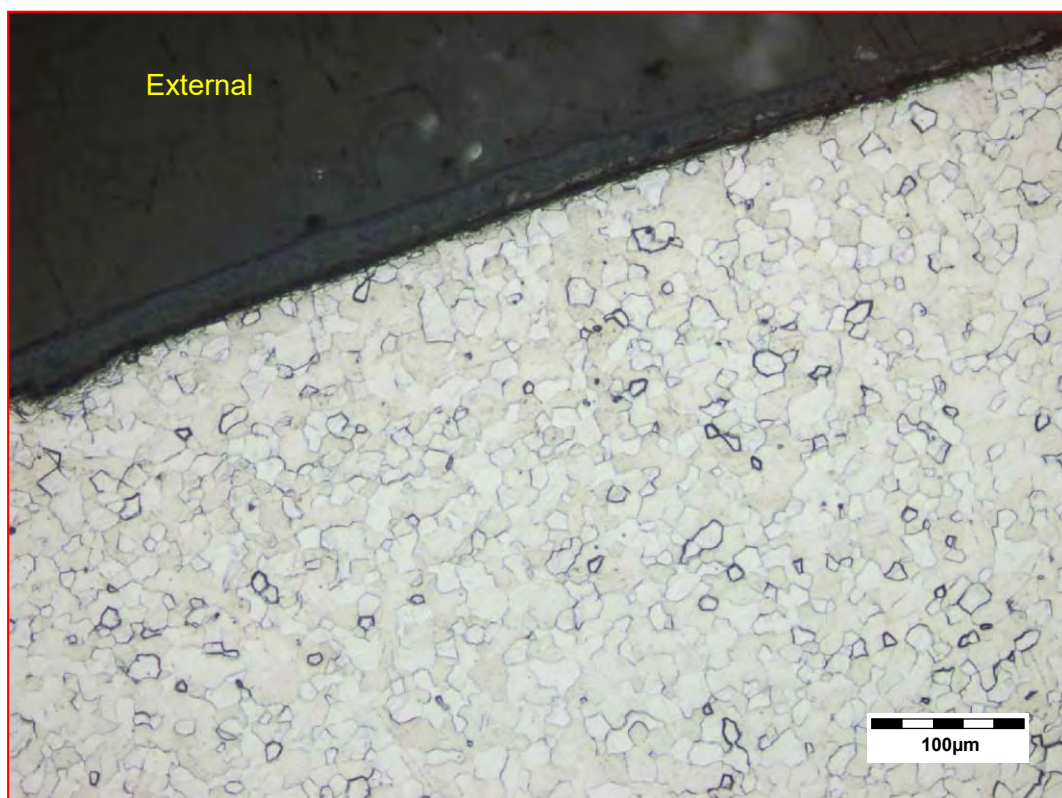
**Figure 204:** Micrograph of the metal tube at 200X magnification.

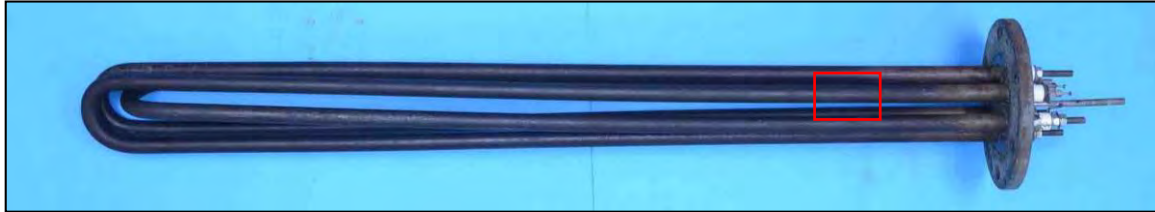
4 Additionally, the heater with blisters was sectioned across one of its blistered metal  
tubes for examination (Figure 205 to Figure 210).

**Figure 205:** The used heater with blisters were sectioned across one of the blister.

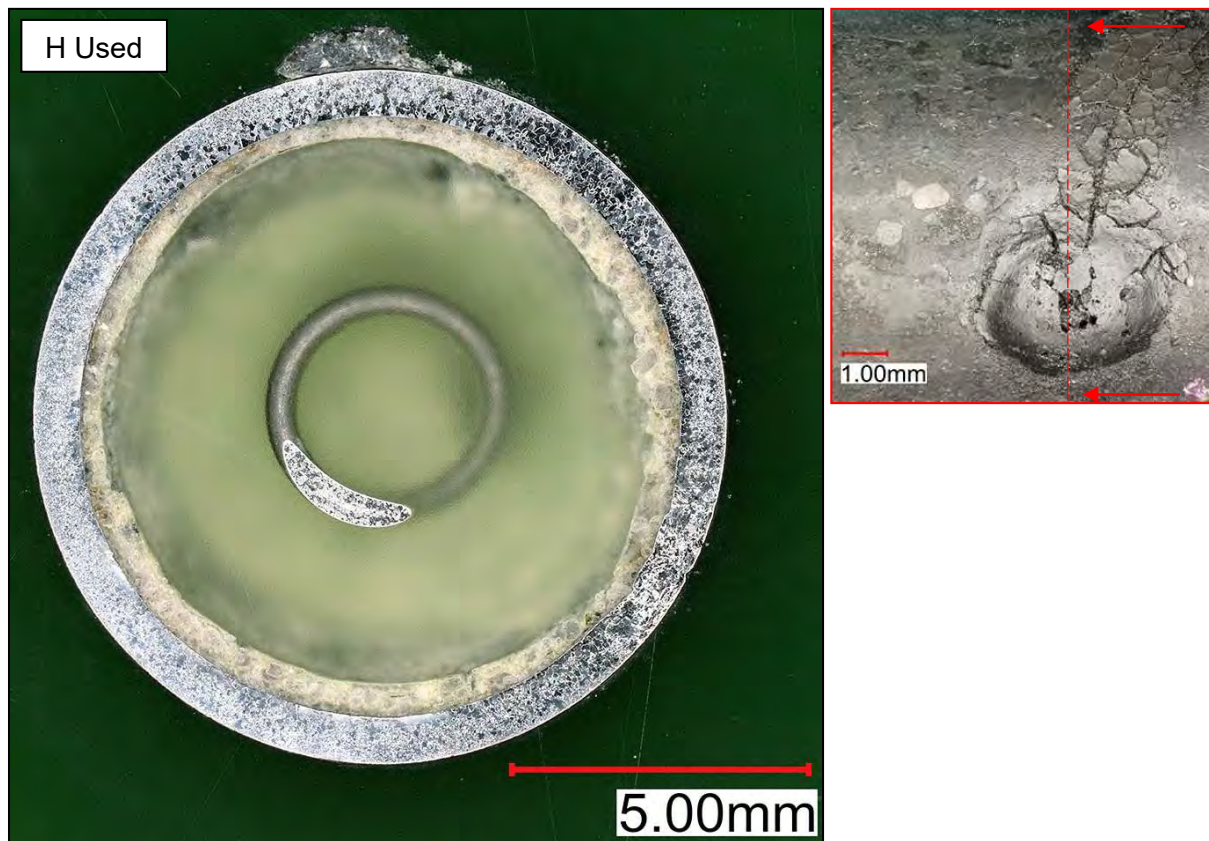
**Figure 206:** Cross section across the blister, metal tube and resistor wire of the used heater.  
The insulation powder inside the metal tube was removed for ease of metallographic examination.

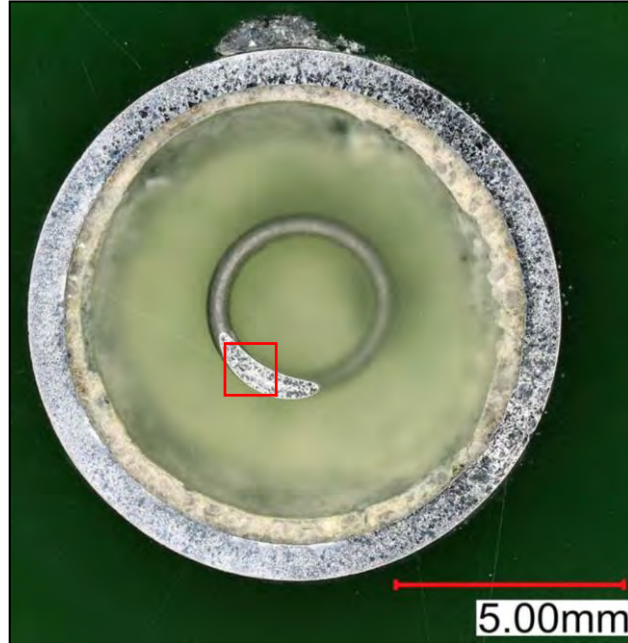
**Figure 207:** Sectional metallographic examination was conducted across a metal tube with blister of used heater.

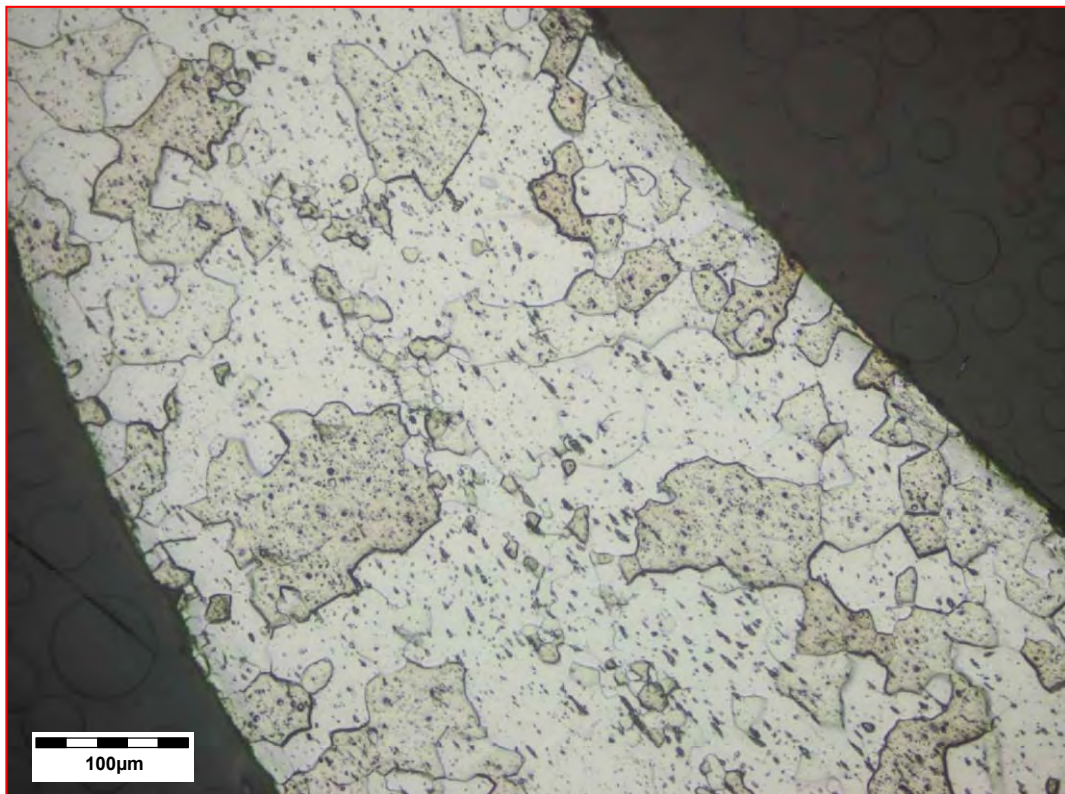
**Figure 208:** Micrograph of the resistance wire at 200X magnification. The resistance wire had experienced grain growth (compared with H New, Figure 202).

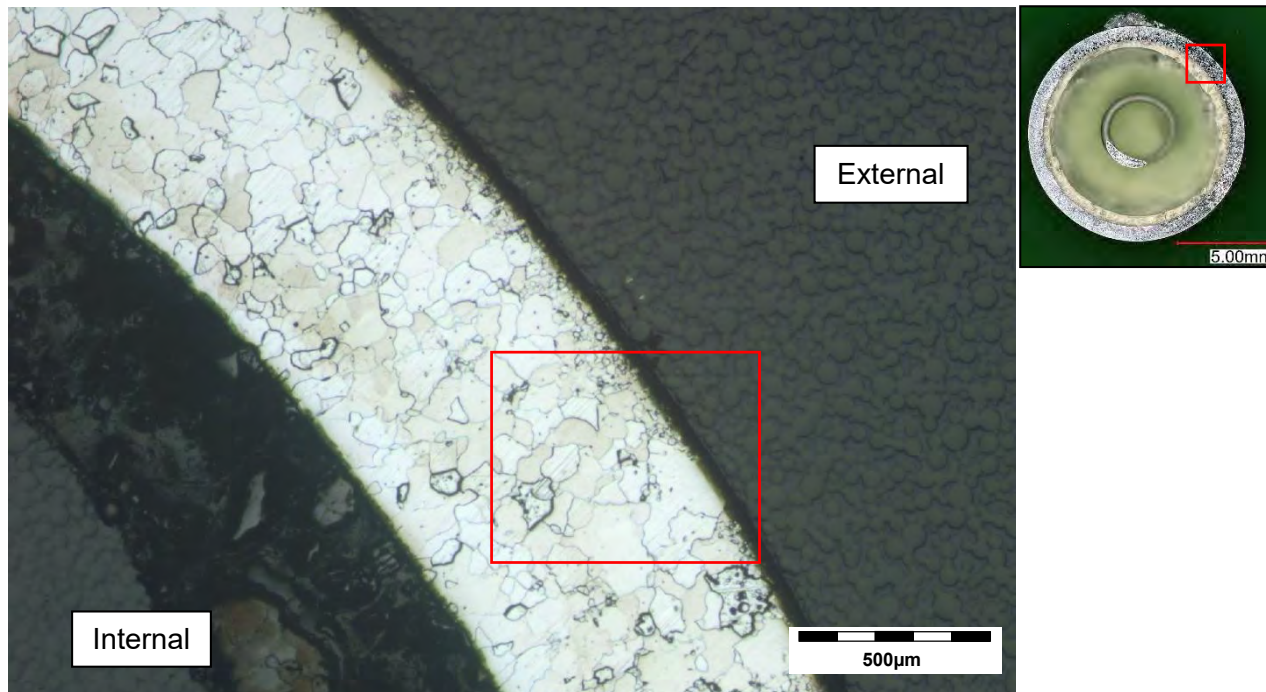
- 6 ➤ The metal tubes had an average grain size of about 106  $\mu\text{m}$  or ASTM number  
range of 3 – 4, indicating that it had been used and experienced grain growth  
8 (Figure 209 and Figure 210).

**Figure 209:** Micrograph of the metal tube at 50X magnification. All the metal tubes were generally similar in microstructure and had experienced grain growth (compared with H New, Figure 203).

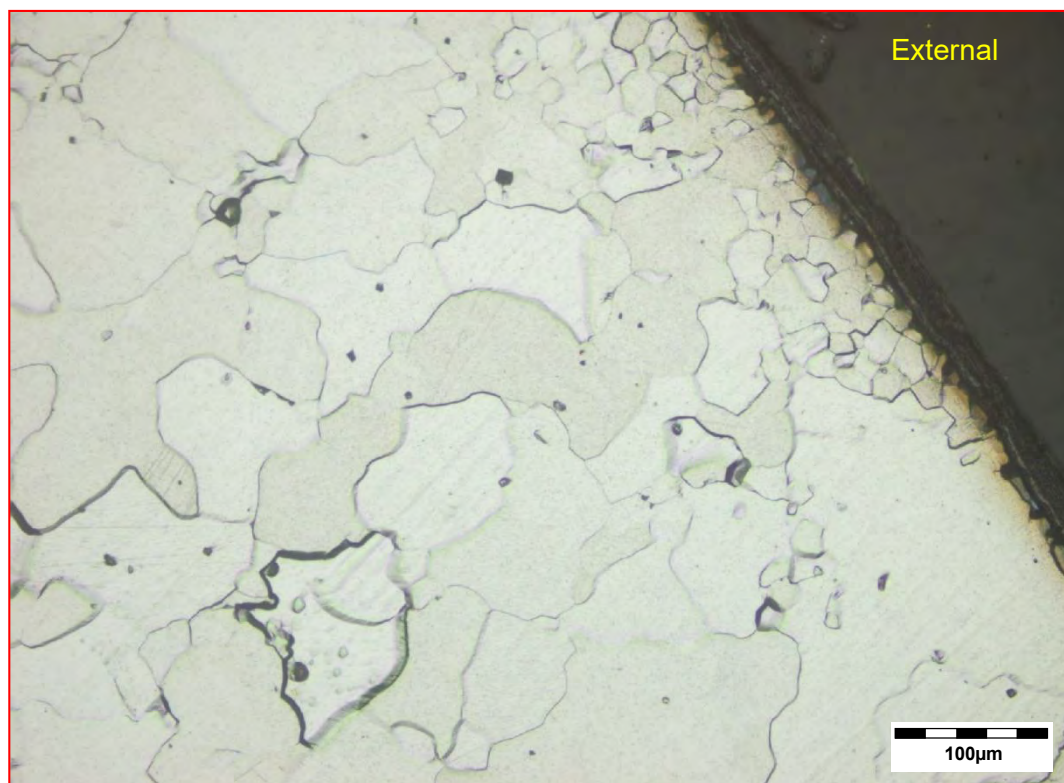
**Figure 210:** Micrograph of the metal tube at 200X magnification (compared with H New, Figure 204).

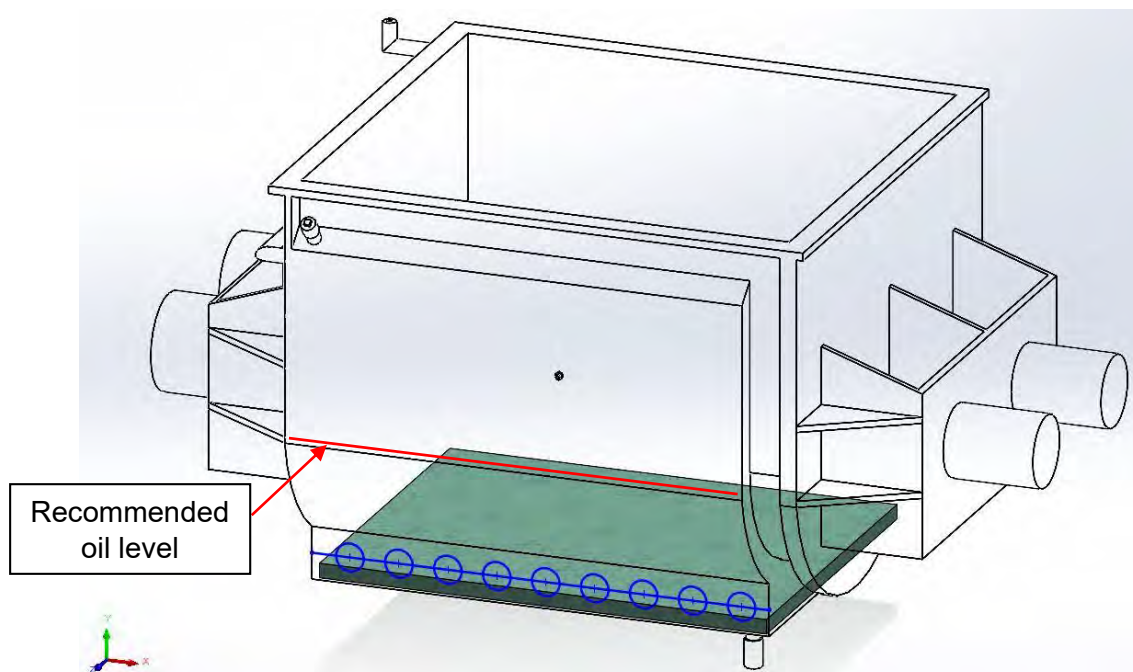
#### 40L oil level

**Figure 211:** 3D model showing the oil fill level at 40L. The level is estimated to be below the heaters.

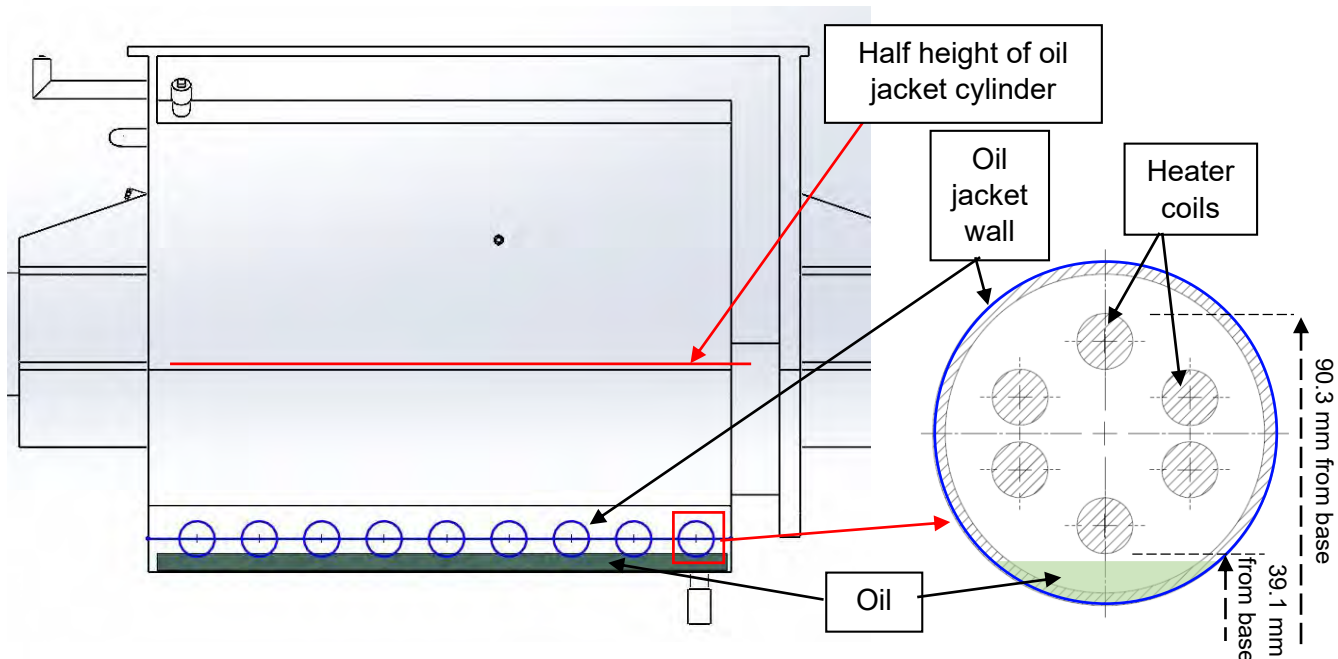
**Figure 212:** 3D model showing the oil fill level at 40L. The level is estimated to be 27 mm below the centreline of heaters.

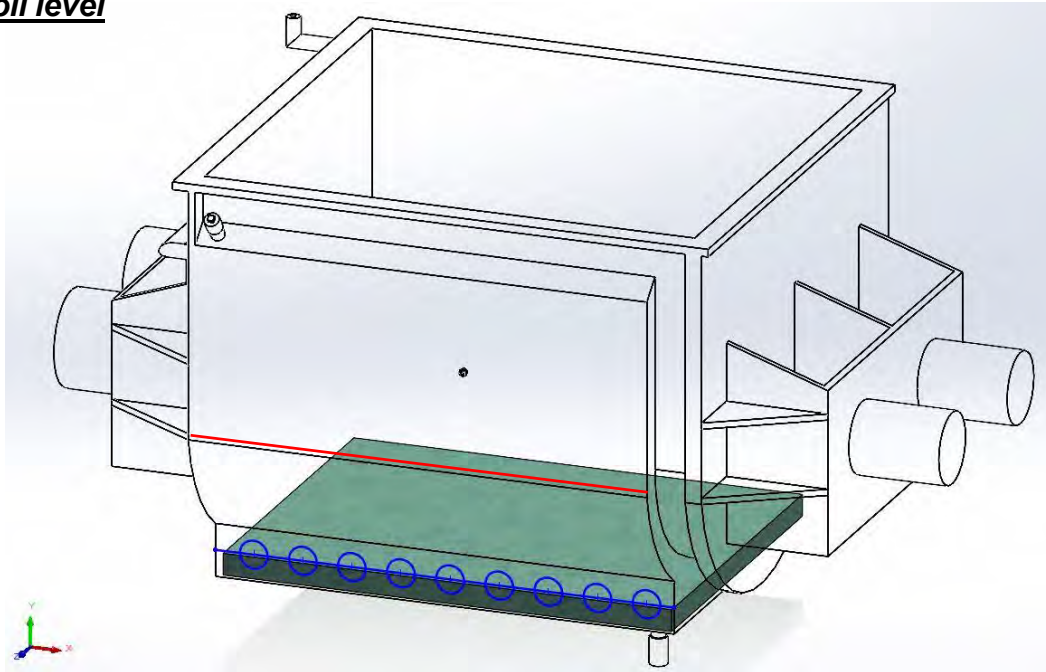
#### 60L oil level

**Figure 213:** 3D model showing the oil fill level at 60L. The level is estimated to be slightly below the centreline of the heaters.

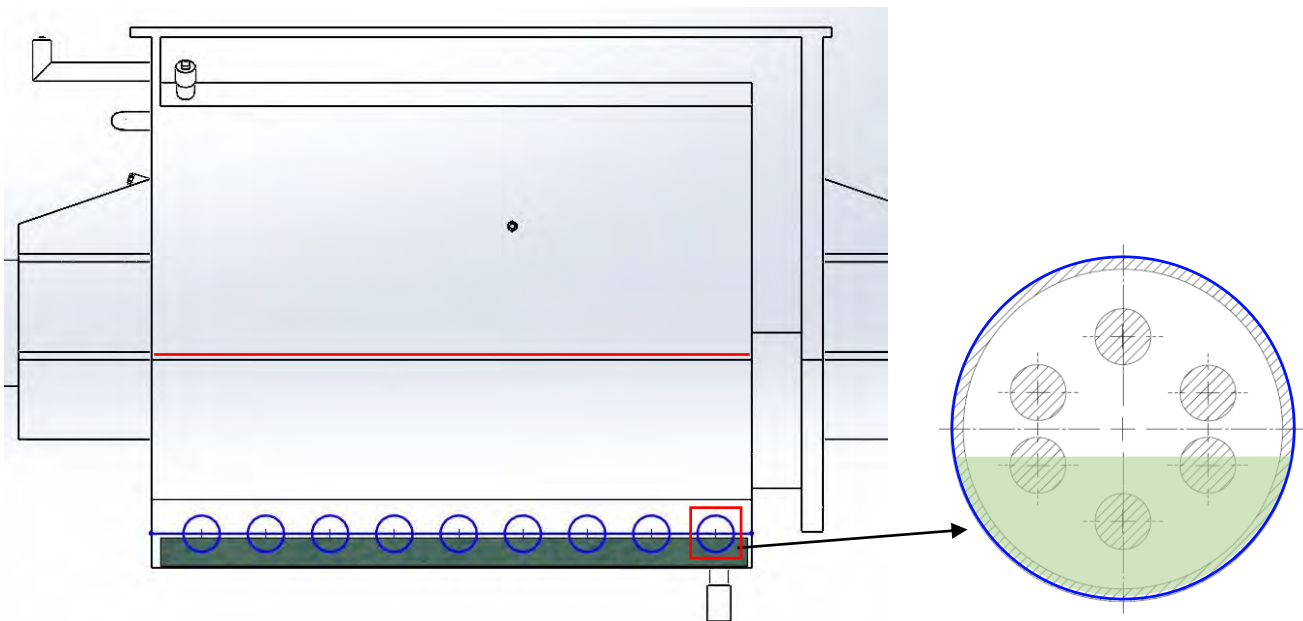
**Figure 214:** Model showing the oil fill level at 60L. The level is estimated to be 8 mm below the centreline of the heaters.

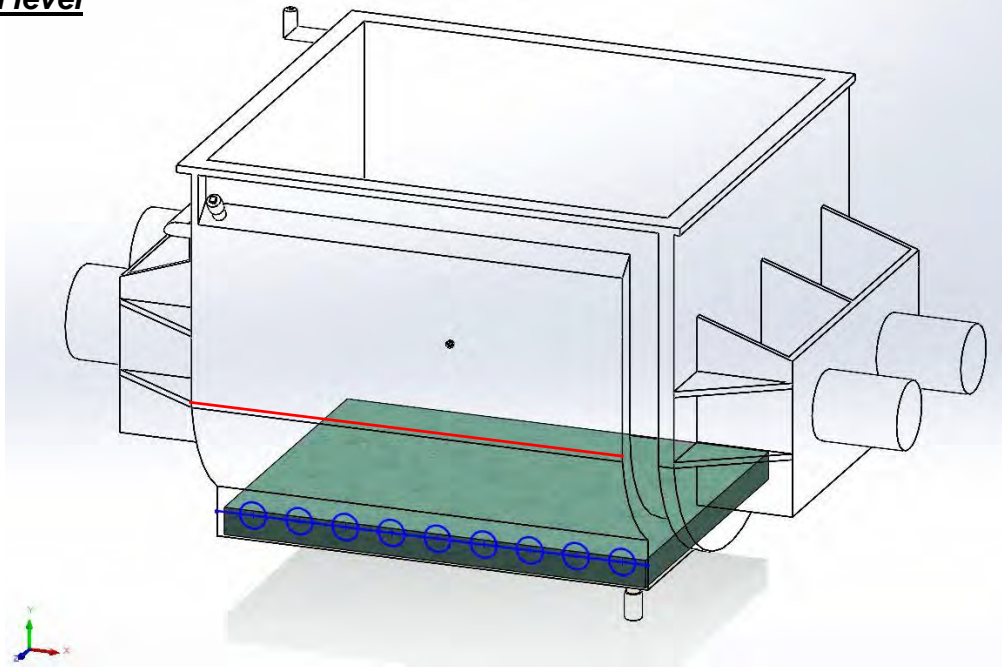
#### 80L oil level

**Figure 215:** 3D model showing the oil fill level at 80L. The level is estimated to be slightly above the centreline of the heaters.
