# **Report of the Inquiry Committee for the accident at Stars Engrg Pte Ltd on 24 February 2021**

**(PART II – ANNEXES)**

| Report No:<br><b>M21091</b> | Subject Group:<br><b>11219</b> | Date:<br><b>10<sup>th</sup> September 2021</b> |
| Title of Report:<br><b>Failure Analysis of a Failed Mixer Machine Retrieved from Unit 32E of Platinum @ Pioneer Building involved in a Fire Explosion Incident</b> | | Date of Last Revision/Revision No: |

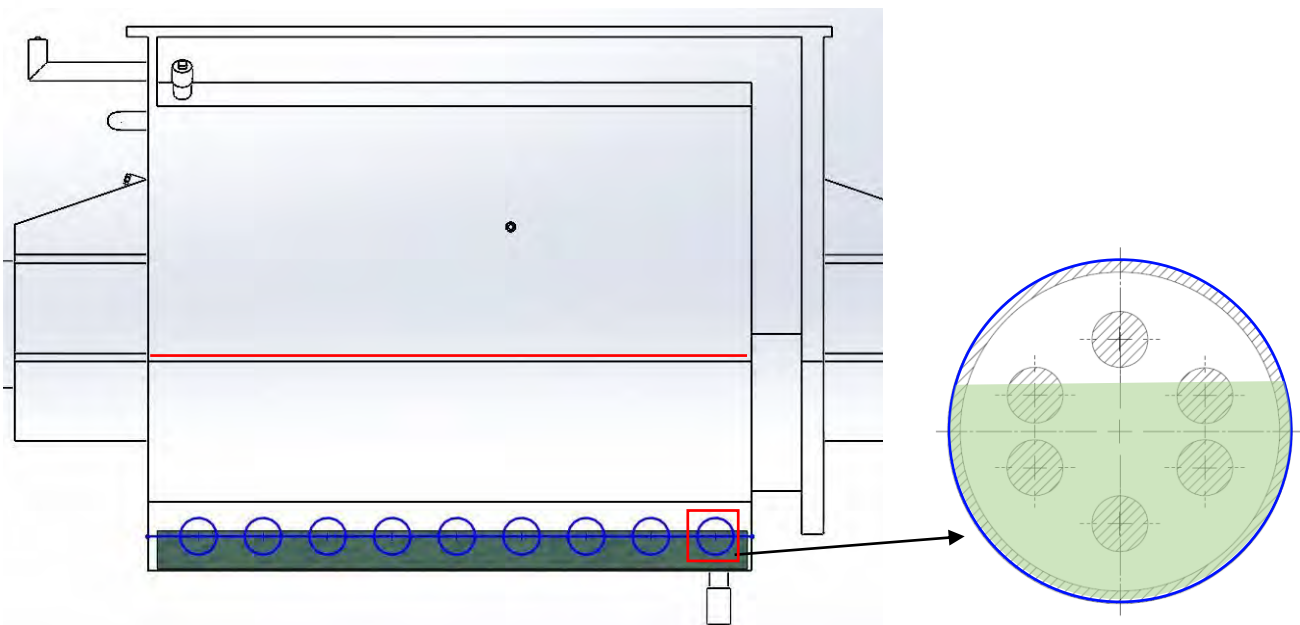
**Figure 216:** 3D model showing the oil fill level at 80L. The level is estimated to be 10 mm above the centreline of the heaters.

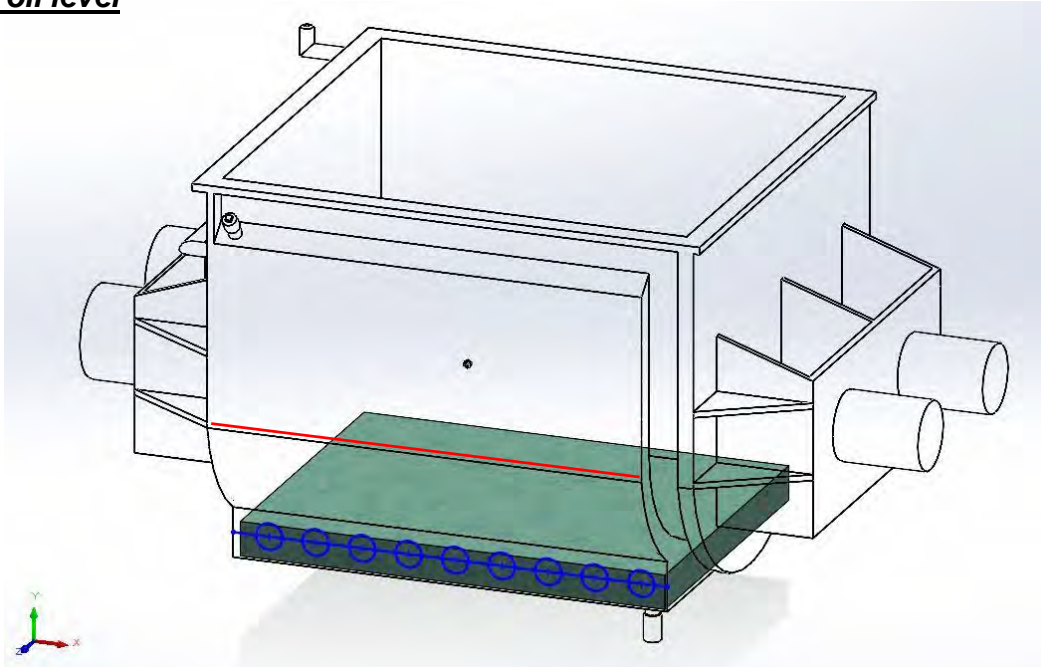
#### 100L oil level

**Figure 217:** 3D model showing the oil fill level at 100L. The level is estimated to be slightly above the centreline of the heaters.

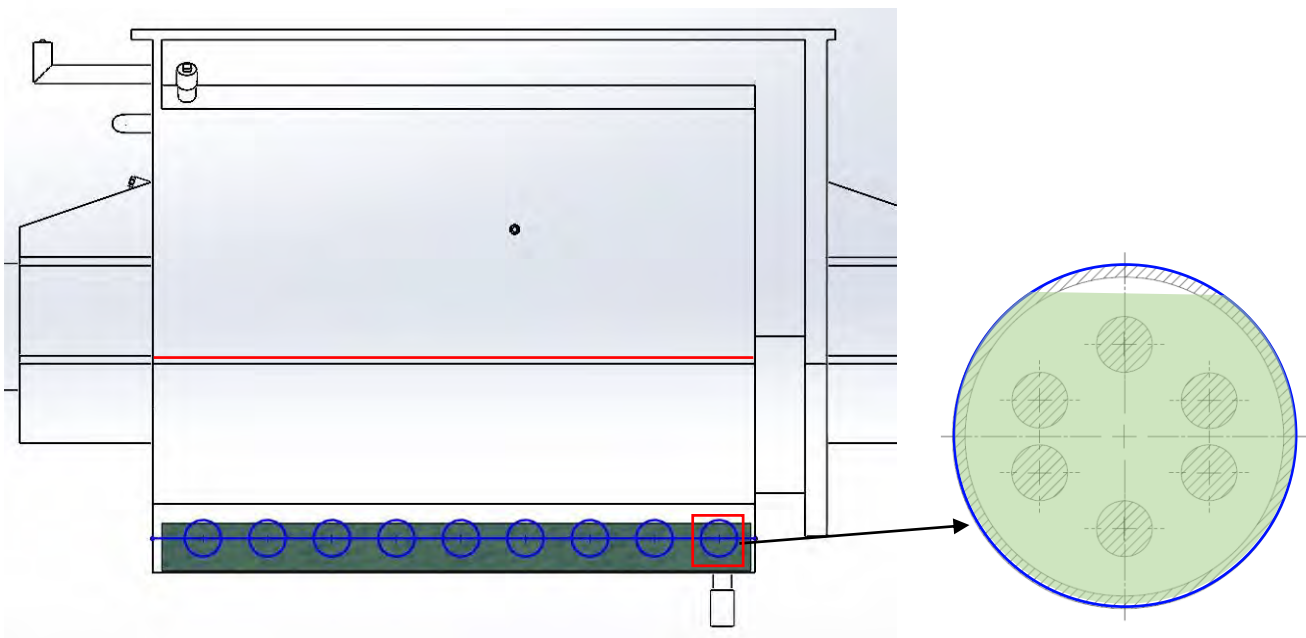
**Figure 218:** 3D model showing the oil fill level at 100L. The level is estimated to be 30 mm above the centreline of the heaters.

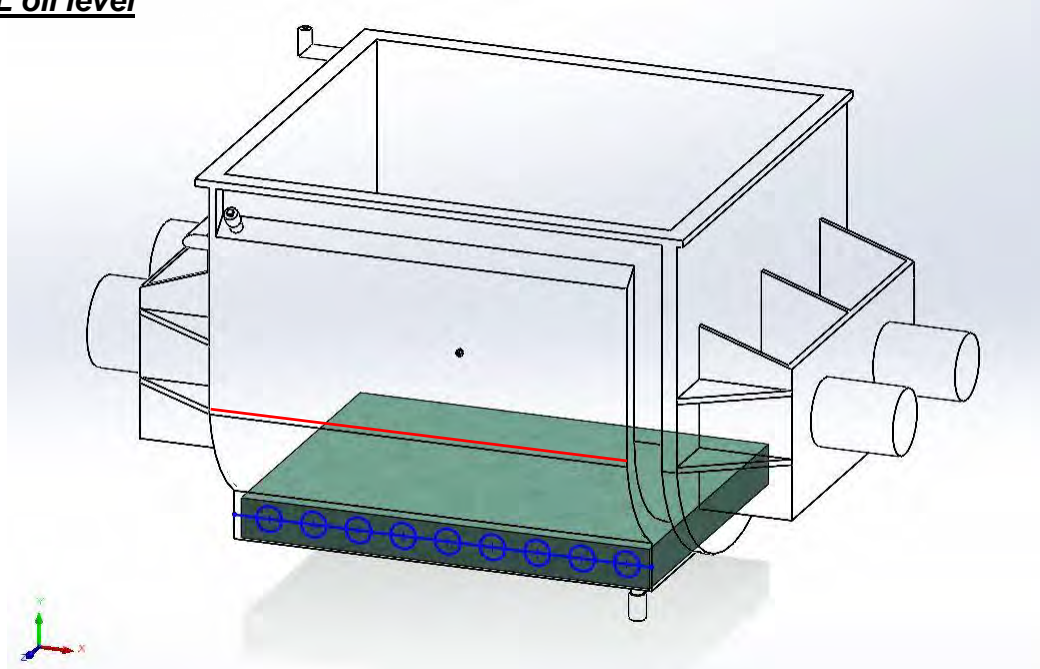
#### 120L oil level

**Figure 219:** 3D model showing the oil fill level at 120L. The level is estimated to be slightly above the centreline of the heaters.

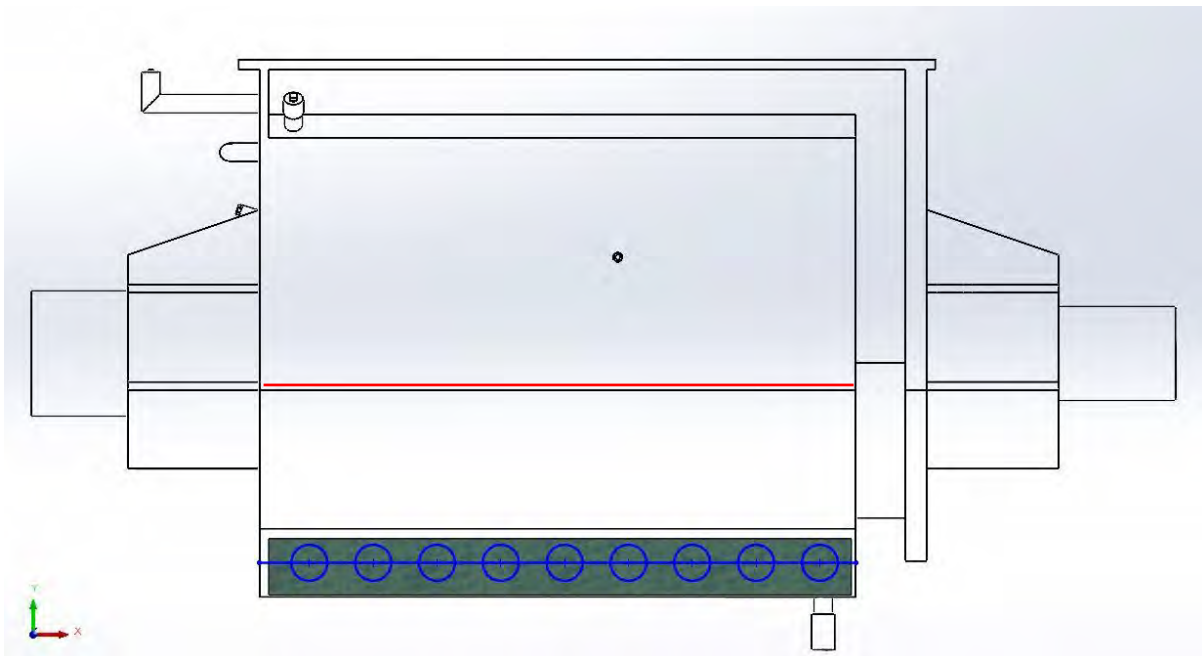
**Figure 220:** 3D model showing the oil fill level at 120L. The level is estimated to be fully covering the heaters.

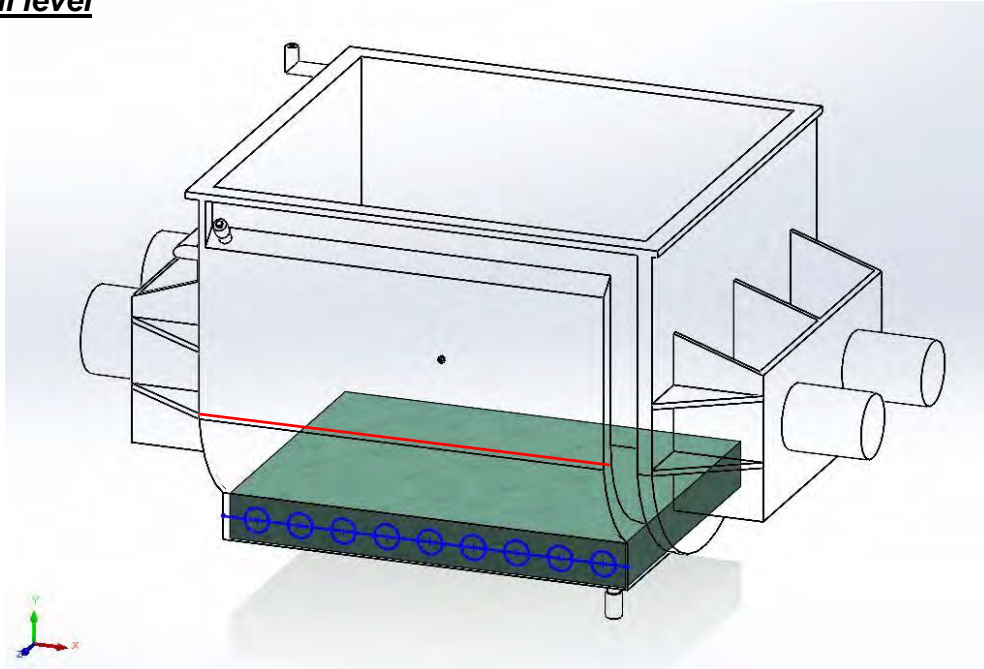
#### 140L oil level

**Figure 221:** 3D model showing the oil fill level at 140L. The level is estimated to be slightly above the centreline of the heaters.

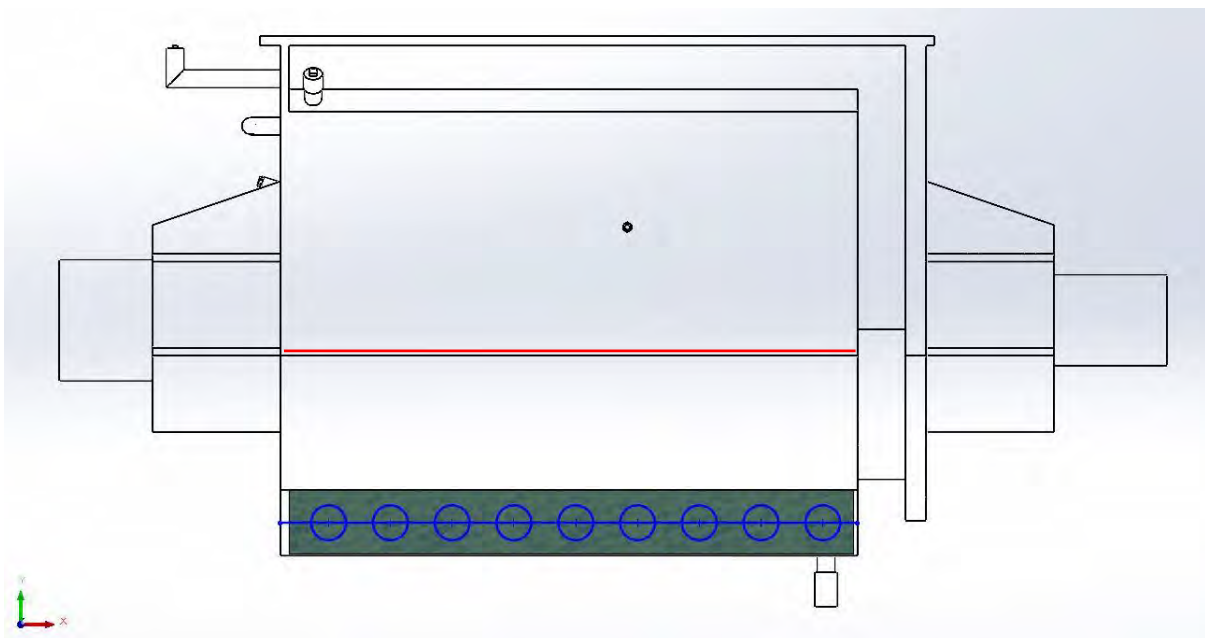
**Figure 222:** 3D model showing the oil fill level at 140L. The level is estimated to be fully covering the heaters.

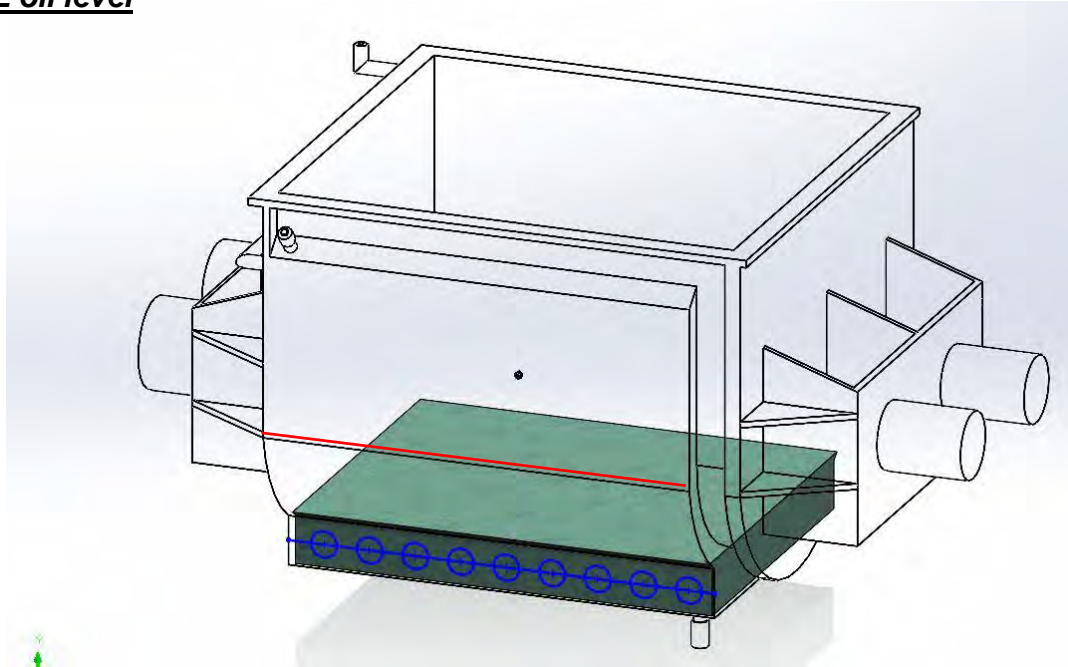
#### 160L oil level

**Figure 223:** 3D model showing the oil fill level at 160L. The level is estimated to be slightly above the centreline of the heaters.

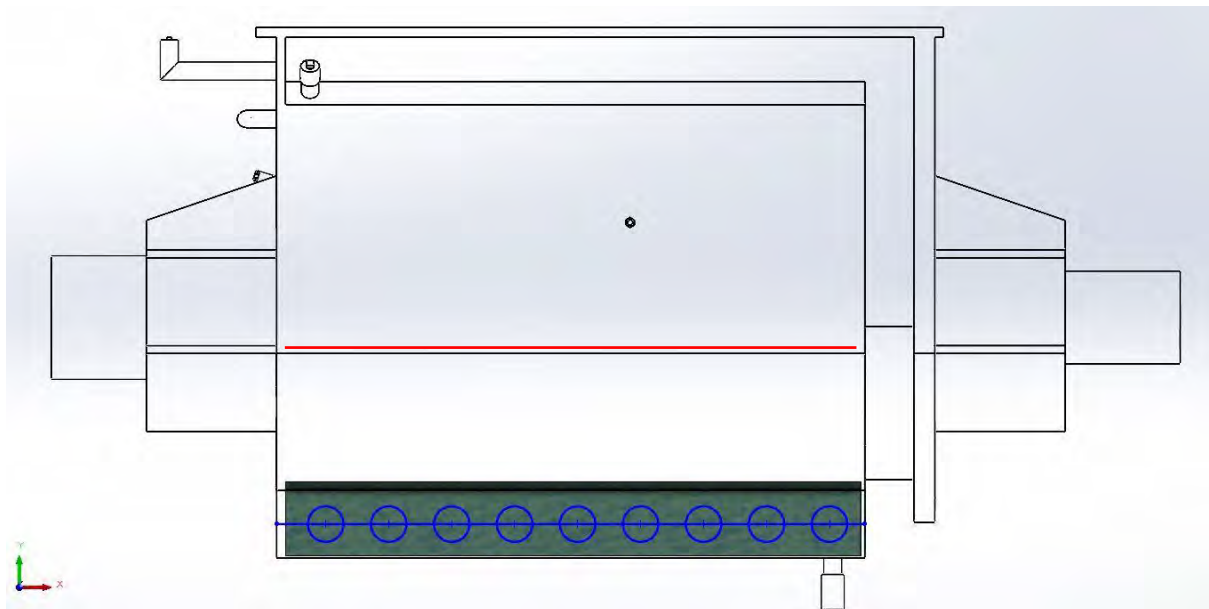
**Figure 224:** 3D model showing the oil fill level at 160L. The level is estimated to be fully covering the heaters.

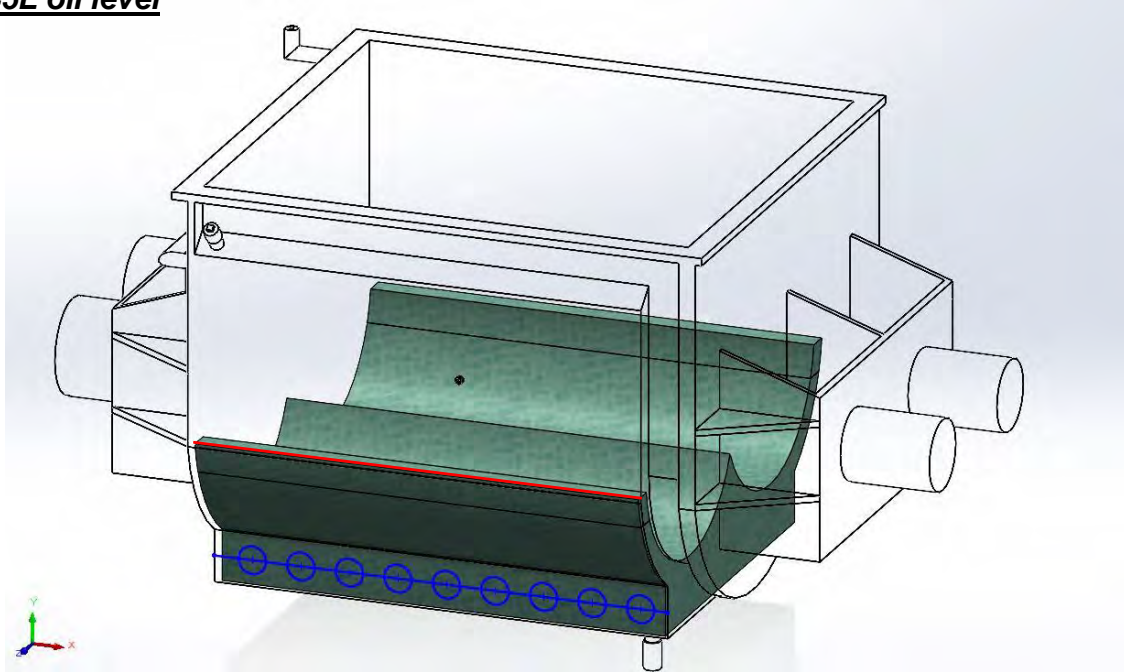
#### 245L oil level

12 Based on the background information provided, the oil jacket did not have sufficient  
oil inside during its operating life. The User Guide states that heat conduction oil is to  
14 be added up to half the height of the cylinder (as stated in Section 3.7). The 3D model  
shows that the amount of oil needed to fill to the stated level is approximately 245L  
16 (Figure 225), much higher than the initial 40L or subsequent 80L.

**Figure 225:** 3D model showing the oil fill level at 245L. This is the estimated volume needed to filled up to half the mixing cylinder height as per the User Guide.

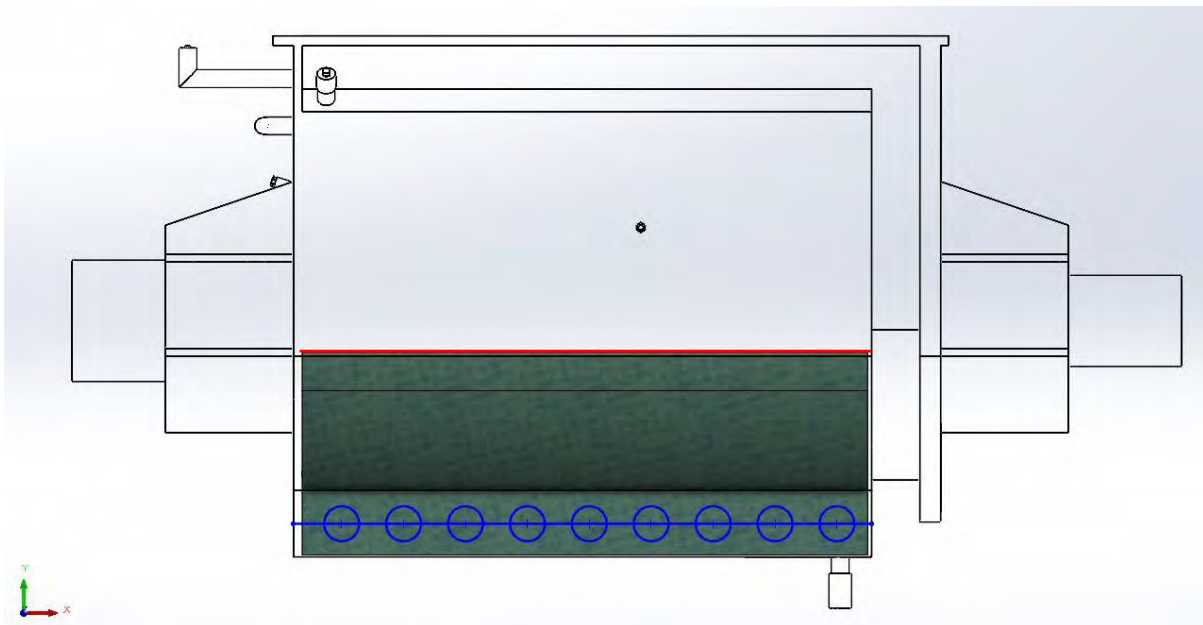
**Figure 226:** 3D model showing the oil fill level at 245L. This is the estimated volume needed to filled up to half the mixing cylinder height as per the User Guide.

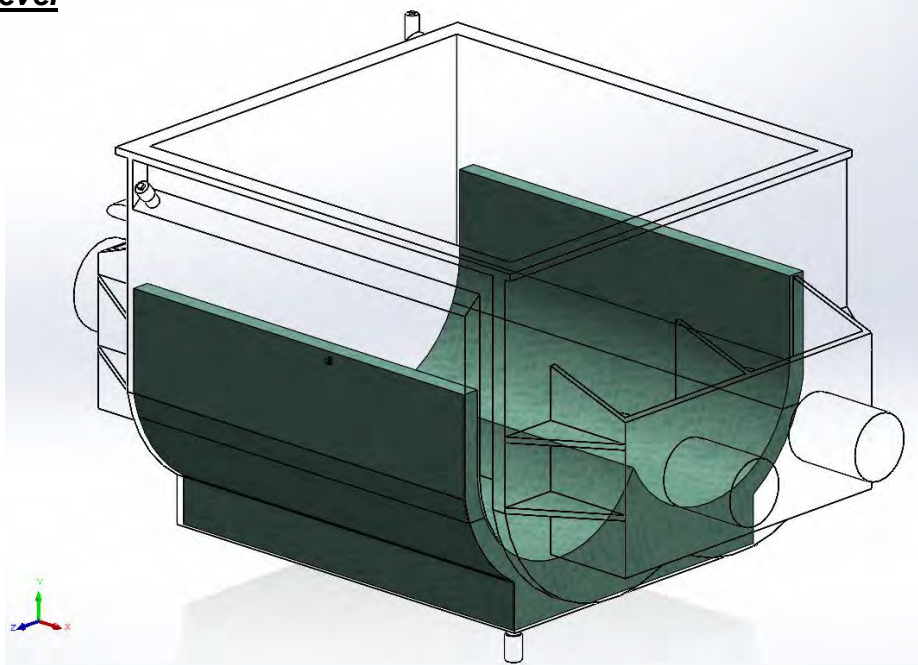
#### 279L oil level

**Figure 227:** 3D model showing the oil fill level at 279L. This is the estimated volume needed to filled up to half the height of the oil jacket's RTD measure points.

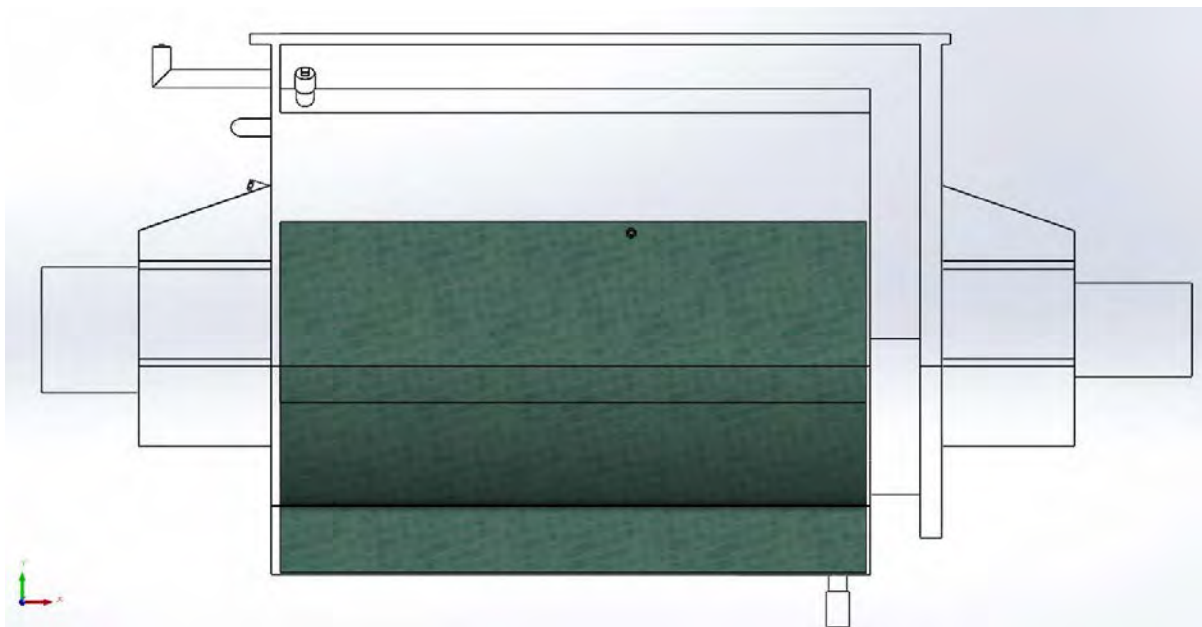
**Figure 228:** 3D model showing the oil fill level at 279L. This is the estimated volume needed to filled up to half the height of the oil jacket's RTD measure points.

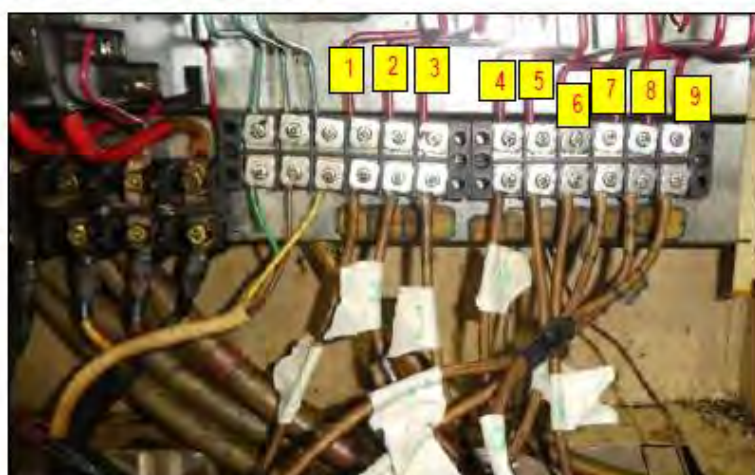
The termination of the heating coil wires

The above figure was furnished by Mr. Ashley Ng from Matcor, showing the termination of the heater wires in the LCP before removal on site. The wires terminated to the contactors are numbered (in yellow box) from left to right. The contactors correspond to the 3 switches at the top of the panel. Each switch controls the group of heaters linked to contactors 1 to 3, 4 to 6, and 7 to 9.

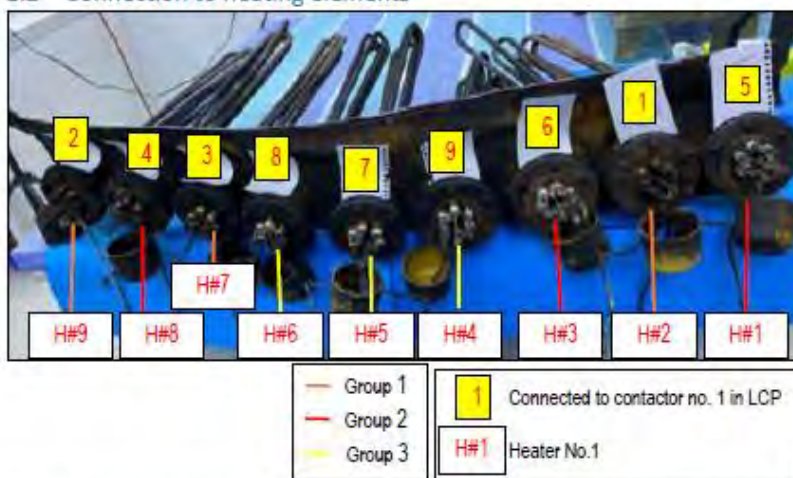
### 1.2 Connection to heating elements

The figure above shows the 9 heaters and their corresponding wire termination in the LCP contactors.

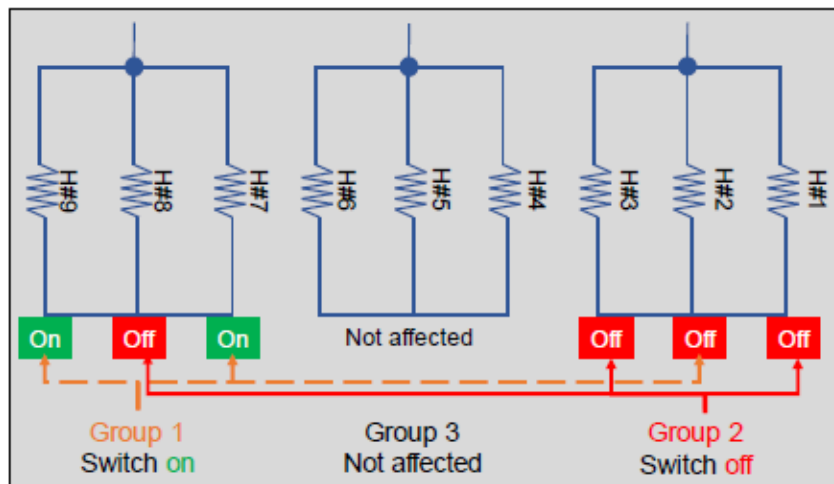
The termination for Group 1 & Group 2 heater switches to the heaters were incorrect. Such termination results in lower heating output if the switch for either group 1 or group 2 is turned off. This is depicted in the following sketch.

*Operating state of heating coils when switch for Group 1 is turned on and switch for Group 2 is turned off.*

When the switch for Group 1 heaters (consist of H#2, H#7 and H#9) is turned on and switch for Group 2 heaters (consist of H#1, H#3 and H#4) is turned off, only H#7 and H#9 will operate. This result in a 2/3 of heating output instead of the full 3 heaters capacity.

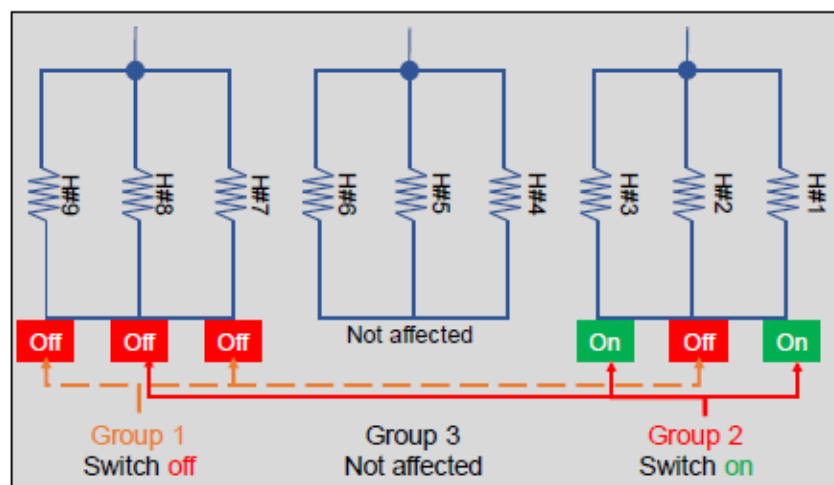
*Operating state of heating coils when switch for Group 2 heaters is turned on and switch for Group 1 is turned off.*

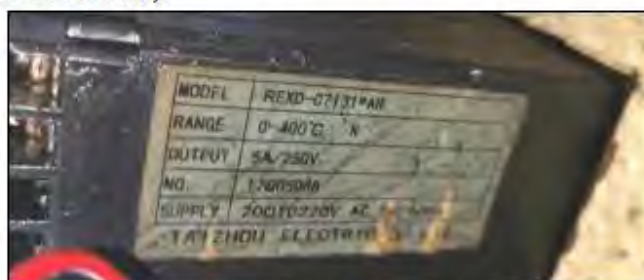
- The 3 groups of heaters' contactors are interlocked with the "Jacket Temperature" thermostat. This means that all the heaters will stop heating when the "Jacket Temperature" thermostat detects a temperature (through RTD sensor) that exceed a pre-set temperature. The thermostat, serial number REXD-C7131\*AN, has a detective temperature range of 0 - 400°C (see Annex for specification sheet of thermostat with model "REXD-C7131\*AN").

*Label with serial number and specification of the thermostat.*

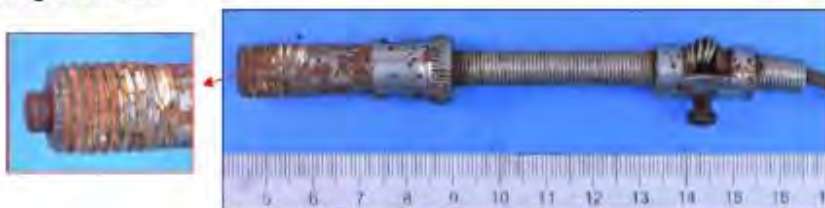
- RTD A resembled a 2-wire Pt100 sensor but cannot be confirmed due to lack of information or serial number.
- RTD A was tested by connecting the RTD terminals to a multimeter and heating the sensor with a lighter. The resistance increases with exposure to heat, confirming it is in working condition.

*RTD A with working sensor on left.*

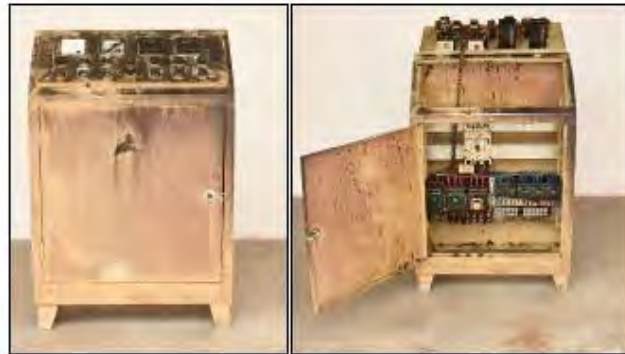
*As-received condition of local control panel.*
